FIELD INSPECTION REPORT

Project Name:	Mountain Valley Pipeline	Inspector:	Matthew Grant
Inspection Date:	Monday, April 4, 2022	Project Contact:	Brian Clauto
Spread G: Montgomery	St11791+86-11900 AR-266.03 ATWS 1487	Weather:	Dry

FIELD INSPECTION PHOTO LOG

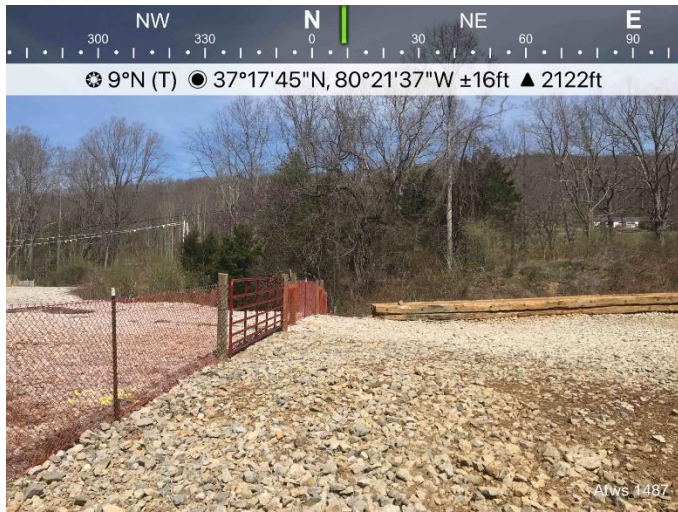
- Figure 1: ATWS 1487 remains dormant and access to ROW locked.

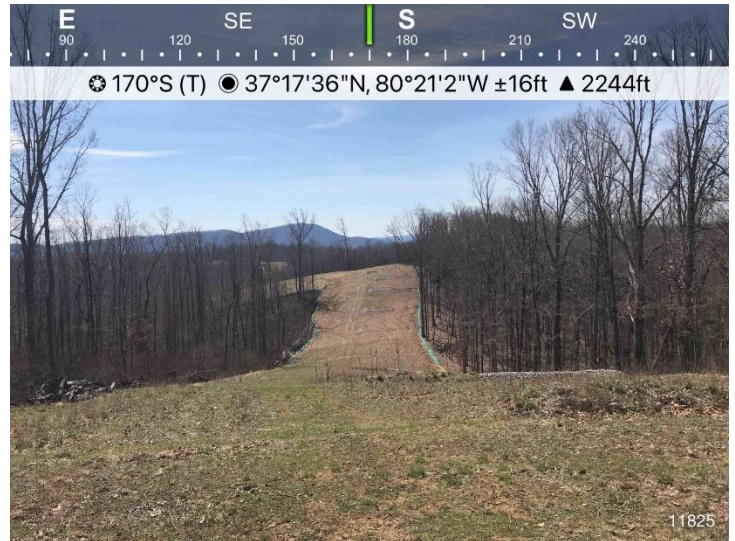
- Figure 2: St11825 is stabilized with ESC and permanent waterbars in place.

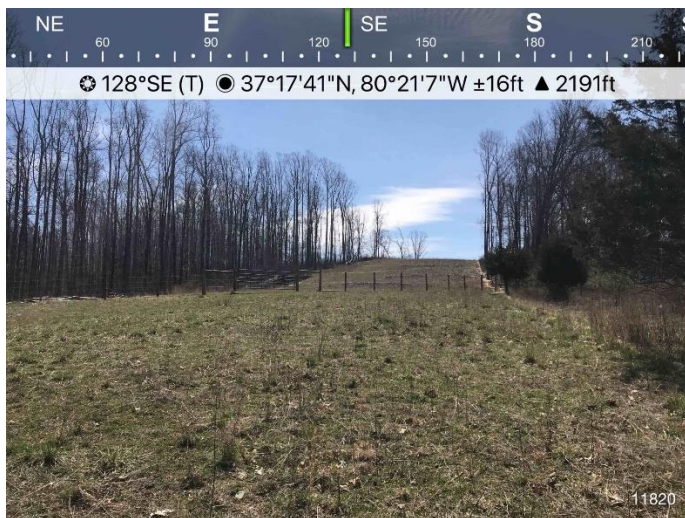
- Figure 3: St 11820 is stabilized

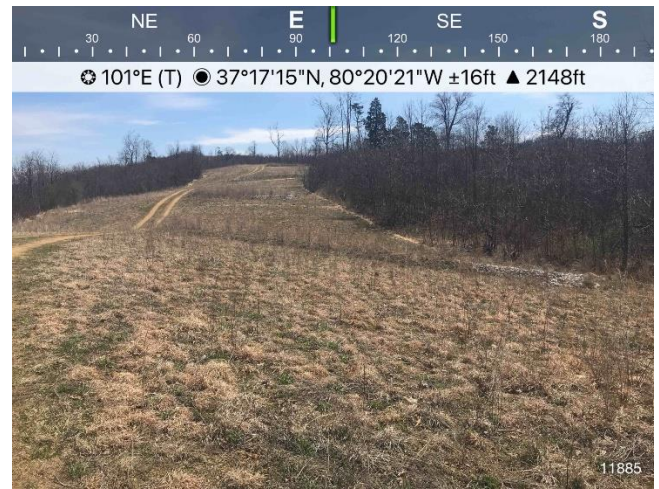
- Figure 4: St 11885 is stabilized and permanent waterbars in place.
