Project Name:	Mountain Valley Pipeline	Inspector:	Matthew Grant		
Inspection Date:	Tuesday, April 19, 2022	Project Contact:	Brian Clauto		
Spread G: Giles	ATWS 1335, 816, 464, 1374, 1056, 1331, 471, 1360, 1333, 1332 AR-GI 240, 241.01, 241.02	Weather:	Dry

## FIELD INSPECTION PHOTO LOG

**Project Name:** Mountain Valley Pipeline

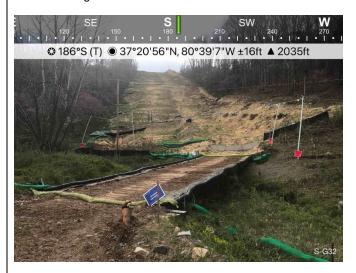
<u>Figure 1</u>: Designated crossing S-G32, ESC's are in place and functioning.

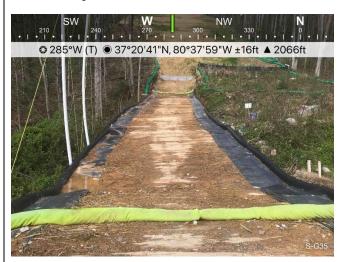
<u>Figure 2</u>: Designated crossing S-G35, ESC's are in place and functioning.

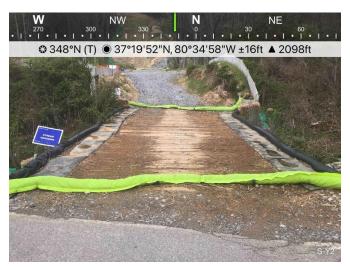
Figure 3: Designated crossing S-Y2, ESC's are in place and functioning.

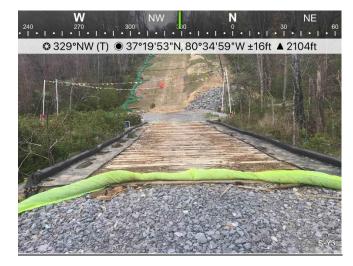
Figure 4: Designated crossing S-Y3, ESC's are in place and functioning.
