Project Name:	Mountain Valley Pipeline	Inspector:	Matthew Grant		
Inspection Date:	Tuesday, June 14, 2022	Project Contact:	Brian Clauto		
Spread G: Montgomery	AR MLV-26 St11668+66-11766+03	Weather:	Dry

FIELD INSPECTION PHOTO LOG

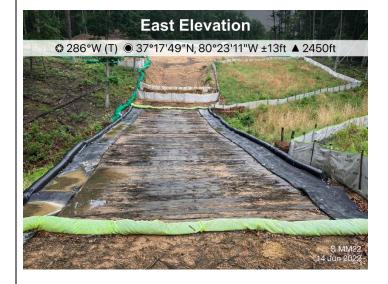
Figure 1: Designated crossing S-MM22, ESC's are in place and functioning.

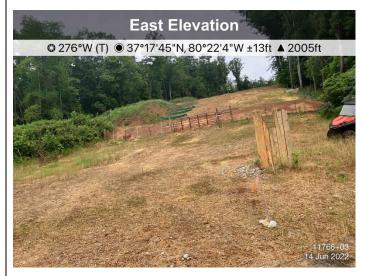
Figure 2: St11766+03, ECD's and stabilization in place.

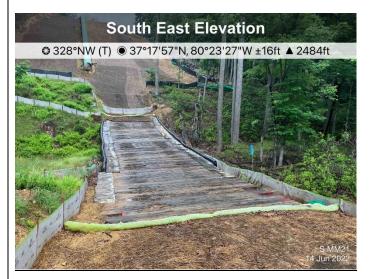
<u>Figure 3</u>: Designated crossing S-MM21, ESC's are in place and functioning.

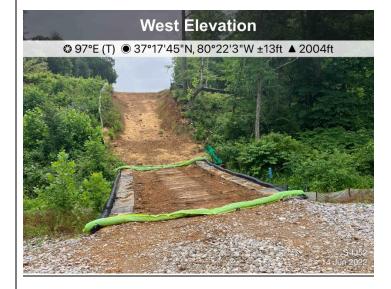
<u>Figure 4</u>: Designated crossing S-IJ52, ESC's are in place and functioning.
