## COMPLAINT INVESTIGATION REPORT

<b>Project Name:</b>	Mountain Valley Pipeline	<b>Inspector:</b>	Marshall Willis
<b>Inspection Date:</b>	Tuesday, July 5, 2022	<b>Project Contact:</b>	Brian Clauto, Cory Chalmers
<b>Spread H: Roanoke County</b>	Garman Road Laydown Yard 049	<b>Weather:</b>	Dry

# FIELD INSPECTION PHOTO LOG

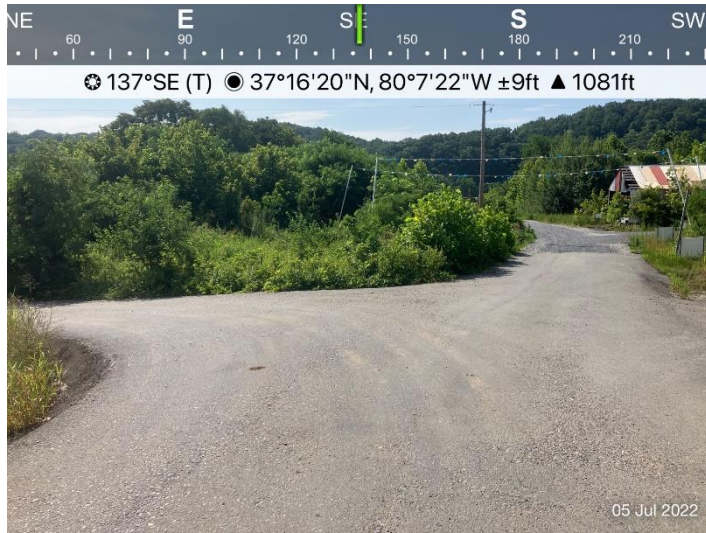
1. Sediment tracking on the road was minimal at the time of inspection and was observed to be coming from dump trucks hauling fill from a site adjacent to the MVP Laydown Yard 049.
2. Further inspection from the MVP site confirmed large un-stabilized fill piles located outside of the MVP LOD on adjacent landowner property to the northeast.
3. Several dump trucks, were observed entering the adjacent site and being loaded with fill material before re-entering onto Garman Rd.
4. Installed ECDs within the MVP LOD were per the approved plans and appeared to be functioning as designed.

**Figure 1: Garman Road** – Looking SE at the end of Garman Rd. toward MVP LY-049 entrance (straight) and towards area of sediment tracking and offsite construction traffic (left).

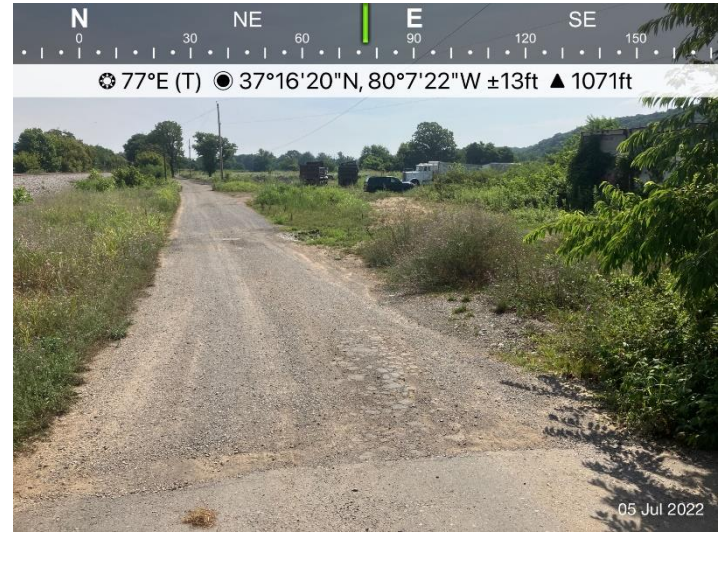
**Figure 2: Garman Road** – Looking E at the end of Garman Rd. towards offsite construction traffic adjacent to MVP LY-049.

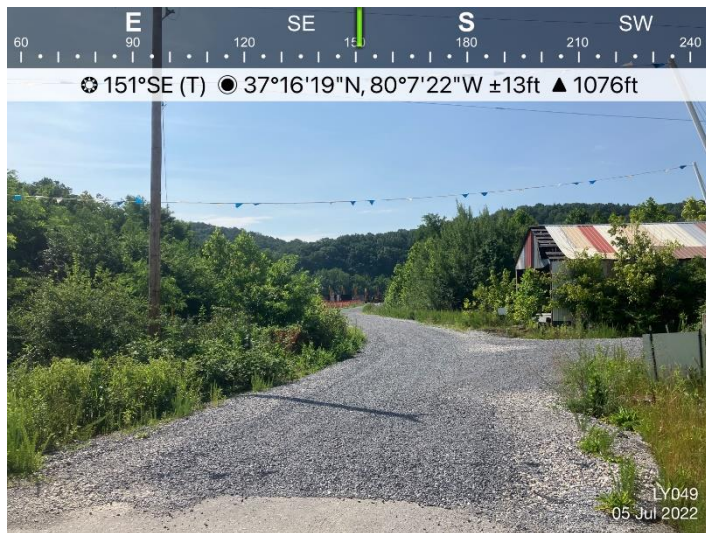
**Figure 3: Garman Road** – Looking SE at the end of Garman Rd. toward MVP LY-049 entrance.

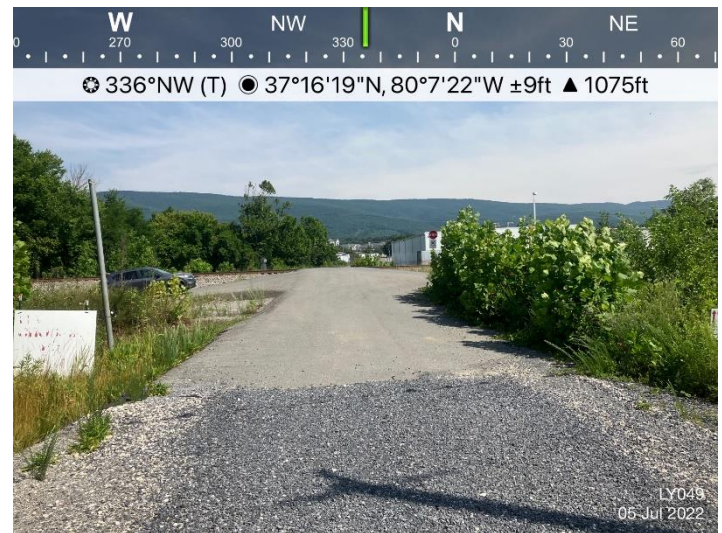
**Figure 4: Laydown Yard 049** – Looking NNW towards Garman Road from the entrance of LY-049.

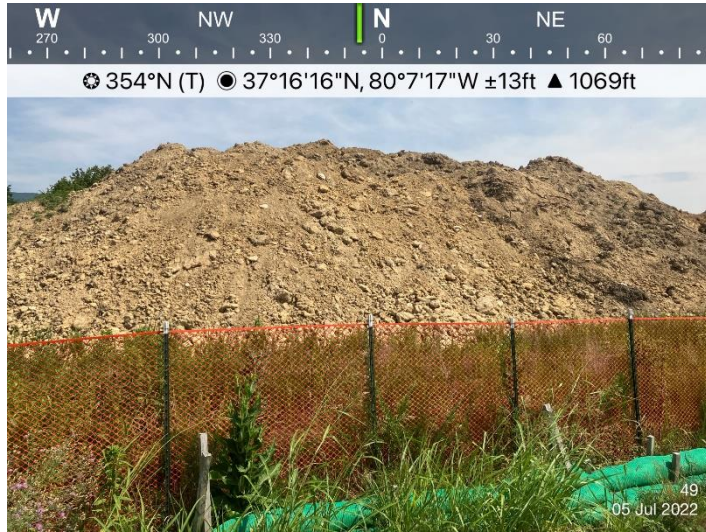
**Figure 5: Laydown Yard 049** – Looking N towards offsite un-stabilized stockpiles. No controls around the stockpiles.

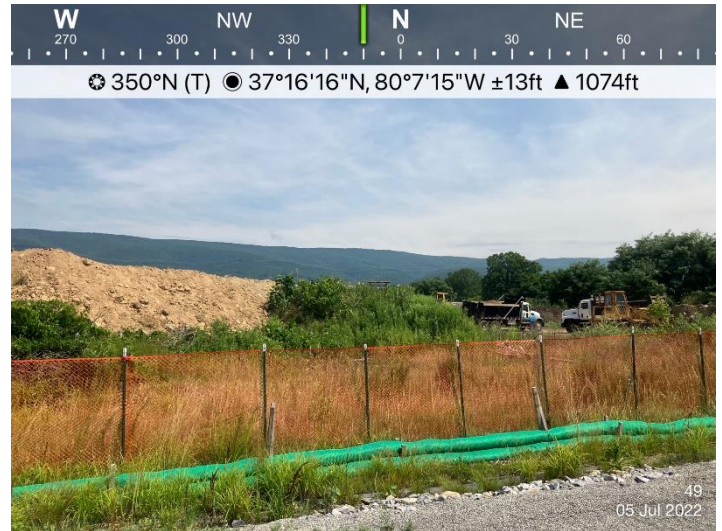
**Figure 6: Laydown Yard 049** – Looking N towards offsite un-stabilized stockpiles. Note truck being loaded with fill material for transport onto Garman Rd.

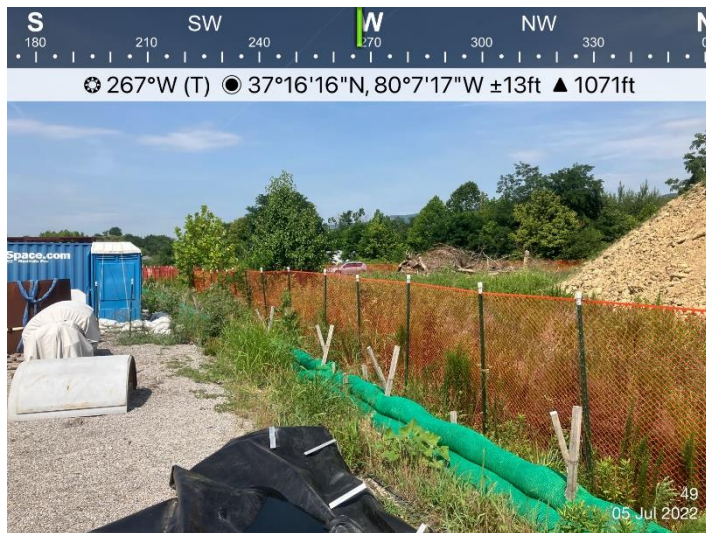
**Figure 7: Laydown Yard 049** – Looking W towards entrance of LY-049. Controls are in place and functioning properly. Note offsite un-stabilized stockpile on left.

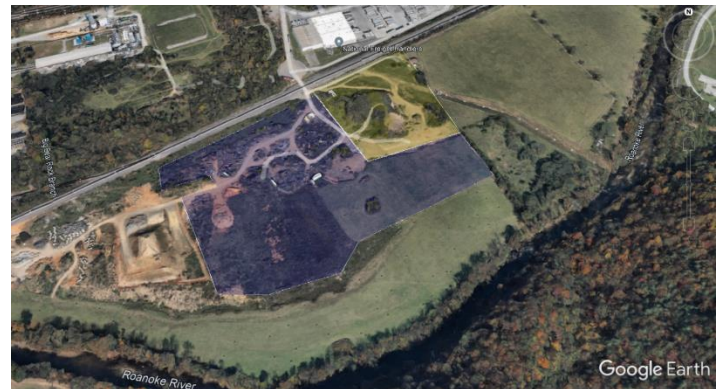
**Figure 7: Laydown Yard 049** – Approximate area of LY-049 shown in blue. Offsite location shown in yellow.
