FIELD INSPECTION REPORT

Project Name:	Mountain Valley Pipeline	Inspector:	Marshall Willis
Inspection Date:	Monday, April 4, 2022	Project Contact:	Brian Clauto, Cory Chalmers
Spread G: Montgomery County	STA 11788+23 – 11900+00 MVP-MN-266.03	Weather:	Dry

FIELD INSPECTION PHOTO LOG

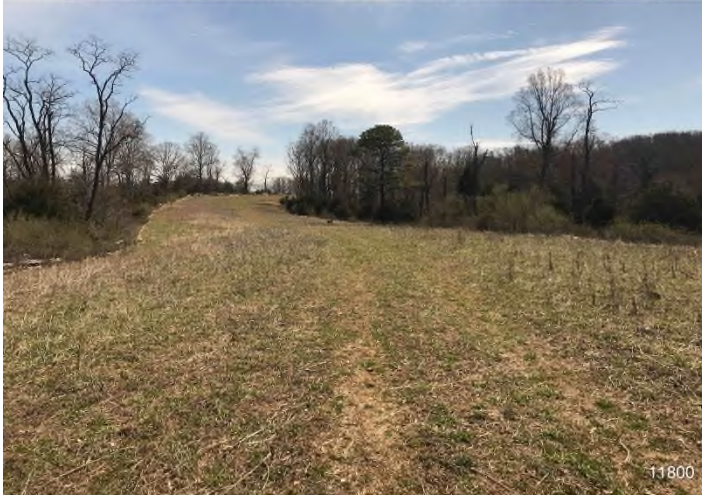
11800

Figure 1: STA 11800+00 – Controls in place and functioning properly.

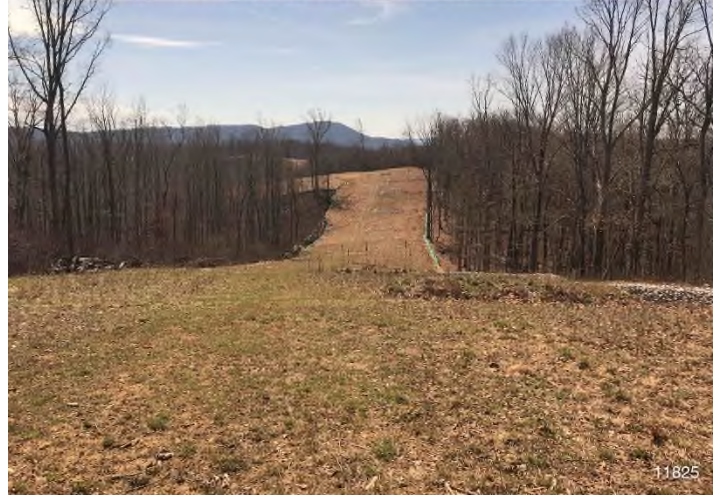
11825

Figure 2: STA 11825+00 – Controls in place and functioning properly.

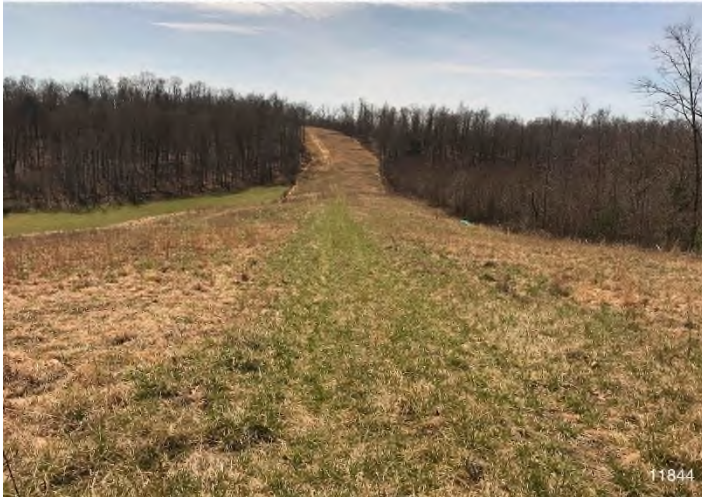
11844

Figure 3: STA 11844+00 – Controls in place and functioning properly.

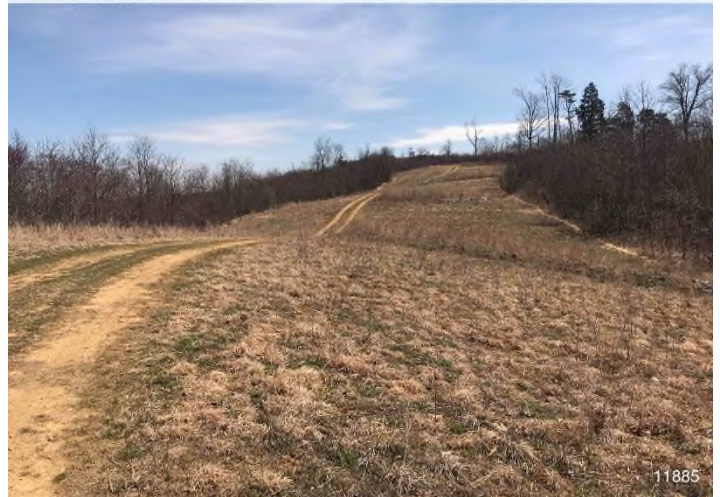
11885

Figure 4: STA 11885+00 – Controls in place and functioning properly.
