FIELD INSPECTION REPORT

Project Name:	Mountain Valley Pipeline	Inspector:	Marshall Willis
Inspection Date:	Tuesday, July 26, 2022	Project Contact:	Brian Clauto, Cory Chalmers
Spread G: Giles County	STA 10749+71 – 10798+83	Weather:	Wet

FIELD INSPECTION PHOTO LOG

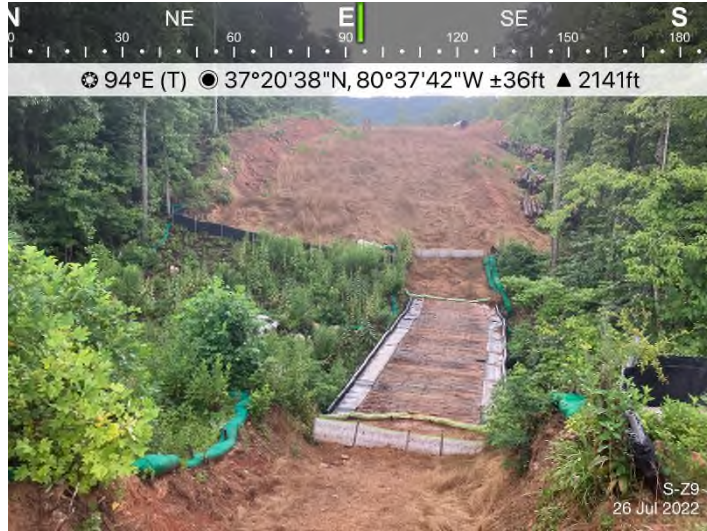
Figure 1: Stream S-Z9 – Controls in place and functioning properly.

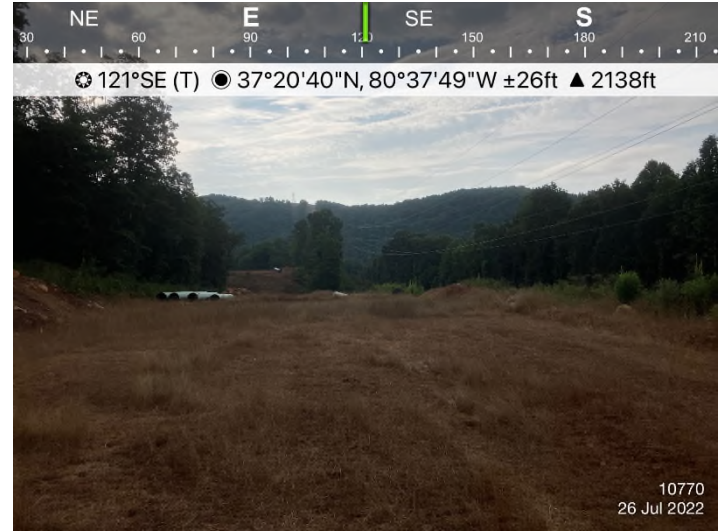
Figure 2: STA 10770+00 – Controls in place and functioning properly.

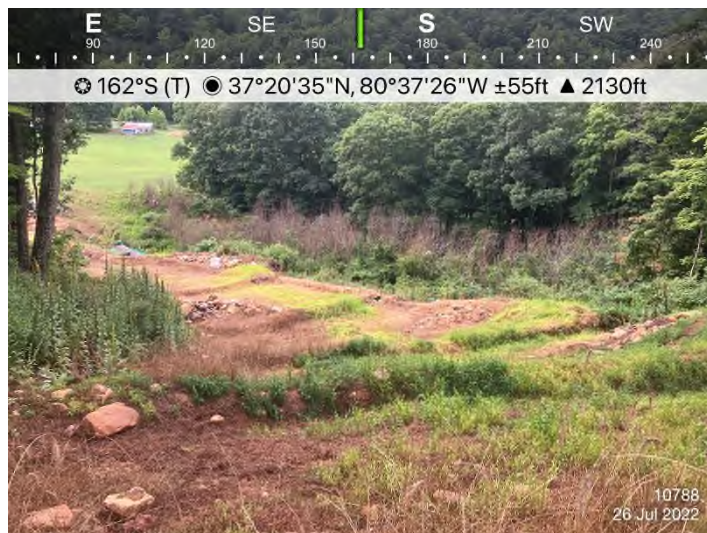
Figure 3: STA 10788+00 – Controls in place and functioning properly.

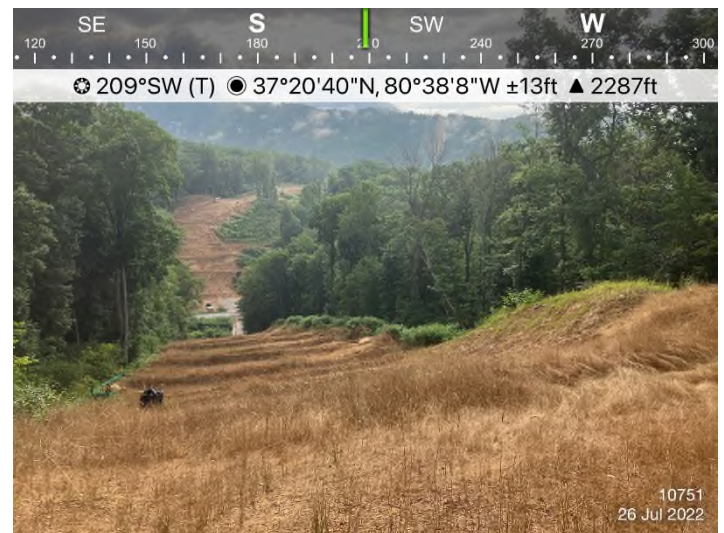
Figure 4: STA 10751+00 – Controls in place and functioning properly.
