## FIELD INSPECTION REPORT

Project Name:	Mountain Valley Pipeline	Inspector:	Marshall Willis
Inspection Date:	Tuesday, July 12, 2022	Project Contact:	Brian Clauto, Cory Chalmers
Spread G: Giles County	STA 11023+80 - 11098+43 MVP-GI-244/245.02	Weather:	Dry

## FIELD INSPECTION PHOTO LOG

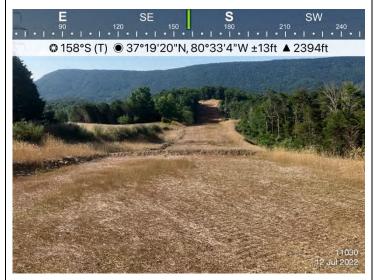
<u>Figure 1</u>: **STA 11030+00** – Controls in place and functioning properly.

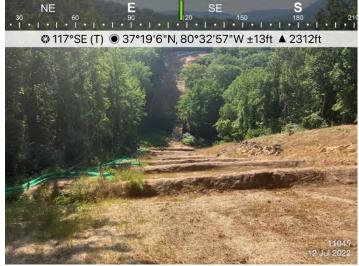
Figure 2: STA 11045+00 – Controls in place and functioning properly.

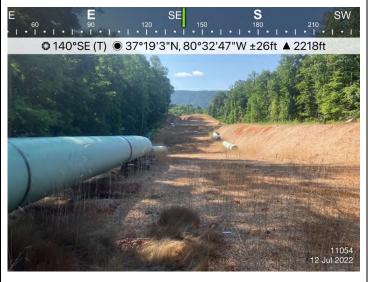
<u>Figure 3</u>: **STA 11054+00** – Controls in place and functioning properly.

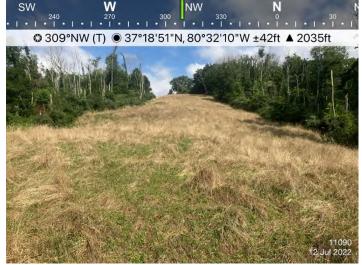
Figure 4: **STA 11090+00** – Controls in place and functioning properly.
