## FIELD INSPECTION REPORT

Project Name:	Mountain Valley Pipeline	Inspector:	Marshall Willis
Inspection Date:	Monday, July 11, 2022	Project Contact:	Brian Clauto, Cory Chalmers
Spread G: Giles County	STA 10819+00 - 10859+34 MVP-GI-241.03/241.02	Weather:	Wet

## FIELD INSPECTION PHOTO LOG

**Project Name:** Mountain Valley Pipeline

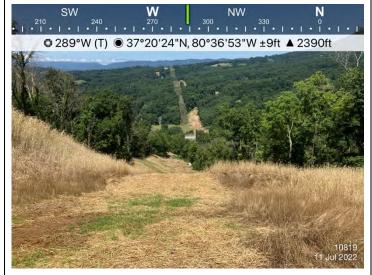
<u>Figure 1</u>: **STA 10819+00** – Controls in place and functioning properly.

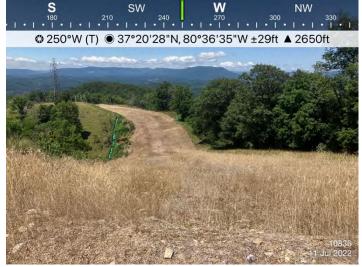
<u>Figure 2:</u> **STA 10836+00** – Controls in place and functioning properly.

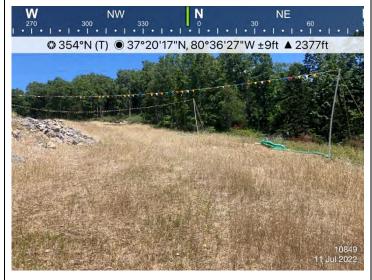
<u>Figure 3</u>: **STA 10849+00** – Controls in place and functioning properly.

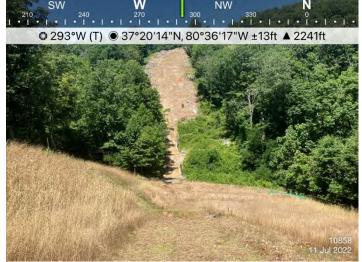
Figure 4: **STA 10858+00** – Controls in place and functioning properly.
