FIELD INSPECTION REPORT

Project Name:	Mountain Valley Pipeline	Inspector:	Marshall Willis
Inspection Date:	Thursday, July 7, 2022	Project Contact:	Brian Clauto, Cory Chalmers
Spread G: Giles County	STA 11254+88 – 11298+30 MVP-GI-253.02	Weather:	Dry

FIELD INSPECTION PHOTO LOG

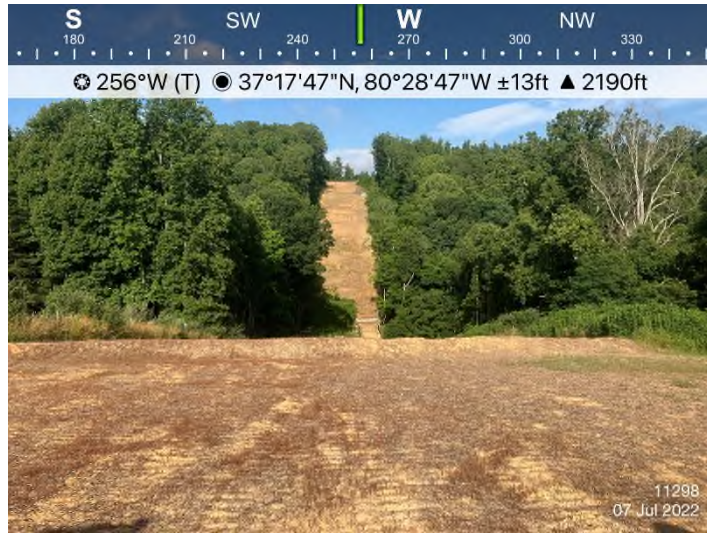
Figure 1: STA 11298+00 – Controls in place and functioning properly.

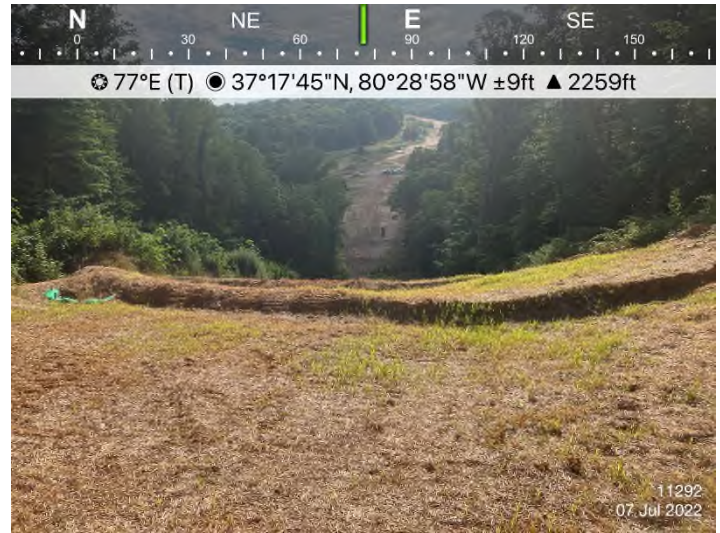
Figure 2: STA 11292+00 – Controls in place and functioning properly.

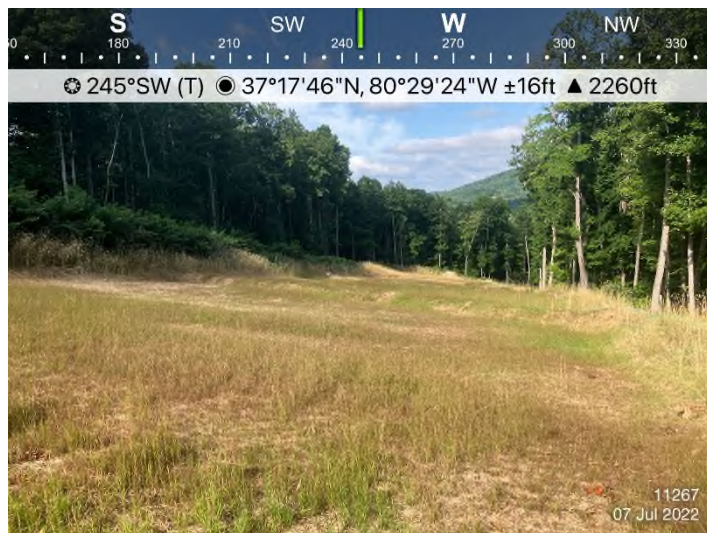
Figure 3: STA 11267+00 – Controls in place and functioning properly.

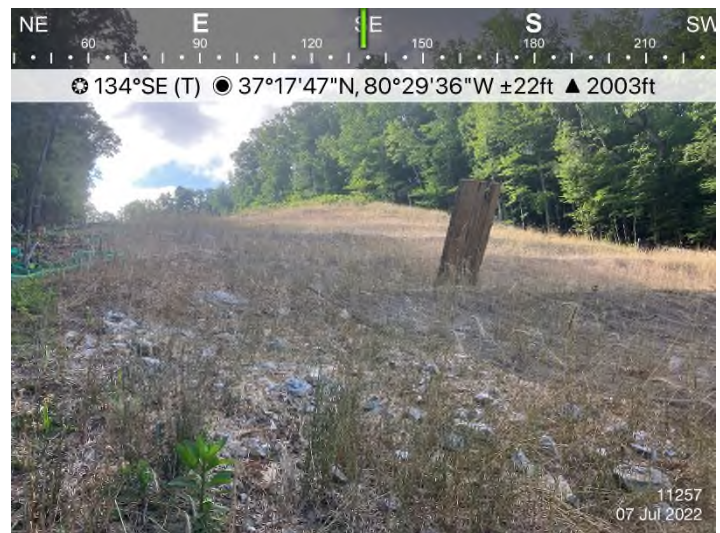
Figure 4: STA 11257+00 – Controls in place and functioning properly.
