FIELD INSPECTION REPORT

Project Name:	Mountain Valley Pipeline	Inspector:	Marshall Willis
Inspection Date:	Monday, June 27, 2022	Project Contact:	Brian Clauto, Cory Chalmers
Spread G: Giles County	STA 10593+00 - 10602+18 STA 10660+00 - 10674+92 STA 10705+00 - 10712+73 MVP-GI-238 MVP-LY-029 MVP-GI-240/241.01	Weather:	Rainy

FIELD INSPECTION PHOTO LOG

Project Name: Mountain Valley Pipeline

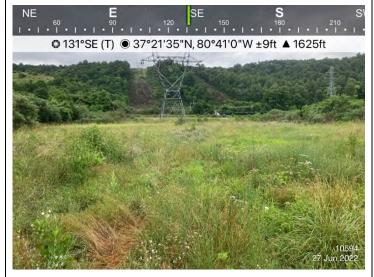
<u>Figure 1</u>: **STA 10594+00** – Controls in place and functioning properly.

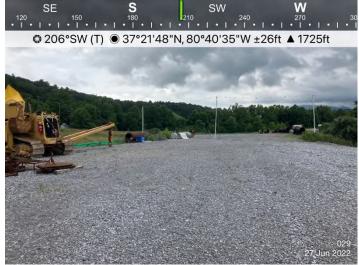
<u>Figure 2:</u> Laydown Yard 029 – Controls in place and functioning properly.

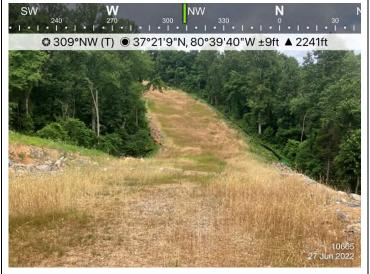
<u>Figure 3</u>: **STA 10665+00** – Controls in place and functioning properly.

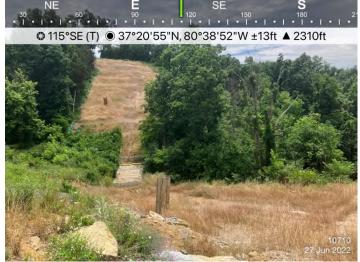
Figure 4: STA 10710+00 – Controls in place and functioning properly.
