FIELD INSPECTION REPORT

Project Name:	Mountain Valley Pipeline	Inspector:	Marshall Willis
Inspection Date:	Tuesday, June 14, 2022	Project Contact:	Brian Clauto, Cory Chalmers
Spread G: Montgomery County	STA 11670+00 – 11770+00 MVP-MLV-AR-26	Weather:	Rainy

FIELD INSPECTION PHOTO LOG

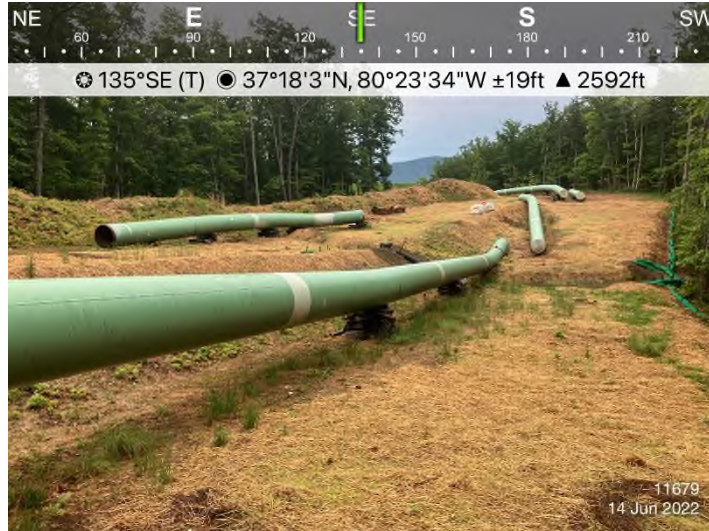
Figure 1: STA 11679+00 – Controls in place and functioning properly. Area stabilized with straw.

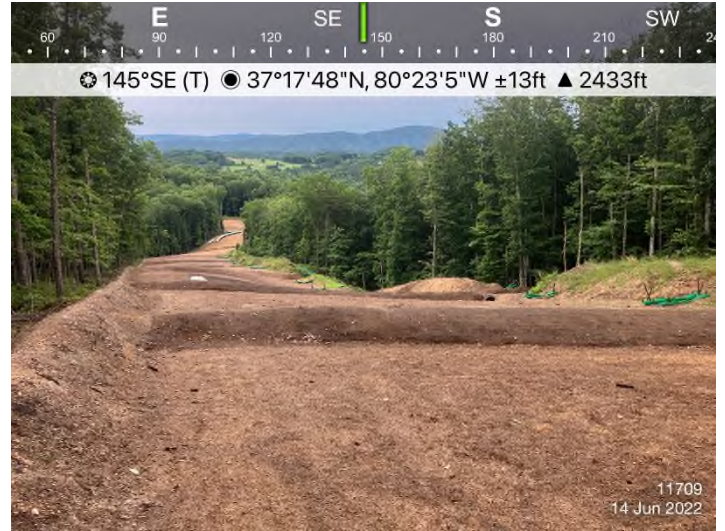
Figure 2: STA 11709+00 – Controls in place and functioning properly. Area stabilized with straw.

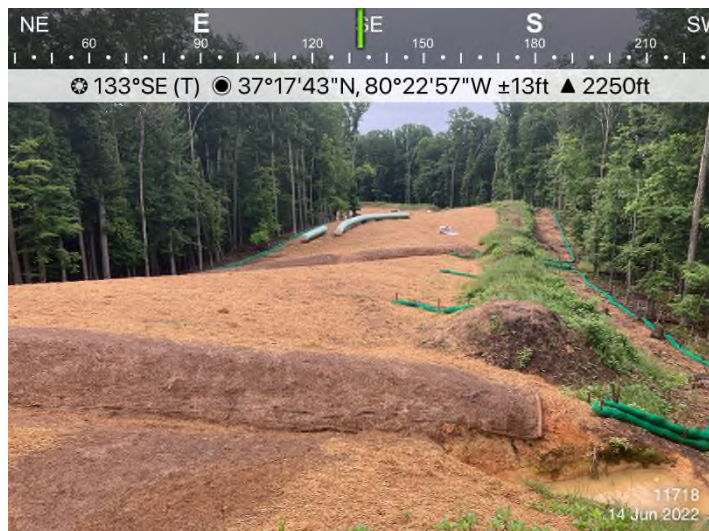
Figure 3: STA 11718+00 – Controls in place and functioning properly. Area stabilized with straw.

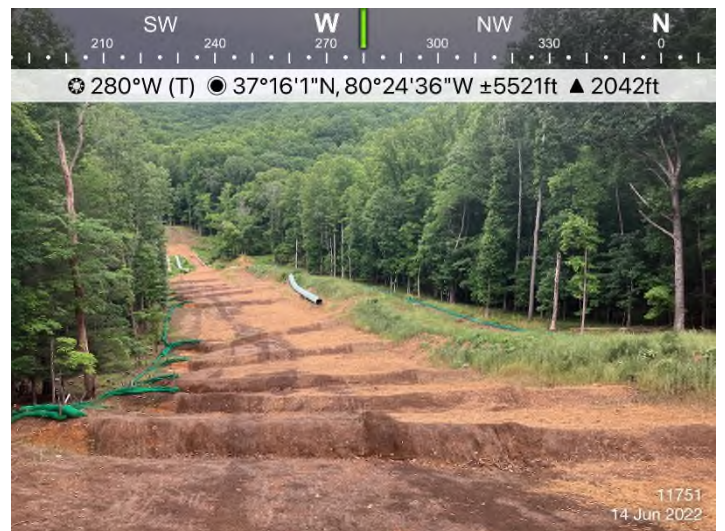
Figure 4: STA 11751+00 – Controls in place and functioning properly. Area stabilized with straw.
