FIELD INSPECTION REPORT

Project Name:	Mountain Valley Pipeline	Inspector:	Marshall Willis
Inspection Date:	Wednesday, May 11, 2022	Project Contact:	Brian Clauto, Cory Chalmers
Spread G: Giles County	STA 10929+71 – 11023+80 MVP-GI-244/234	Weather:	Dry

FIELD INSPECTION PHOTO LOG

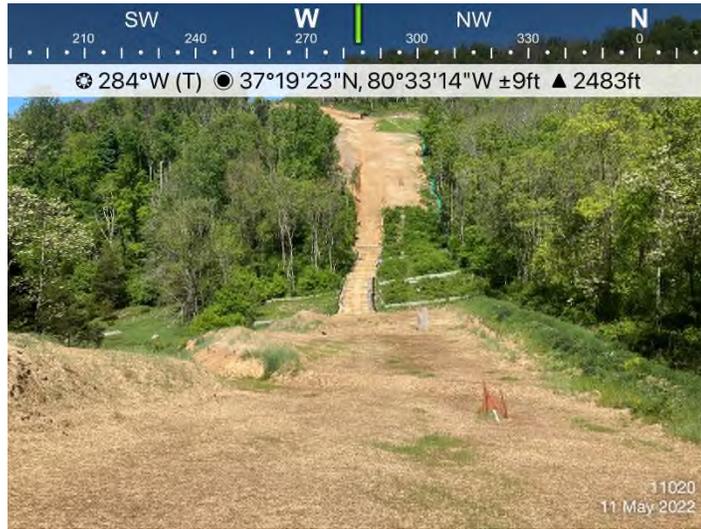
Figure 1: STA 11020+00 – Controls in place and functioning properly. Area stabilized with straw.

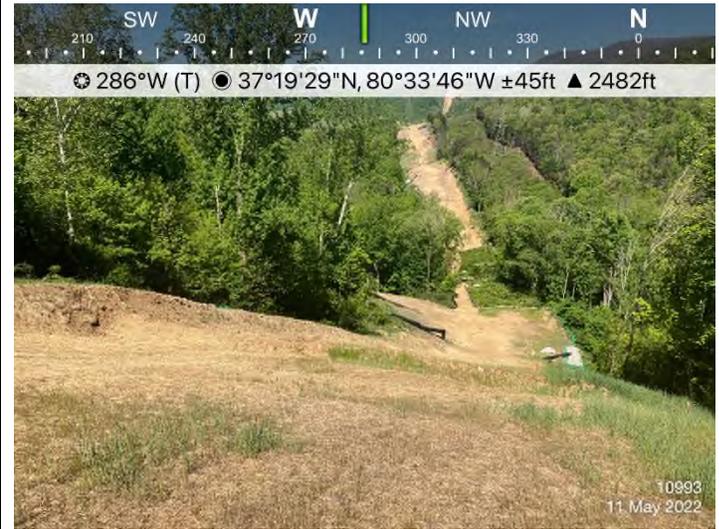
Figure 2: STA 10993+00 – Controls in place and functioning properly. Area stabilized with straw.

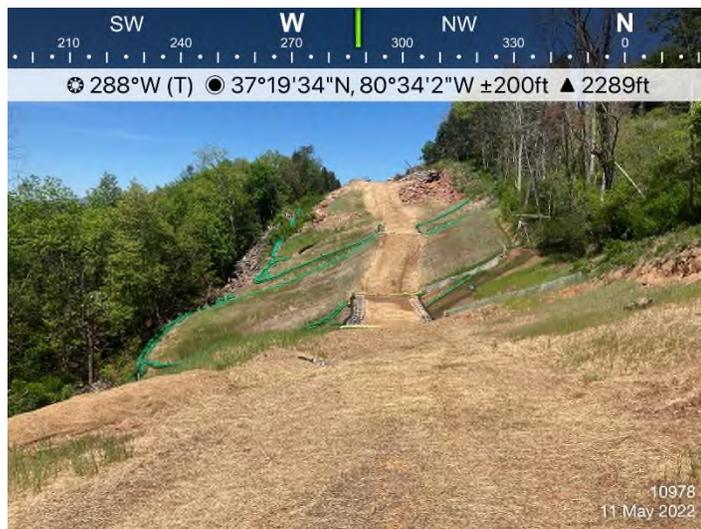
Figure 3: STA 10978+00 – Controls in place and functioning properly. Area stabilized with straw.

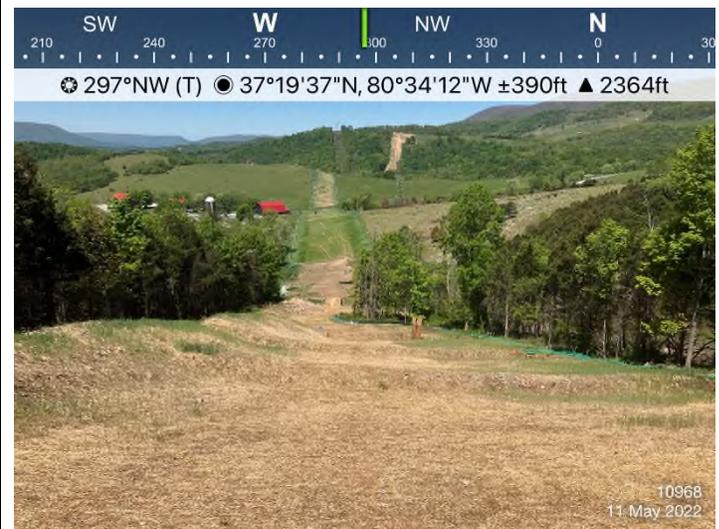
Figure 4: STA 10968+00 – Controls in place and functioning properly. Area stabilized with straw.
