## **FIELD INSPECTION REPORT**

Project Name:	Mountain Valley Pipeline	Inspector:	Marshall Willis
Inspection Date:	Tuesday, April 19, 2022	Project Contact:	Brian Clauto, Cory Chalmers
Spread G: Montgomery County	STA 11596+94 - 11620+00 MVP-MN-258.03/258.04/258.05	Weather:	Wet

## FIELD INSPECTION PHOTO LOG

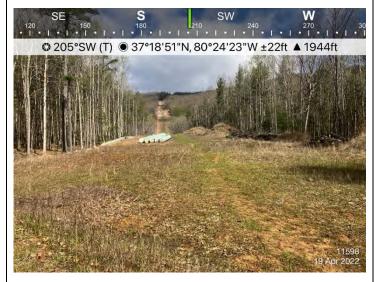
Figure 1: **STA 11598+00** – Controls in place and functioning properly.

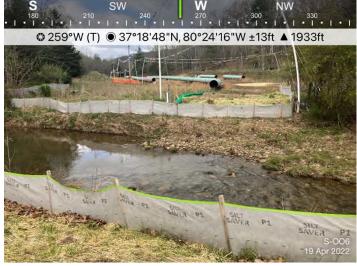
<u>Figure 2:</u> **Stream S-OO6** – Controls in place and functioning properly along Craig Creek crossing.

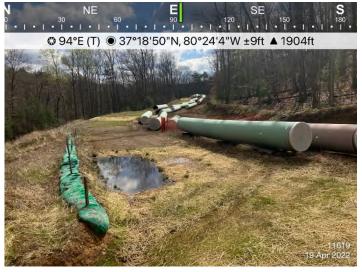
<u>Figure 3</u>: **STA 11619+00** – Controls in place and functioning properly.

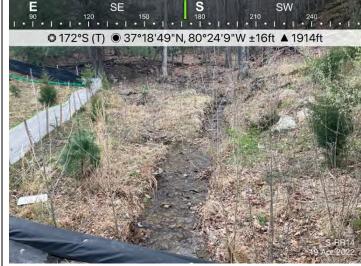
<u>Figure 4</u>: **Stream S-RR14** – Controls in place and functioning properly along stream crossing.
