## FIELD INSPECTION REPORT

<b>Project Name:</b>	Mountain Valley Pipeline	<b>Inspector:</b>	Matthew Grant
<b>Inspection Date:</b>	Monday, August 22, 2022	<b>Project Contact:</b>	Brian Clauto
<b>Spread G: Giles</b>	AR GI 241.03, 241.02 St10820-10804	<b>Weather:</b>	Wet

# FIELD INSPECTION PHOTO LOG

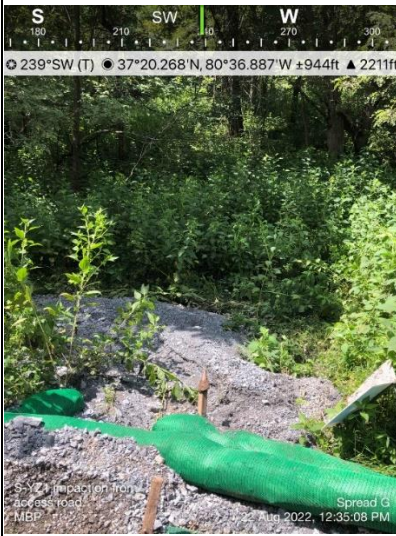
Designated stream S-YZ1 has been impacted approximately 2000 ft. with access road stone. Remove sediment/stone per FERC approval and land owner approval.

- Figure 1: Designated stream S-Z1 has been impacted by access road stone.

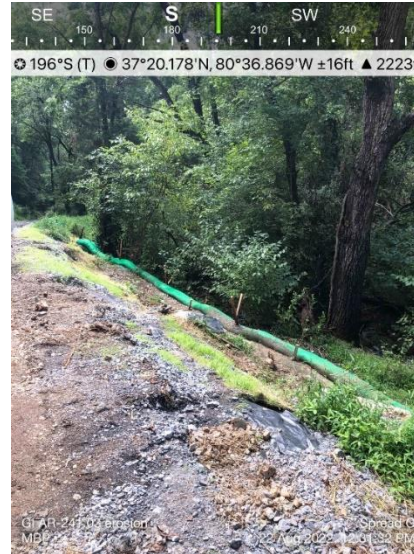
Access road 241.03 has areas of erosion and will require repair.

- Figure 2: AR GI 241.03 has areas of erosion that will require repair.

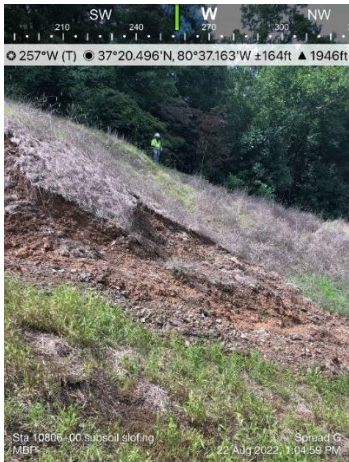
- Figure 3: St10805 subsoil stockpile has slipped and will require repair.

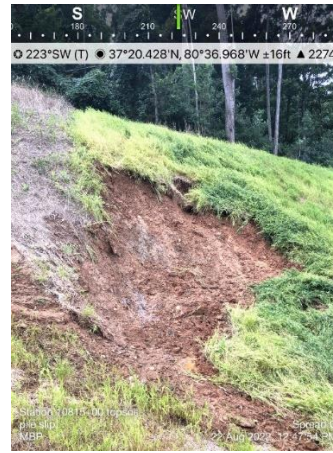
ST 10806+00, STA 10808+00, & STA10815+00 sloughing of subsoil pile, repair and restabilize subsoil pile.

- Figure 4: St10806 subsoil stockpile has slipped and will require repair.

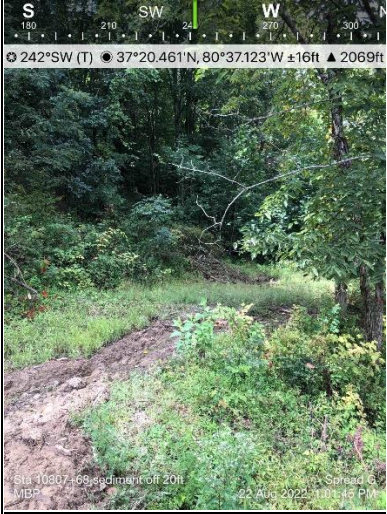
St 10807+68 Retrieve sediment that is outside the limit of disturbance approximately 15 ft. to 20 ft. and restabilize the disturbed area.

■ **Figure 5:** St10807+68 sediment has escaped off LOD.
