FIELD INSPECTION REPORT

Project Name:	Mountain Valley Pipeline	Inspector:	Matthew Grant
Inspection Date:	Monday, December 5, 2022	Project Contact:	Brian Clauto
Spread G: Giles	ATWS 1334, 469, 1391, 1390, 464 St 10710+13-10750 GI 241.04, 241.02	Weather:	Dry

FIELD INSPECTION PHOTO LOG

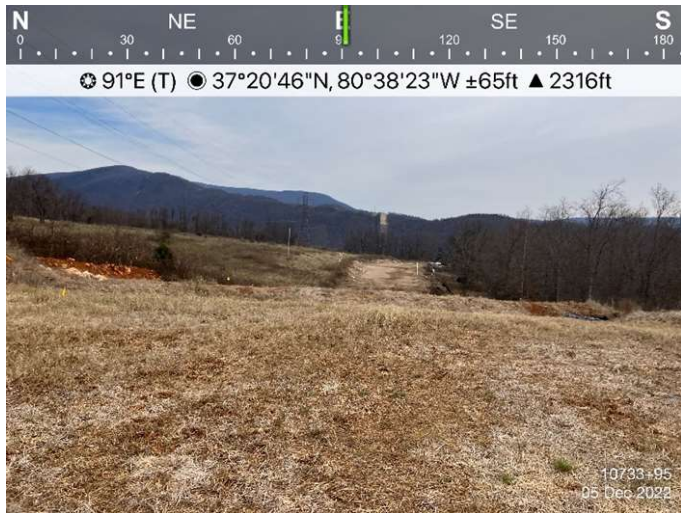
Figure 1: St 10733+95, area is stabilized and ECD's are in place.

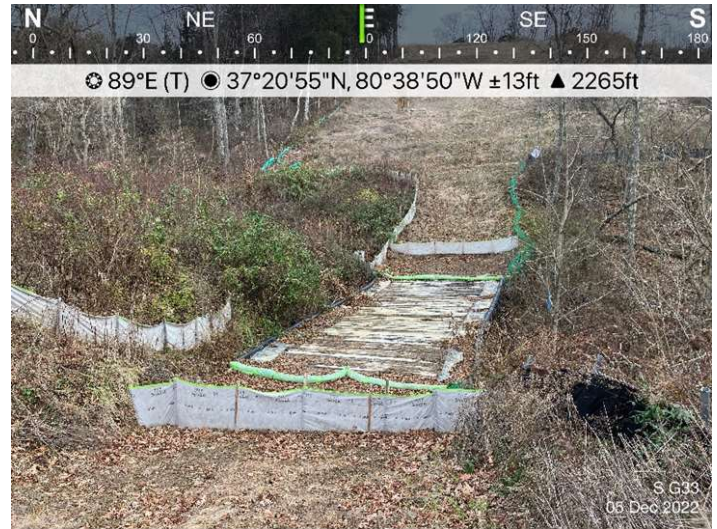
Figure 2: Designated crossing S-G33, ECD's are in place.

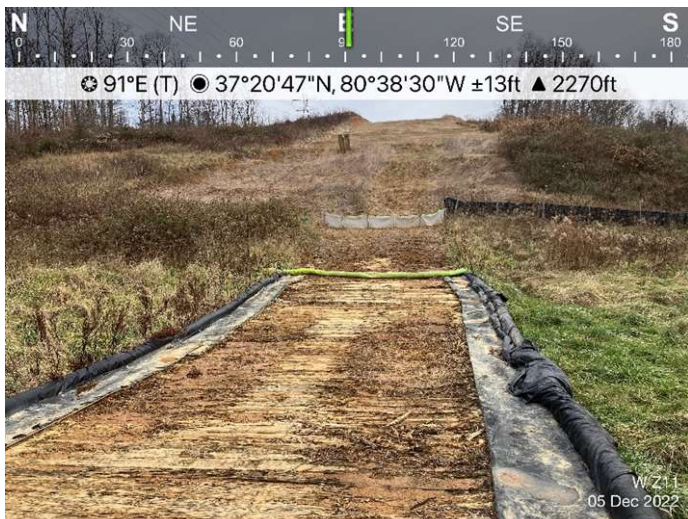
Figure 3: Designated crossing W-Z11, ECD's are in place.

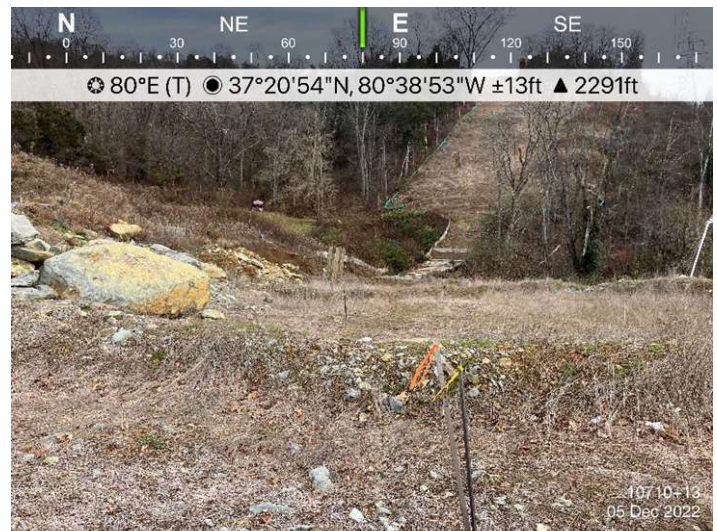
Figure 4: St 10710+13, area is stabilized and ECD's are in place.
