Project Name:	Mountain Valley Pipeline	Inspector:	Matthew Grant
Inspection Date:	Monday, November 28, 2022	Project Contact:	Brian Clauto
Spread G: Giles	ATWS 1370, 1370A St 11297-11252 GI 253.02	Weather:	Wet

FIELD INSPECTION PHOTO LOG

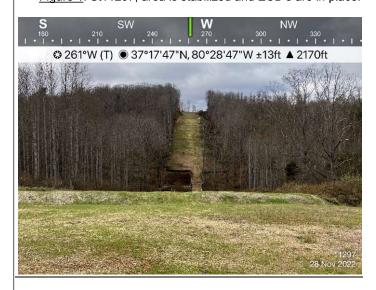
Figure 1: St11297, area is stabilized and ECD's are in place.

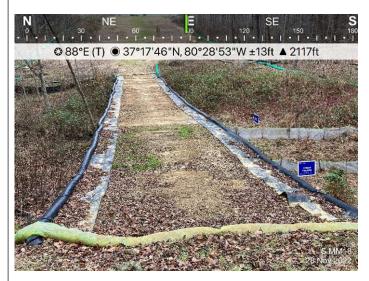
Figure 2: Designated crossing S-MM18, ECD's are in place.

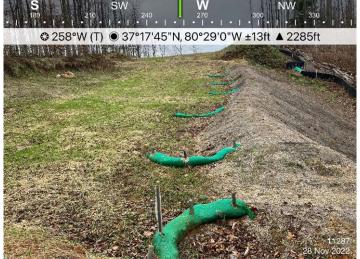
Figure 4: St11287, area is stabilized and ECD's are in place.
