FIELD INSPECTION REPORT

Project Name:	Mountain Valley Pipeline	Inspector:	Matthew Grant
Inspection Date:	Tuesday, November 1, 2022	Project Contact:	Brian Clauto
Spread G: Montgomery	ATWS 1487 St 11900-11790 MN 266.03	Weather:	Wet

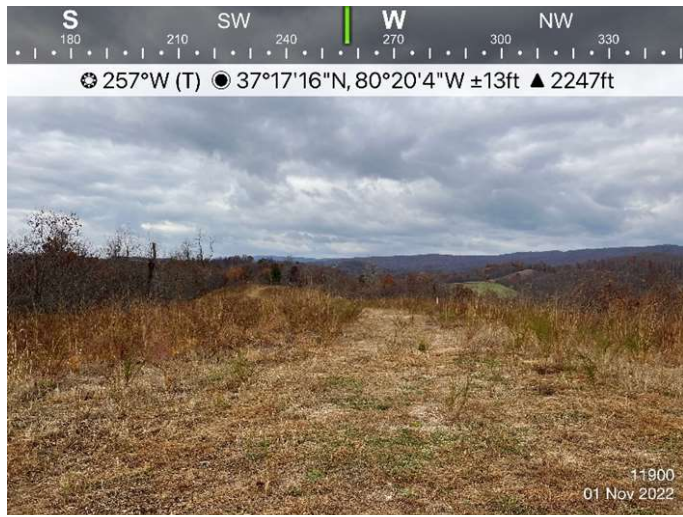
Figure 1: St 11900, area is stabilized and ECD's are in place.

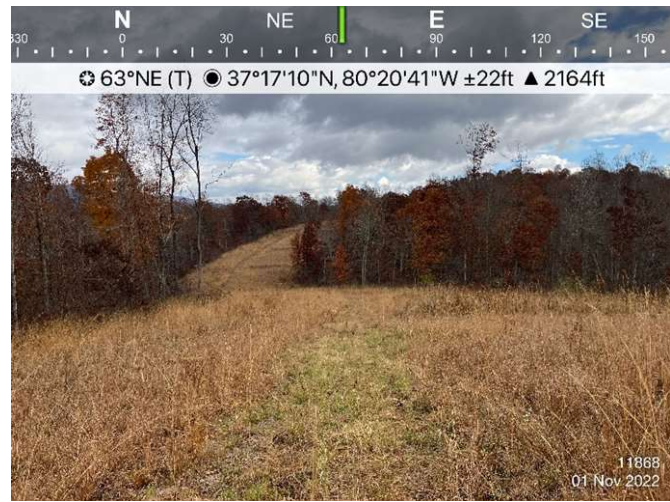
Figure 2: St 11868, area is stabilized and ECD's are in place.

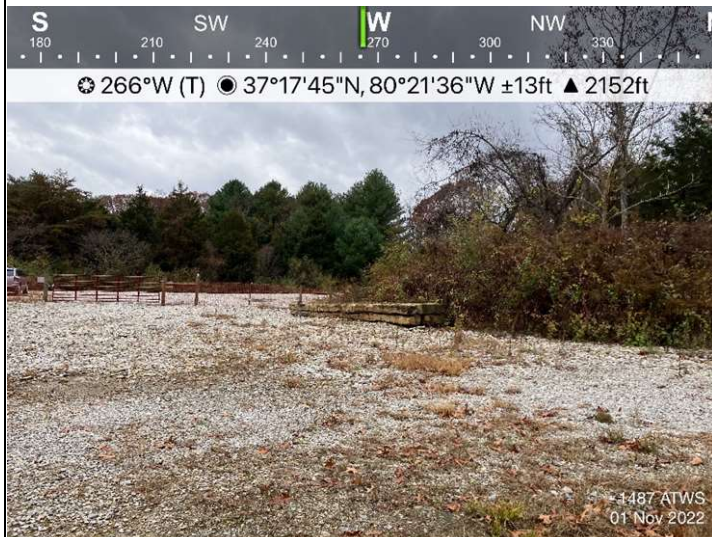
Figure 3: ATWS 1487, ECD's are in place.

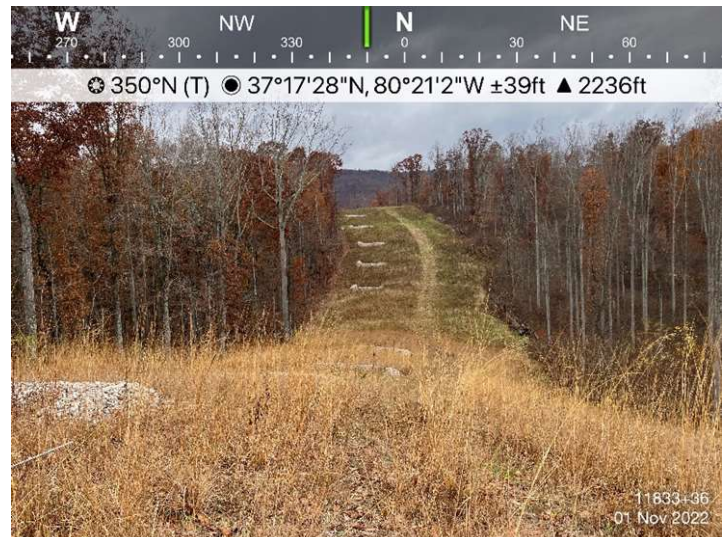
Figure 4: St 11833+36, area is stabilized and ECD's are in place.
