Project Name:	Mountain Valley Pipeline	Inspector:	Matthew Grant
Inspection Date:	Tuesday, October 18, 2022	Project Contact:	Brian Clauto
Spread G: Giles	ATWS 1331, 471 St 10928-10973 GI 242.01	Weather:	Dry

## FIELD INSPECTION PHOTO LOG

**Project Name: Mountain Valley Pipeline**

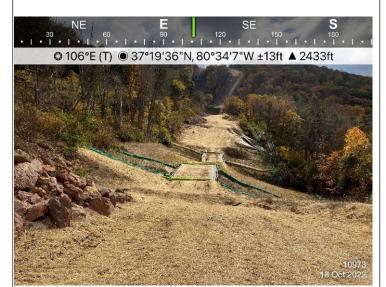
Figure 2: Designated crossing S-Y3 ECD's are in place.

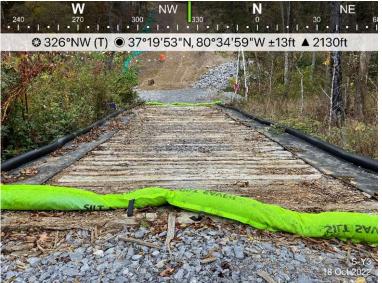
Figure 3: Designated crossing S-Y2, ECD's are in place.

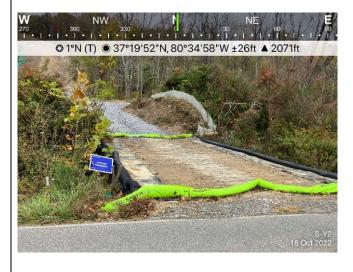
Figure 4: St10940, area is stabilized and ECD's are in place.
