Project Name:	Mountain Valley Pipeline	Inspector:	Matthew Grant
Inspection Date:	Wednesday, October 5, 2022	Project Contact:	Brian Clauto
Spread G: Giles	ATWS 1331, 471, 470, 1333 St 10883+31-10930	Weather:	Dry

FIELD INSPECTION PHOTO LOG

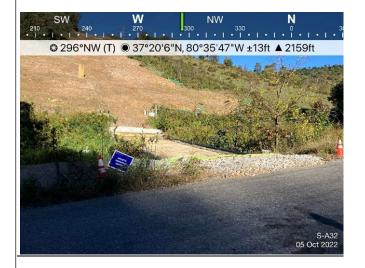
Figure 1: Designated crossing S-A32, ECD's are in place.

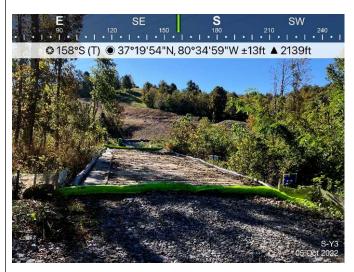
Figure 2: Designated crossing S-Y3 ECD's are in place.
