FIELD INSPECTION REPORT

Project Name:	Mountain Valley Pipeline	Inspector:	Marshall Willis
Inspection Date:	Tuesday, September 27, 2022	Project Contact:	Brian Clauto, Cory Chalmers
Spread G: Giles County	STA 11353+21 – 11471+52 MVP-CR-258.01 MVP-GI-256	Weather:	Dry

FIELD INSPECTION PHOTO LOG

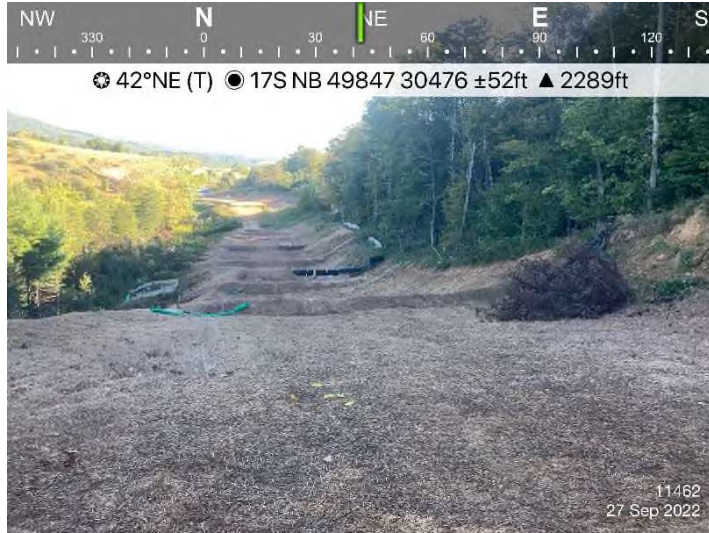
Figure 1: STA 11462+00 – Controls in place and functioning properly. Area stabilized with straw.

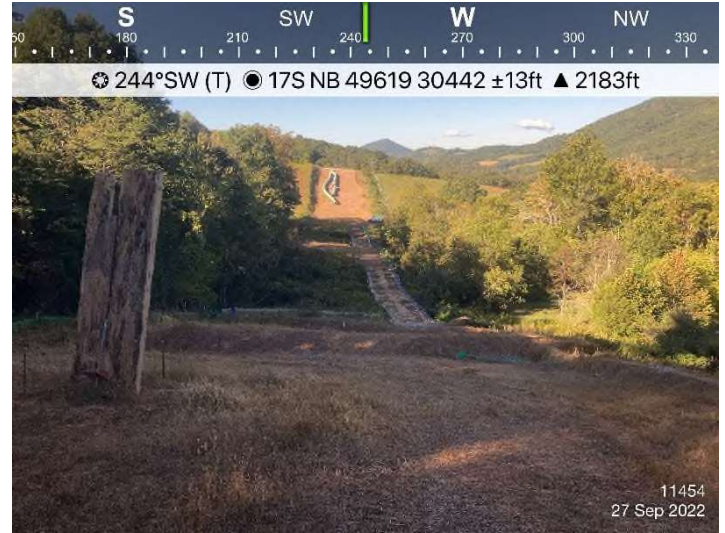
Figure 2: STA 11454+00 – Controls in place and functioning properly. Area stabilized with straw.

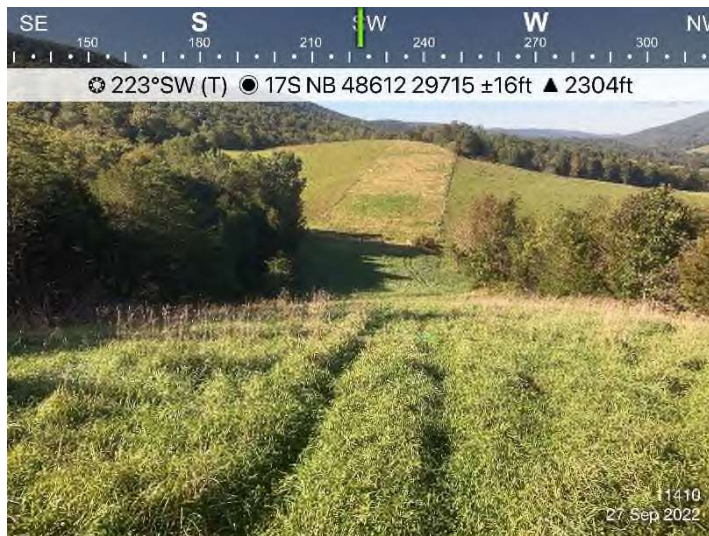
Figure 3: STA 11410+00 – Controls in place and functioning properly.

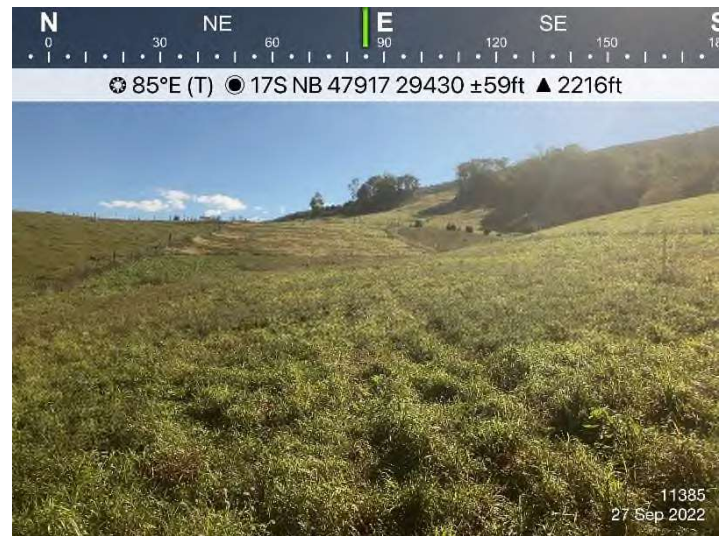
Figure 4: STA 11385+00 – Controls in place and functioning properly.
