Project Name:	Mountain Valley Pipeline	Inspector:	Matthew Grant
Inspection Date:	Tuesday, September 27, 2022	Project Contact:	Brian Clauto
Spread G: Craig	AR CR258.01 St11470-11357	Weather:	Dry

FIELD INSPECTION PHOTO LOG

Project Name: Mountain Valley Pipeline

Date: Tuesday, September 27, 2022

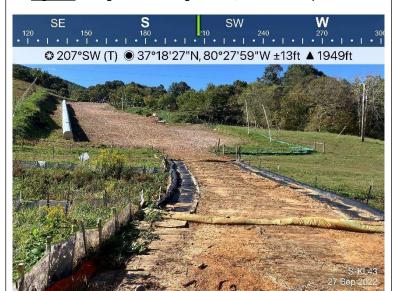
■ Figure 1: Designated crossing S-KL43, ECD's are in place.

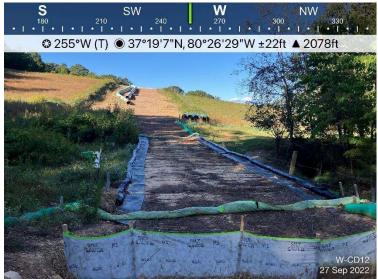
Figure 2: Designated crossing W-CD12, ECD's are in place.

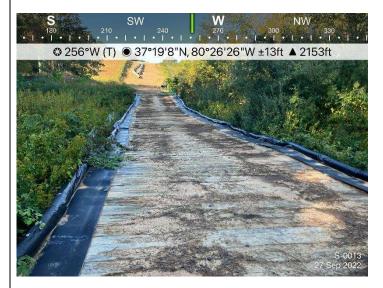
Figure 3: Designated crossing S-0013, ECD's are in place.

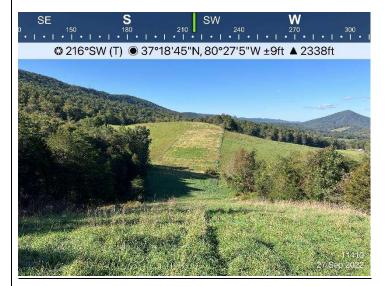
Figure 4: St11410, area is stabilized and ECD's are in place.
