FIELD INSPECTION REPORT

Project Name:	Mountain Valley Pipeline	Inspector:	Matthew Grant
Inspection Date:	Monday, May 15, 2023	Project Contact:	Brian Clauto
Spread G: Giles	AR GI 249.01, 249.02, 243.01, 242.01 ATWS 1331, 471	Weather:	Rainy

FIELD INSPECTION PHOTO LOG

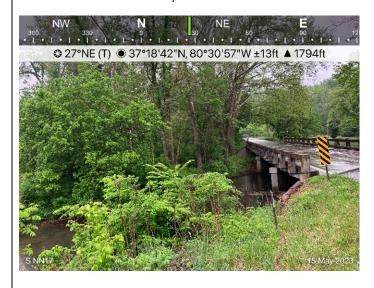
<u>Figure 1</u>: Designated crossing S-NN17, remains undisturbed and ESC measure are in place.

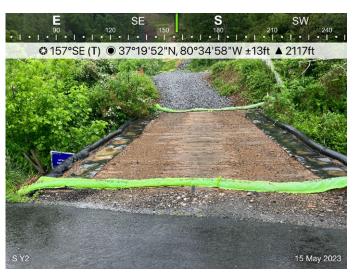
Figure 2: Designated crossing S-Y2, ESC measures in place.

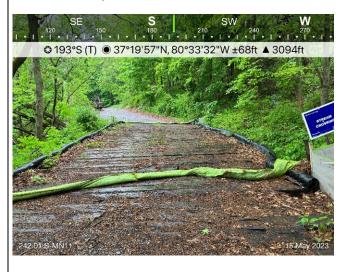
<u>Figure 3:</u> AR GI 242.01 designated crossing S-MN11, ESC measures in place.

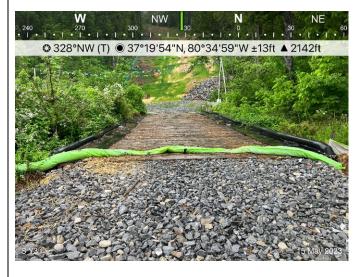
Figure 4: Designated crossing S-Y3, ESC measures in place.
