## FIELD INSPECTION REPORT

Project Name:	Mountain Valley Pipeline	Inspector:	Marshall Willis		
Inspection Date:	Monday, May 15, 2023	Project Contact:	Brian Clauto, Cory Chalmers		
Spread G: Giles County	STA 10929+71 - 10972+00	Weather:	Rainy

## FIELD INSPECTION PHOTO LOG

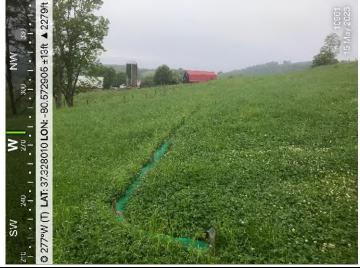
<u>Figure 1</u>: **STA 10961+00** – Permanent vegetative cover established. Ground cover is uniform, mature enough to survive and will inhibit erosion.

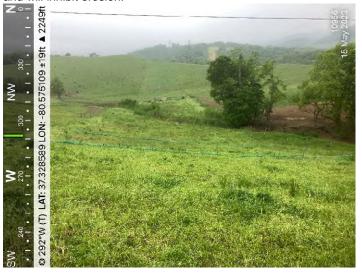
Figure 2: STA 10956+00 – Permanent vegetative cover established. Ground cover is uniform, mature enough to survive and will inhibit erosion.

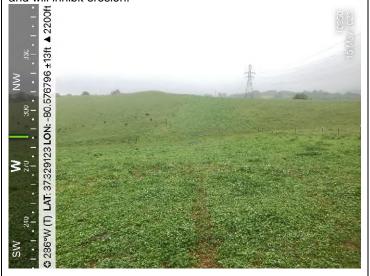
<u>Figure 3</u>: **STA 10950+00** – Permanent vegetative cover established. Ground cover is uniform, mature enough to survive and will inhibit erosion.

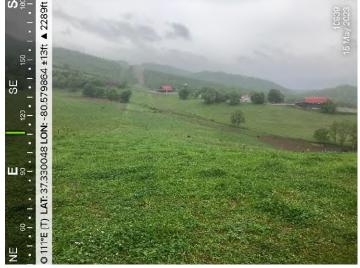
<u>Figure 4</u>: **STA 10939+00** – Permanent vegetative cover established. Ground cover is uniform, mature enough to survive and will inhibit erosion.
