FIELD INSPECTION REPORT

Project Name:	Mountain Valley Pipeline	Inspector:	Matthew Grant
Inspection Date:	Monday, May 22, 2023	Project Contact:	Brian Clauto
Spread G: Montgomery	AR MN 266, 266.03 Sta 11900-11988	Weather:	Dry

FIELD INSPECTION PHOTO LOG

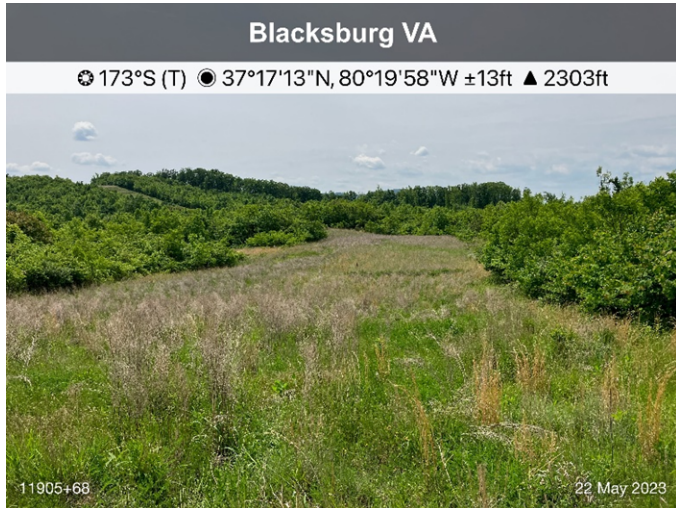
Figure 1: Sta 11905+68 ECD's and stabilization are in place.

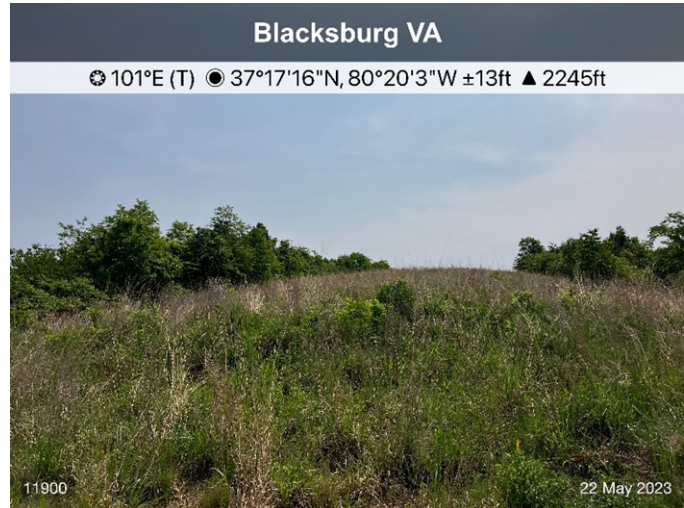
Figure 2: Sta 11900 ECD's and stabilization are in place.

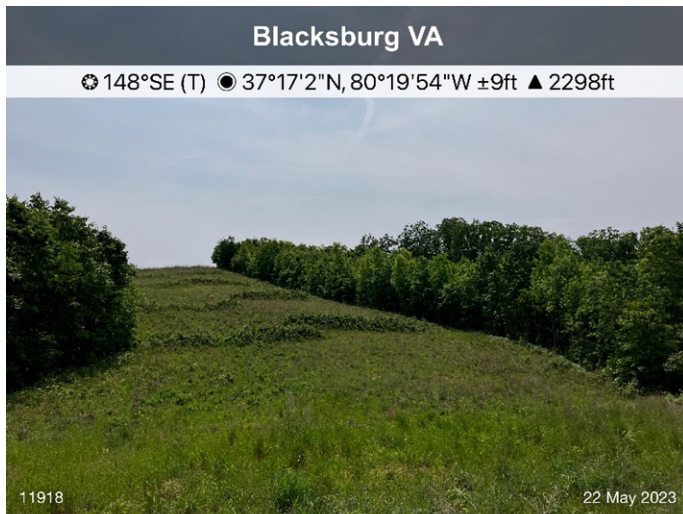
Figure 3: Sta 11918 ECD's and stabilization are in place.

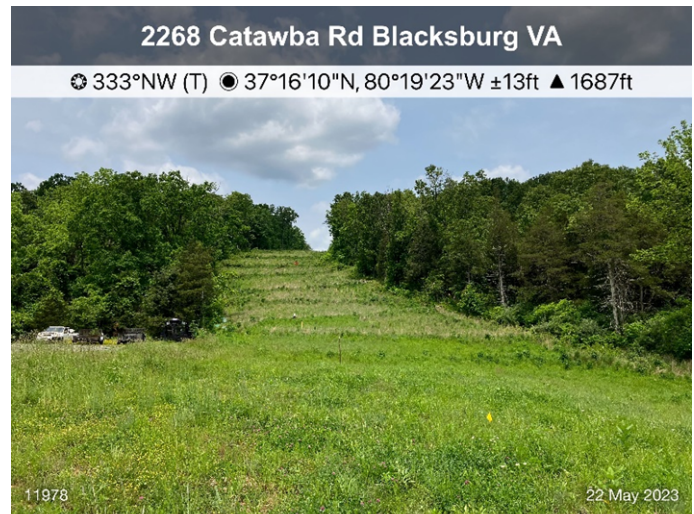
Figure 4: Sta 11978 ECD's and stabilization are in place.
