FIELD INSPECTION REPORT

Project Name:	Mountain Valley Pipeline	Inspector:	Marshall Willis
Inspection Date:	Monday, June 26, 2023	Project Contact:	Brian Clauto, Cory Chalmers
Spread G: Giles County	STA 10930+00 – 11025+00 MVP-GI-244	Weather:	Dry

FIELD INSPECTION PHOTO LOG

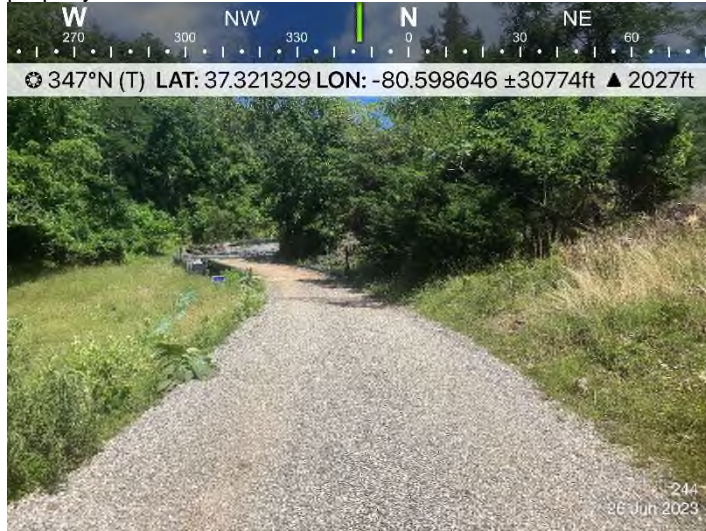
Figure 1: MVP-GI-244 – Controls in place and functioning properly.

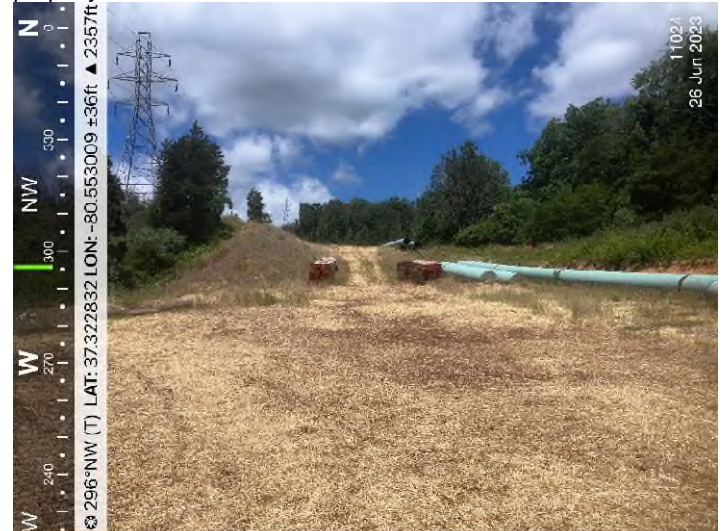
Figure 2: STA 11024+00 – Controls in place and functioning properly. Area stabilized with straw.

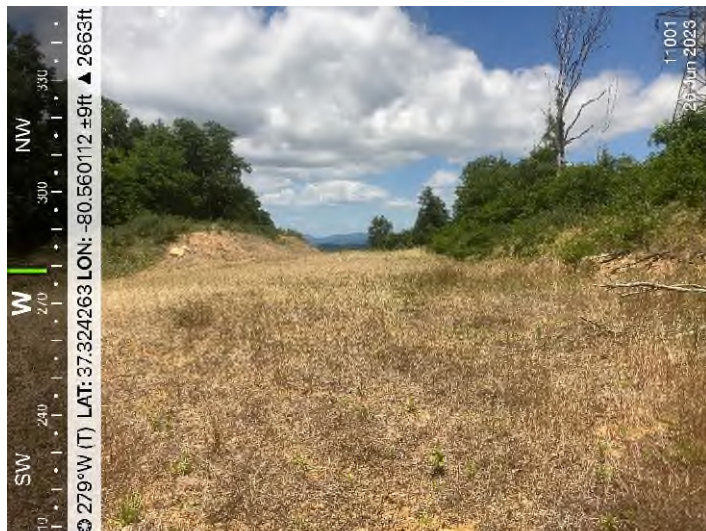
Figure 3: STA 11001+00 – Controls in place and functioning properly.

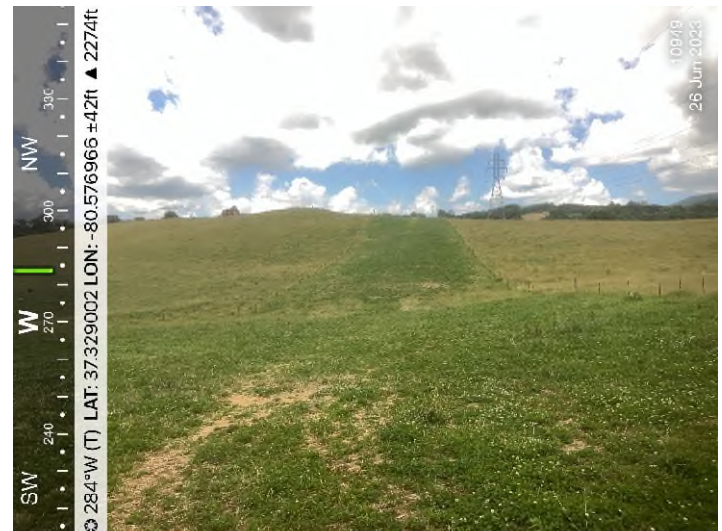
Figure 4: STA 10949+00 – Controls in place and functioning properly. Area at final grade.
