FIELD INSPECTION REPORT

| Project Name: | Mountain Valley Pipeline | Inspector: | Matthew Grant | | | |
| Inspection Date: | Monday, June 26, 2023 | Project Contact: | Brian Clau | to | | |
| Spread G: Giles | AR GI 244 Sta 10927-11024 ATWS 1331, 471 | Weather: | Dry | | | |

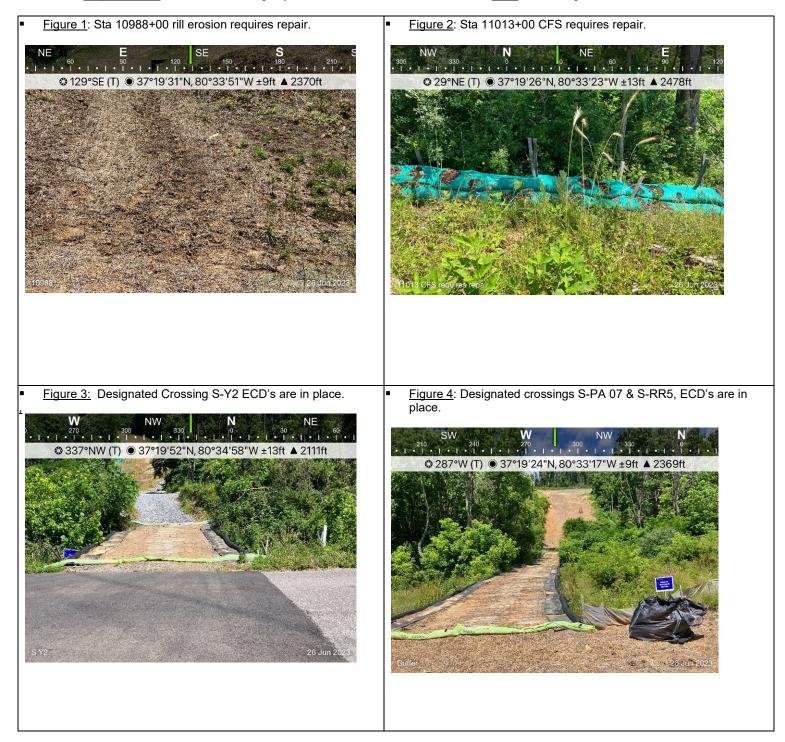
| Project Name: | Mountain Valley Pipeline | Inspector: | Matthew Grant | | | |
|--|--|---|---|---|---|---|
| Sta 11013+00 CFS requires repair. Sta 10988+00 rill erosion requires repair and re stabilized. | | | | | | |

| Project Name: | Mountain Valley Pipeline | Inspector: | Matthew Grant | | | |
|--|--|---|---|---|---|---|
| Recommended Corrective Action : Maintain and install all controls per the approved PSS&S. | | | | | | |
