FIELD INSPECTION REPORT

Project Name:	Mountain Valley Pipeline	Inspector:	Matthew Grant
Inspection Date:	Monday, August 14, 2023	Project Contact:	Brian Clauto
Spread G: Giles	AR GI256.02 Sta 11330+06-11328 ATWS 1147	Weather:	Wet

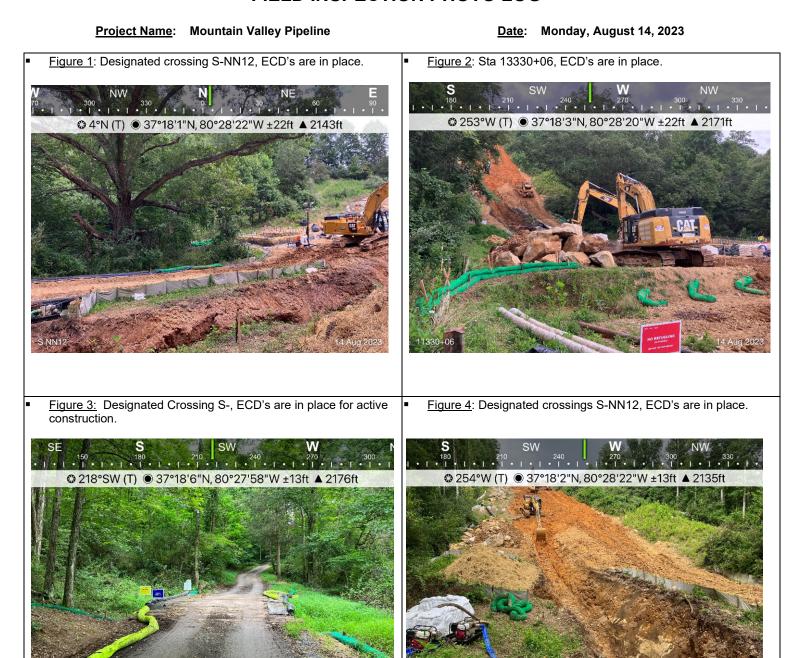
S NN13

3.	Areas of o	ffsite	sediment deposition o	bserve	d?				\boxtimes		
 <u>Comments:</u> Inspected the following resources: S-NN13, S-NN14, S-KL43, S-NN12 ECD's were in place and functioning at the designated crossing. 												
Routine Maintenance: (72-Hour Deadline from Notification) - N/A Ineffective Controls: (24-Hour Deadline from Notification) - N/A Recommended Corrective Action: N/A
