FIELD INSPECTION REPORT

Project Name:	Mountain Valley Pipeline	Inspector:	Marshall Willis
Inspection Date:	Monday, July 24, 2023	Project Contact:	Brian Clauto, Cory Chalmers
Spread G: Giles County Craig County	STA 11471+52 – 11353+67 MVP-CR-258.01 MVP-GI-256.02	Weather:	Dry

FIELD INSPECTION PHOTO LOG

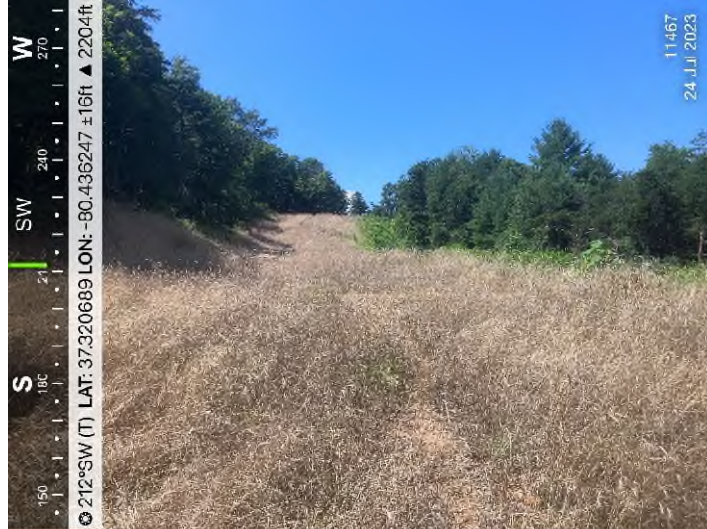
Figure 1: STA 11467+00 – Controls in place and functioning properly.

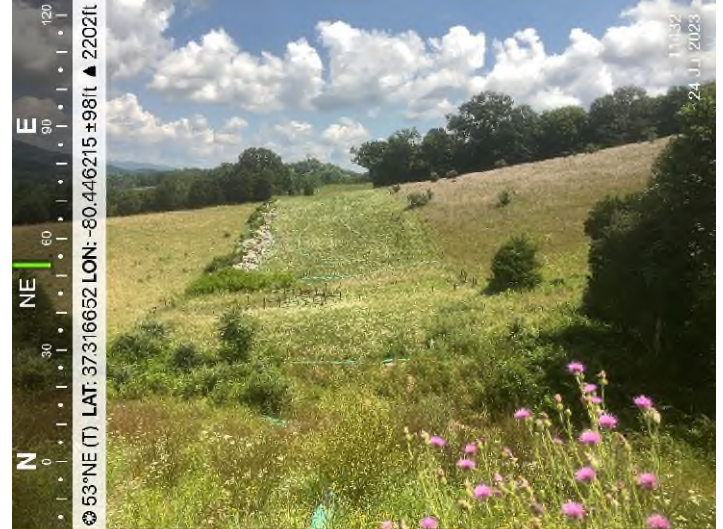
Figure 2: STA 11432+00 – Controls in place and functioning properly.

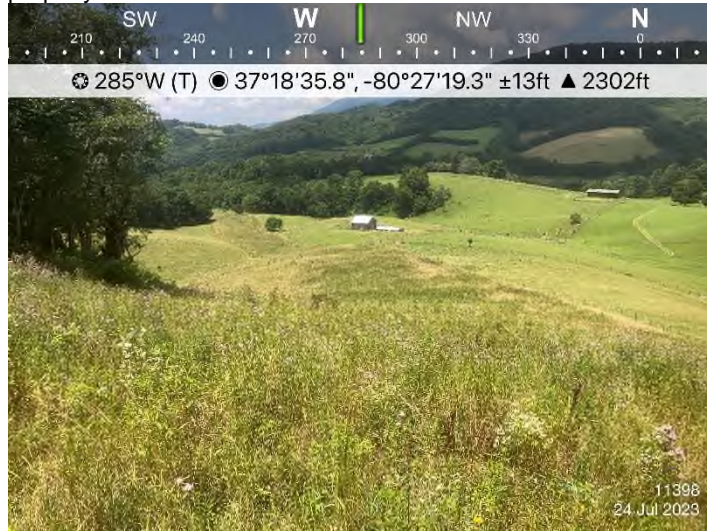
Figure 3: STA 11398+00 – Controls in place and functioning properly.

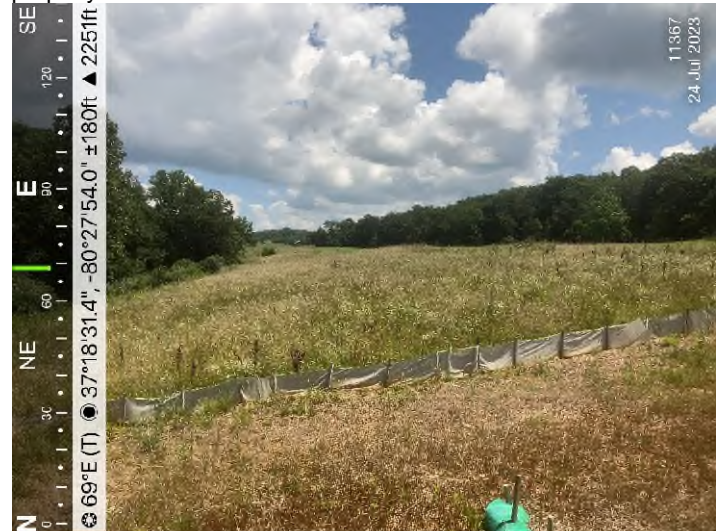
Figure 4: STA 11367+00 – Controls in place and functioning properly.
