FIELD INSPECTION REPORT

Project Name:	Mountain Valley Pipeline	Inspector:	Marshall Willis
Inspection Date:	Monday, August 21, 2023	Project Contact:	Brian Clauto, Cory Chalmers
Spread G: Giles County Montgomery County	STA 11740+00 – 11766+80 MVP-MLV-AR-26 Stevens Gap Trail	Weather:	Dry

FIELD INSPECTION PHOTO LOG

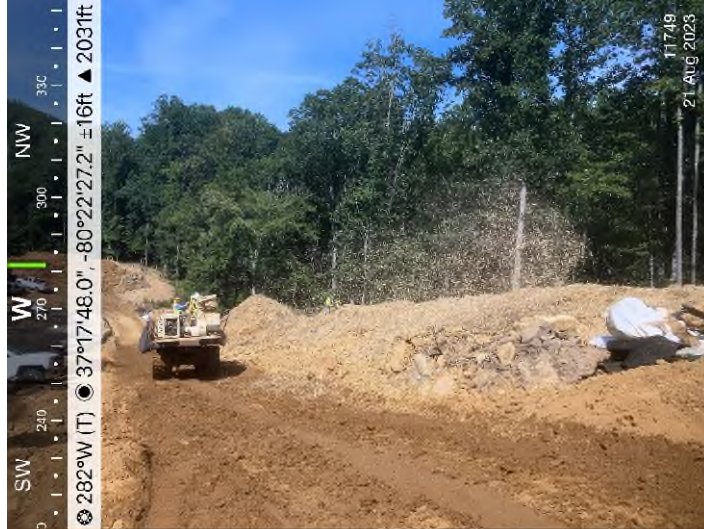
Figure 1: STA 11749+00 – Controls in place and functioning properly. Crews stabilizing stockpiles with straw mulch.

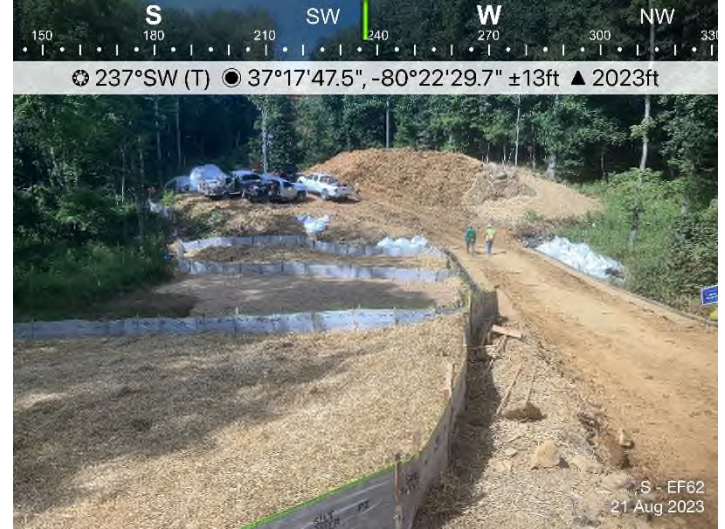
Figure 2: Stream S-EF62 – Controls in place and functioning properly.

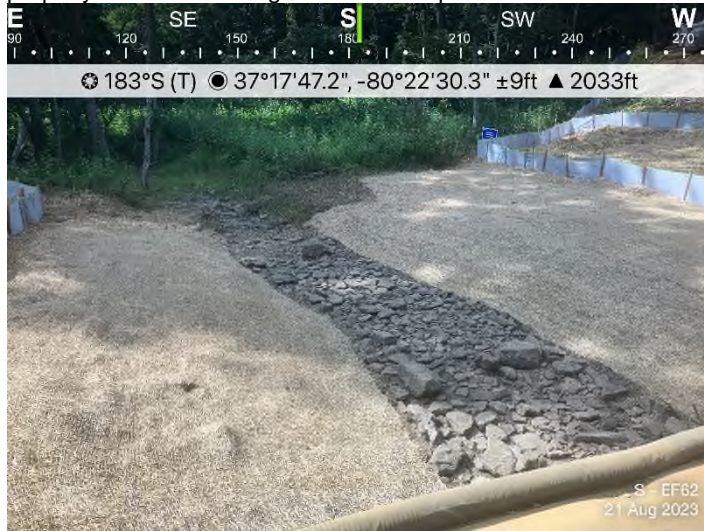
Figure 3: Stream S-EF62 – Controls in place and functioning properly. Stream crossing has been completed.

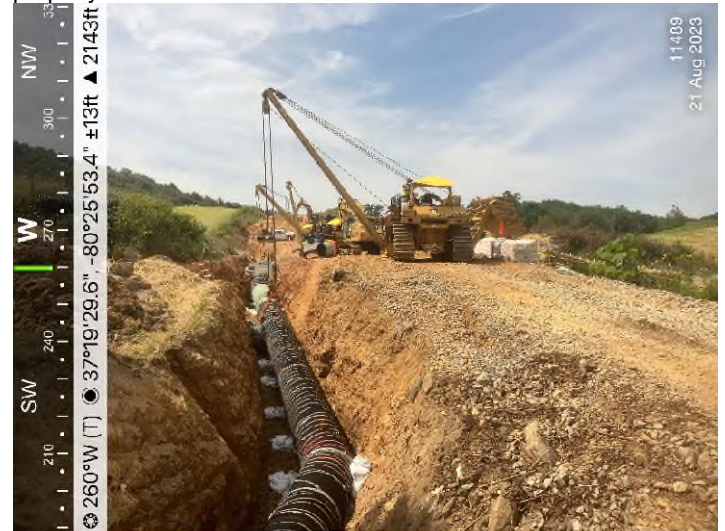
Figure 4: STA 11489+00 – Controls in place and functioning properly.
