FIELD INSPECTION REPORT

Project Name:	Mountain Valley Pipeline	Inspector:	Marshall Willis
Inspection Date:	Monday, August 14, 2023	Project Contact:	Brian Clauto, Cory Chalmers
Spread G: Giles County	STA 10592+30 – 10605+42 MVP-GI-238 STA 10560+00 – 10566+54 MVP-GI-237 STA 11327+83 – 11330+00 MVP-GI-256	Weather:	Rainy

FIELD INSPECTION PHOTO LOG

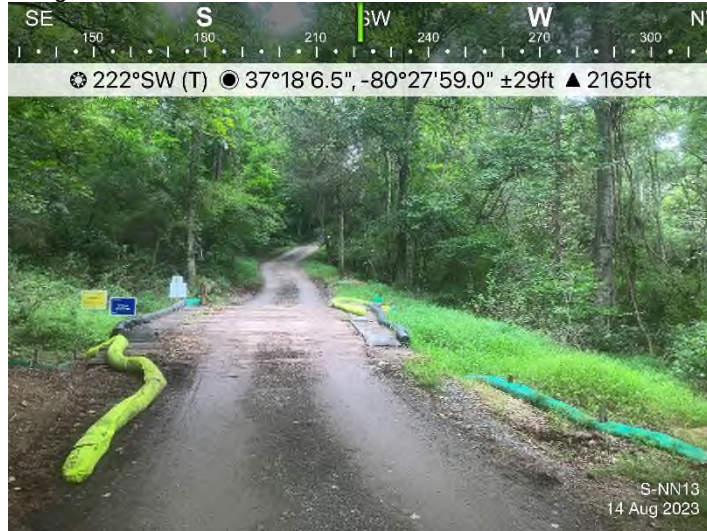
Figure 1: S-NN13 – Controls in place and functioning properly along MVP-GI-256.02.

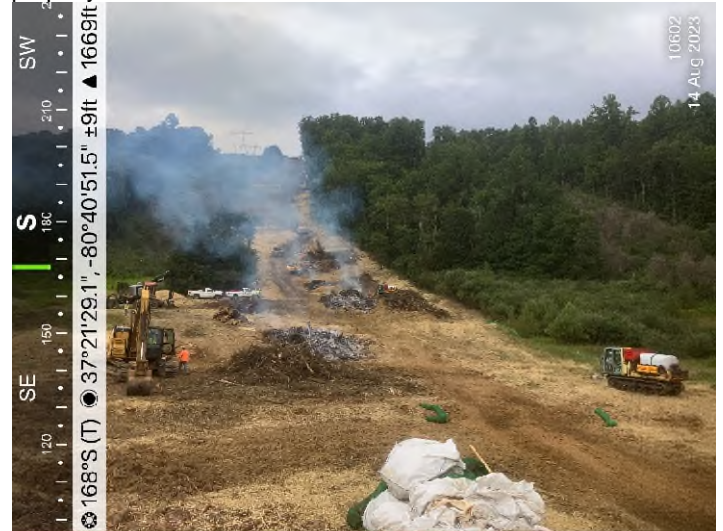
Figure 2: STA 10602+00 – Controls in place and functioning properly.

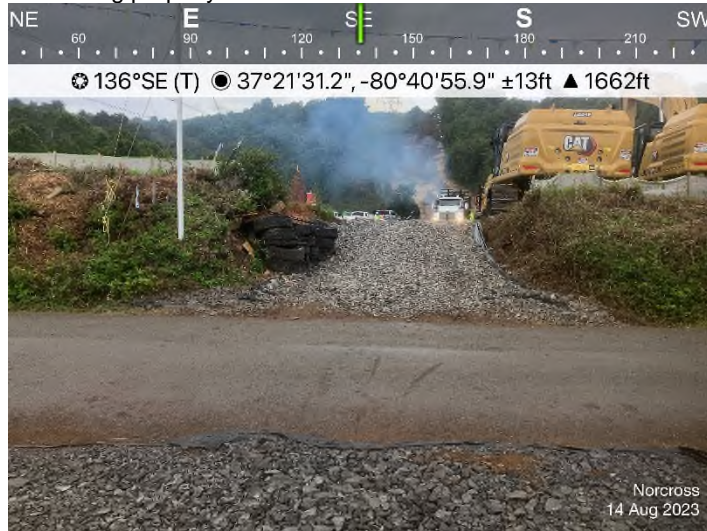
Figure 3: Norcross Road Crossing – Controls in place and functioning properly.

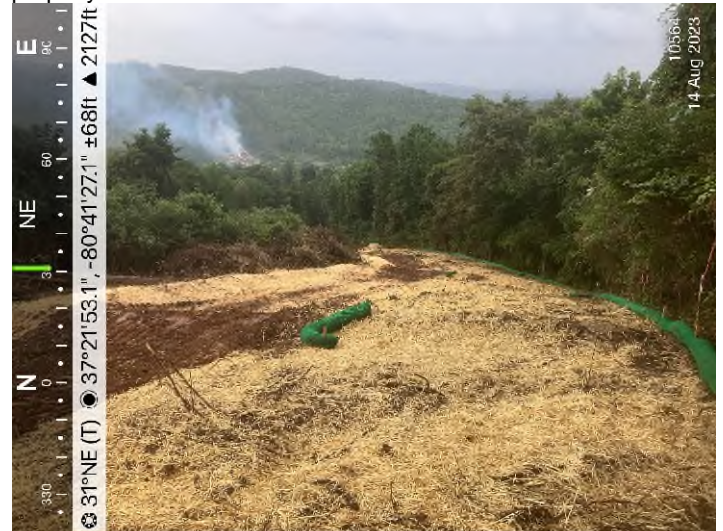
Figure 4: STA 10564+00 – Controls in place and functioning properly.
