COMPLAINT INVESTIGATION REPORT

Project Name:	Mountain Valley Pipeline	Inspector:	Matthew Grant
Inspection Date:	Monday, September 11, 2023	Project Contact:	Brian Clauto
Spread G: Montgomery County	AR MN 258.04, 258.03 ATWS 1057, 1373 Sta 11618+70-11600	Weather:	Wet

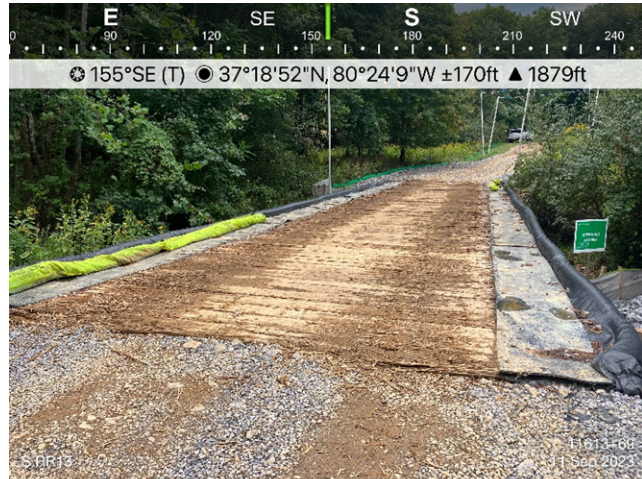
Figure 1: Designated stream S-RR13, ECD's were in place for active construction.

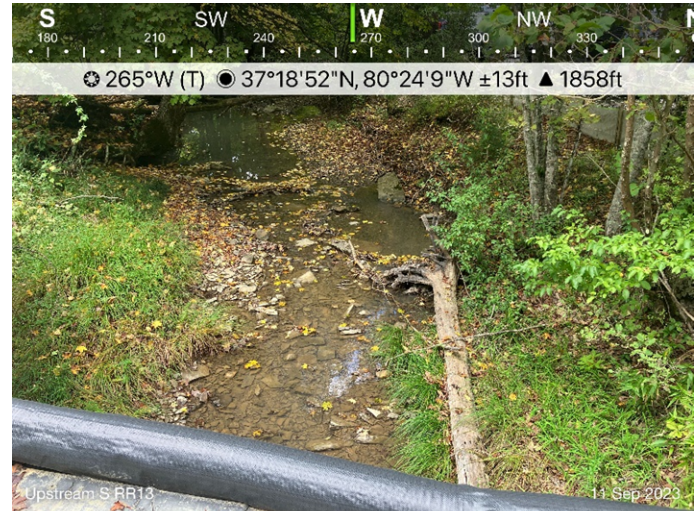
Figure 2: Upstream of designated stream S-RR13.

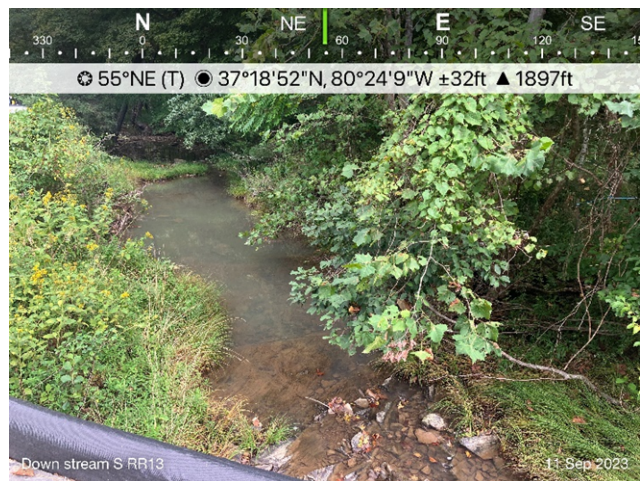
Figure 3: Downstream of S-RR13.

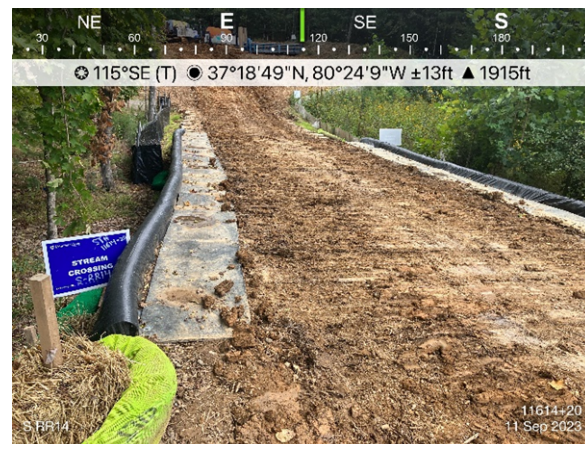
Figure 4: Designated crossing S-RR14, ECD's were in place for active construction.

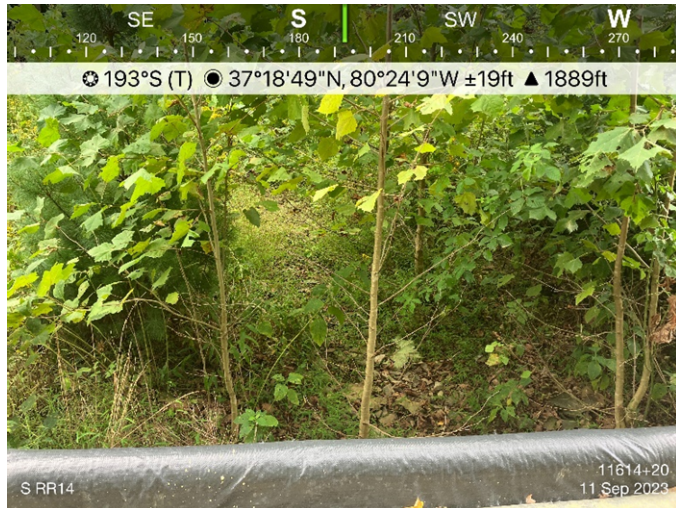
Figure 5: Upstream of S-RR14 crossing.

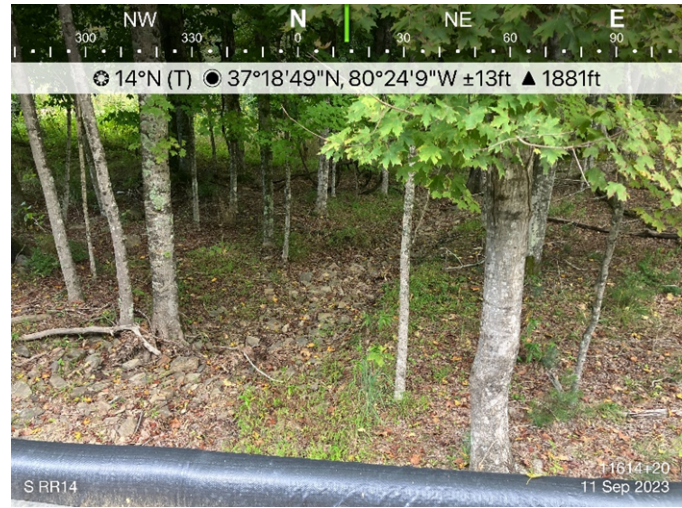
Figure 6: Downstream of S-RR14 crossing.

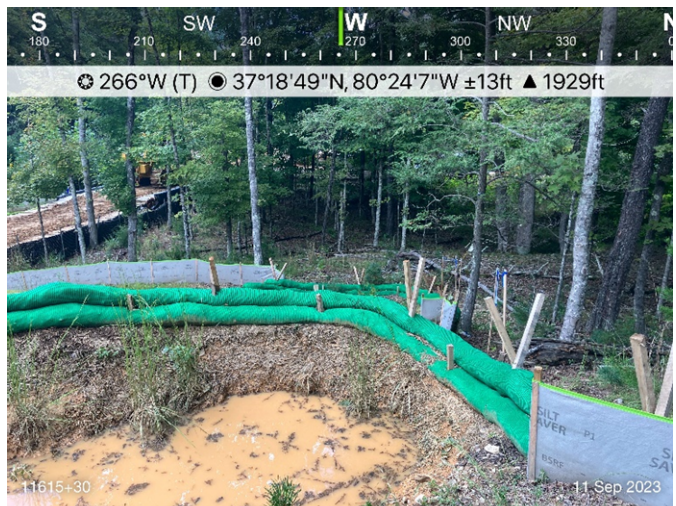
Figure 7: Sta 11615+30, ECD appears to be functioning above S-RR14.

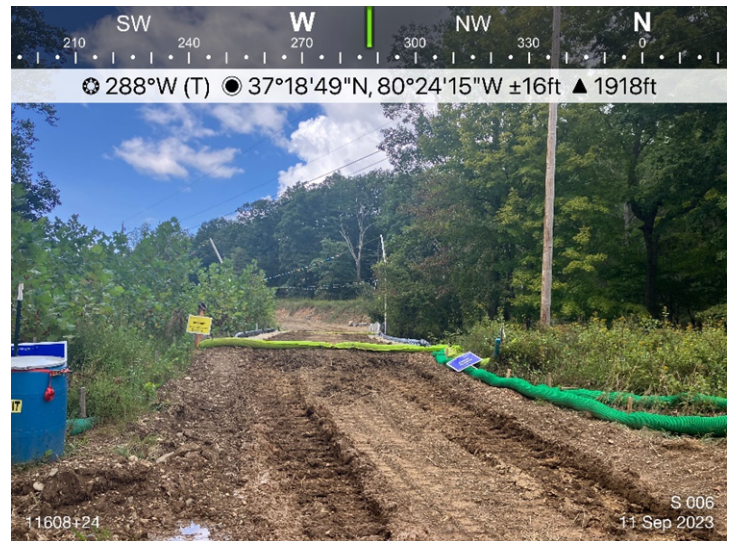
Figure 8: Designated crossing S-006, ECD's were in place.

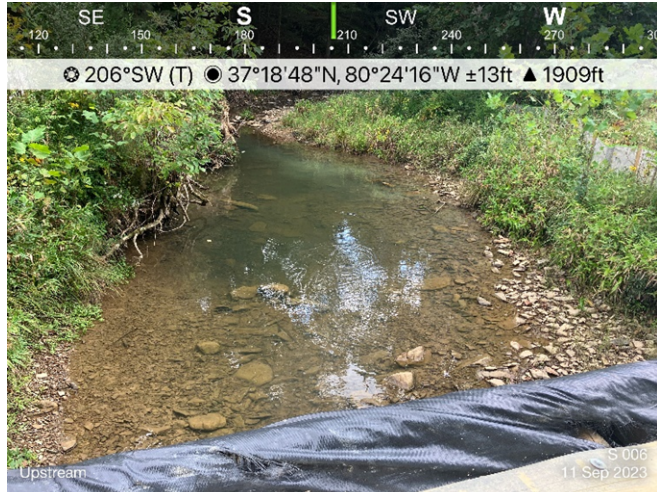
Figure 9: Upstream of S-006 crossing.

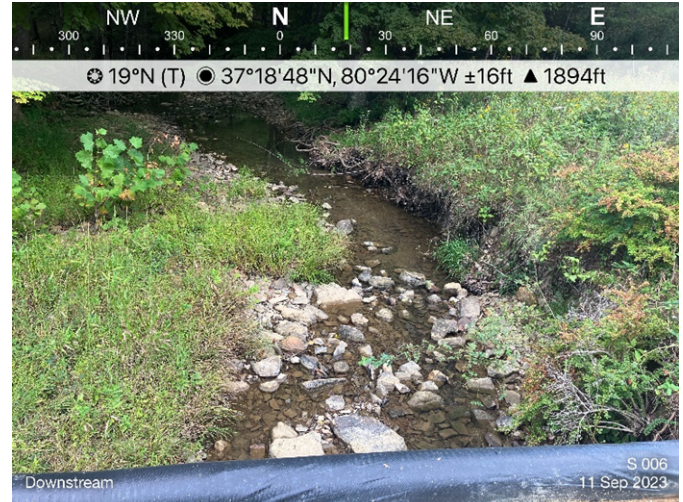
Figure 10: Downstream of S-006 crossing.

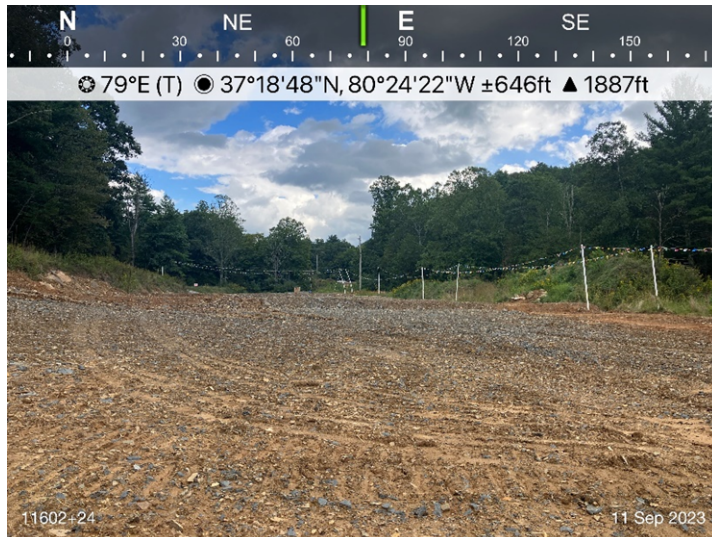
Figure 7: Sta 11602, ECD were in place.

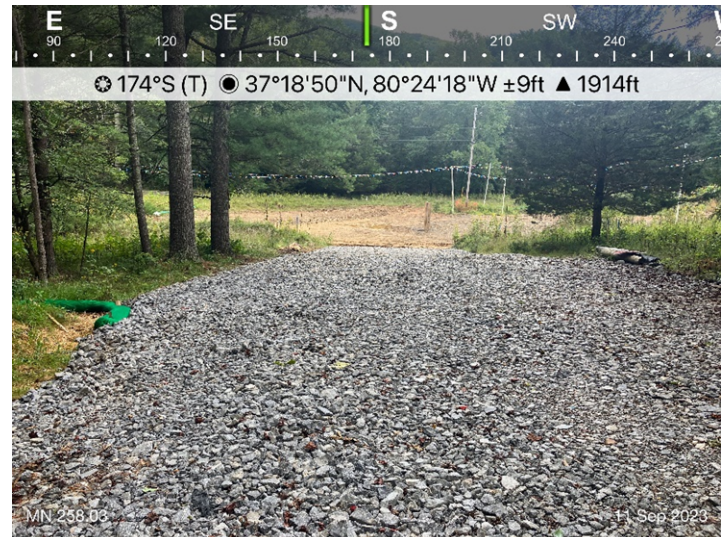
Figure 8: AR MN 258.03, ECD's were in place.
