FIELD INSPECTION REPORT

Project Name:	Mountain Valley Pipeline	Inspector:	Marshall Willis
Inspection Date:	Tuesday, August 29, 2023	Project Contact:	Brian Clauto, Cory Chalmers
Spread G: Giles County	STA 10592+72 – 10656+80 MVP-MLV-AR-24	Weather:	Wet

FIELD INSPECTION PHOTO LOG

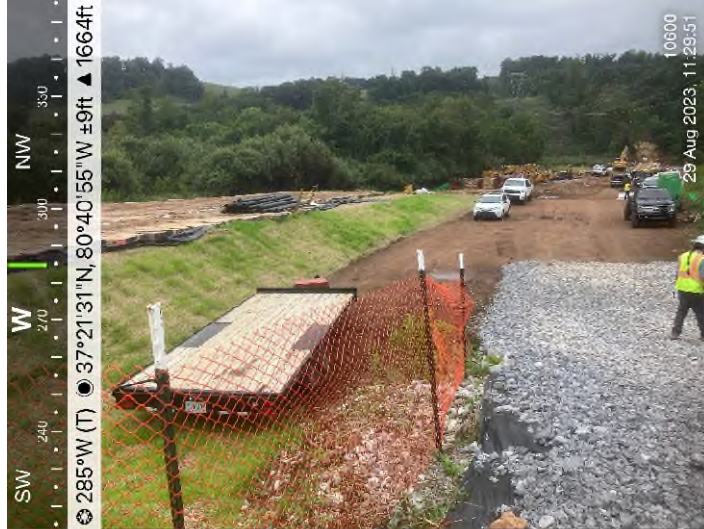
Figure 1: STA 10600+00 – Controls in place and functioning properly.

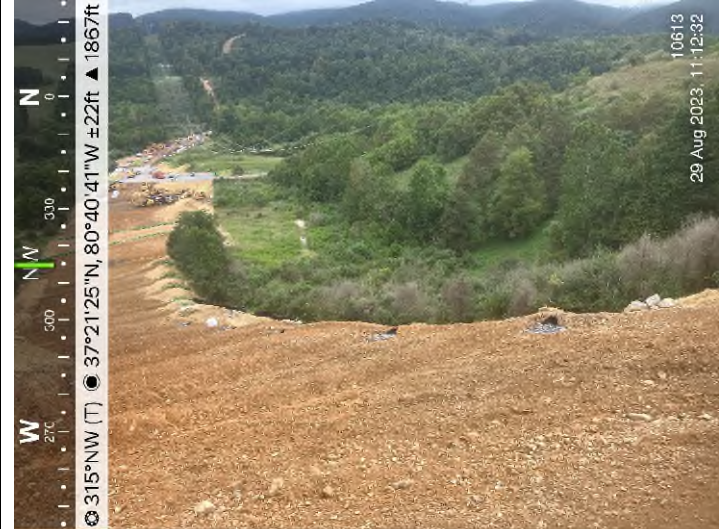
Figure 2: STA 10613+00 – Controls in place and functioning properly.

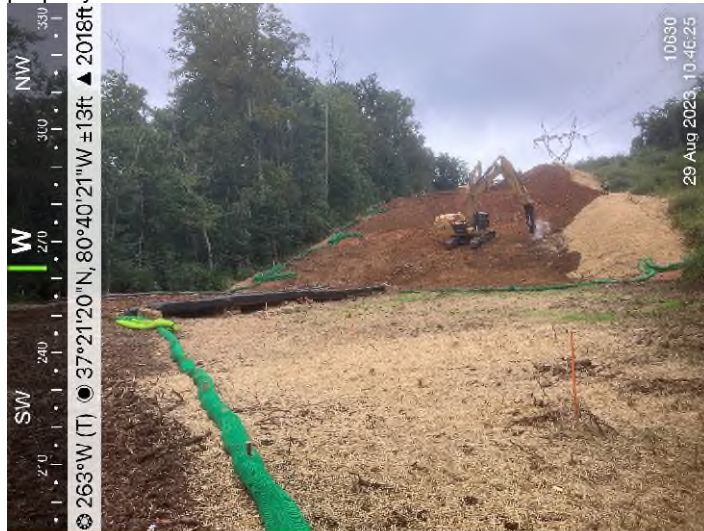
Figure 3: STA 10630+00 – Controls in place and functioning properly.

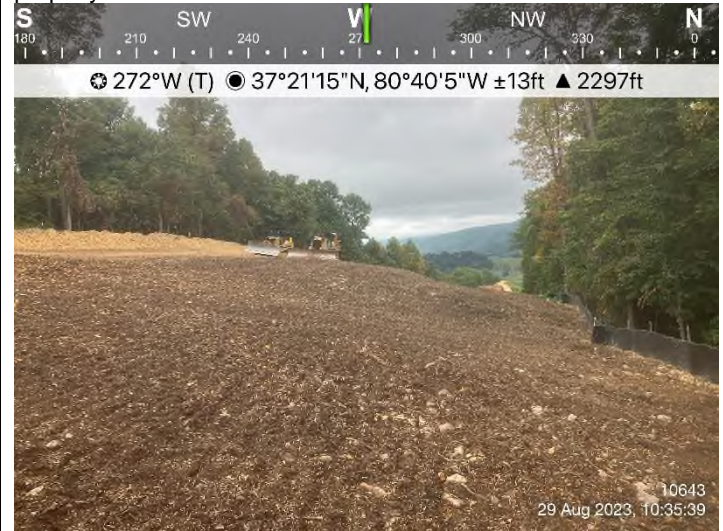
Figure 4: STA 10643+00 – Controls in place and functioning properly.
