FIELD INSPECTION REPORT

Project Name:	Mountain Valley Pipeline	Inspector:	Matthew Grant		
Inspection Date:	Wednesday, September 20, 2023	Project Contact:	Brian Clauto		
Spread G: Giles	Sta 10530-105519+31, 10592+79- 10600, 11641+57-10656 ATWS 610, 610A, 1124, 1130, 815, 339A, 1135, 1136 AR GI234, 235, 236, 238, 239	Weather:	Dry

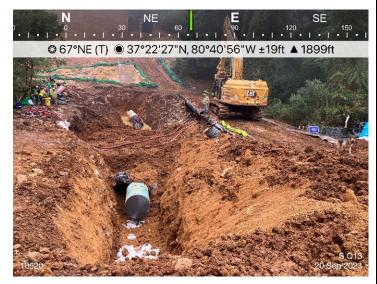
Figure 1: Designated crossing S-Q13, ECD's are in place.

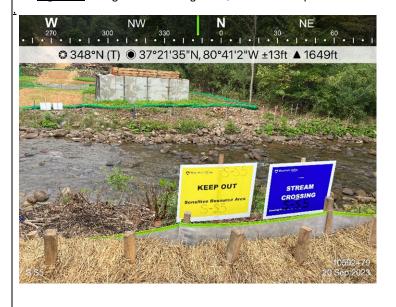
Figure 3: Designated crossing S-S5, ECD's are in place.

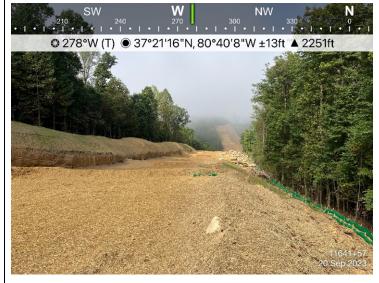
Figure 4: Sta11641+57, ECD's are in place.
