FIELD INSPECTION REPORT

Project Name:	Mountain Valley Pipeline	Inspector:	Matthew Grant
Inspection Date:	Monday, December 4, 2023	Project Contact:	Brian Clauto
Spread G: Giles	Sta 11158+68-11174, 10930-10926+11, 11614+20-11607+81 ATWS 1464, 471, 1331, 1373, 1057 AR GI 249.03	Weather:	Dry

FIELD INSPECTION PHOTO LOG

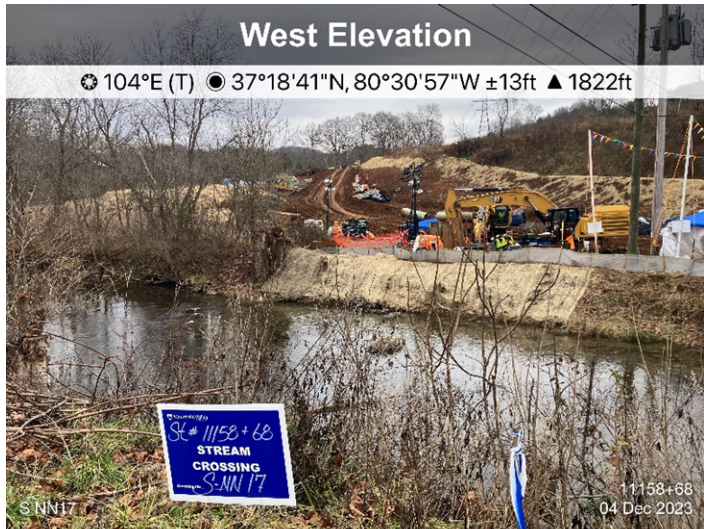
- Figure 1: Designated crossing S-NN17, ECD's are in place for active construction.

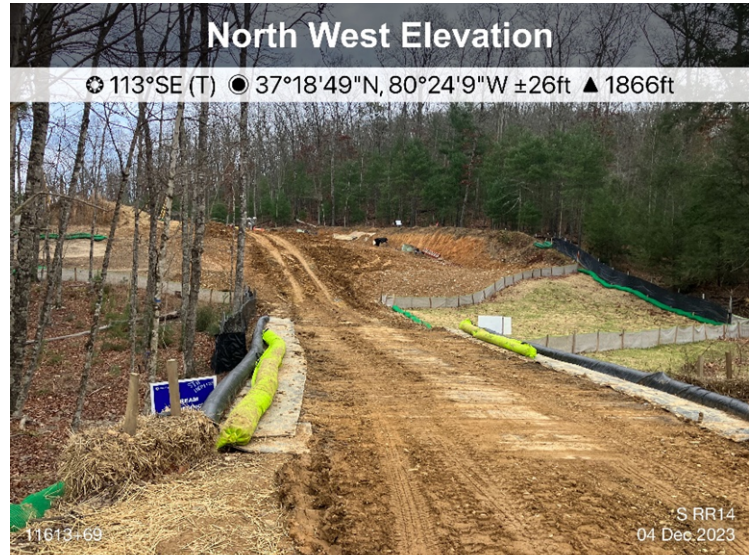
- Figure 2: Designated crossing S-RR14, ECD's are in place for active construction.

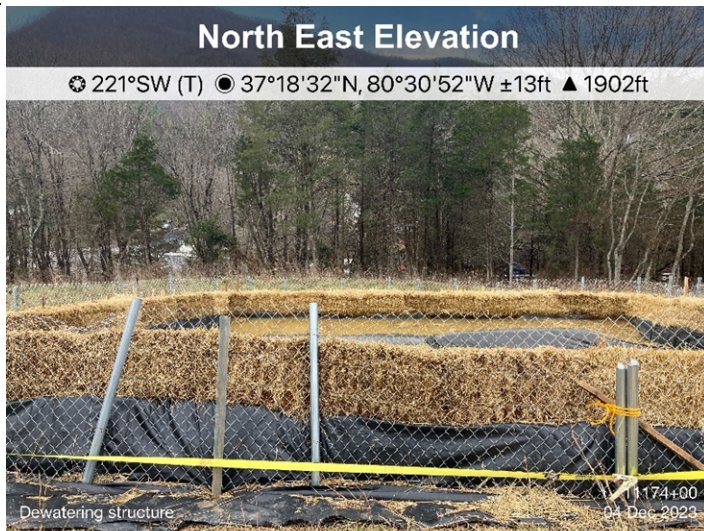
- Figure 3: Sta 11174 dewatering structure in place and functioning for S-NN17.

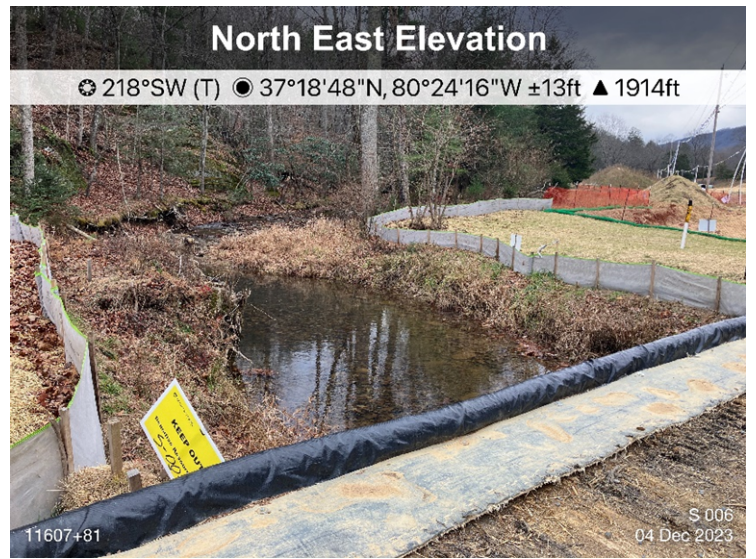
- Figure 4: Designated crossing S-006 bore site, ECD's are in place.
