COMPLAINT INVESTIGATION REPORT

Project Name:	Mountain Valley Pipeline	Inspector:	Marshall Willis
Inspection Date:	Thursday, December 14, 2023	Project Contact:	Brian Clauto, Cory Chalmers
Spread H: Roanoke County	MVP-RO-283 STA 12796+62 – 12807+43	Weather:	Wet

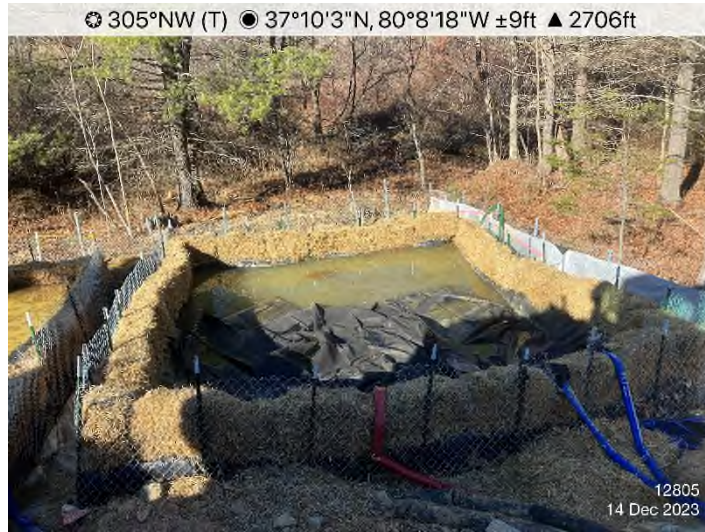
Figure 1: STA 12805+00 – Dewatering structures installed and functioning properly.

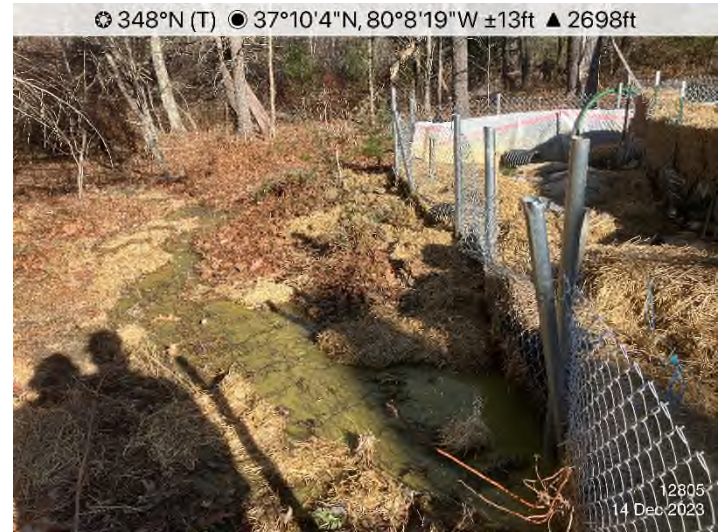
Figure 2: STA 12805+00 – Dewatering structures installed and functioning properly.

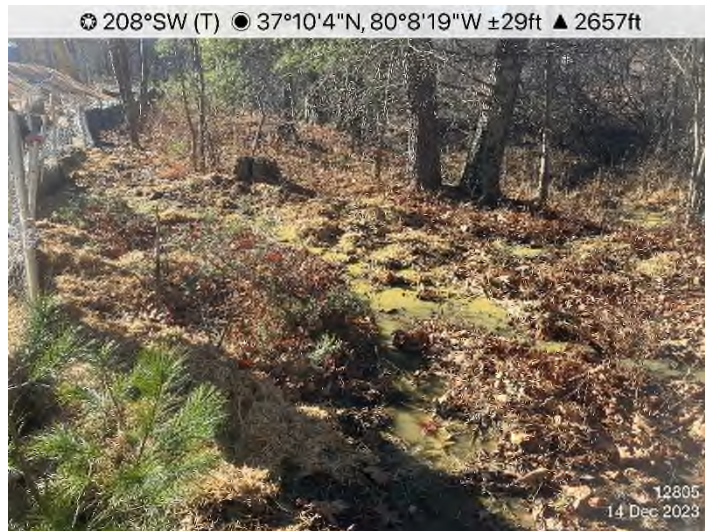
Figure 3: STA 12805+00 – Treated water discharged outside LOD from dewatering structure at STA 12805+00.

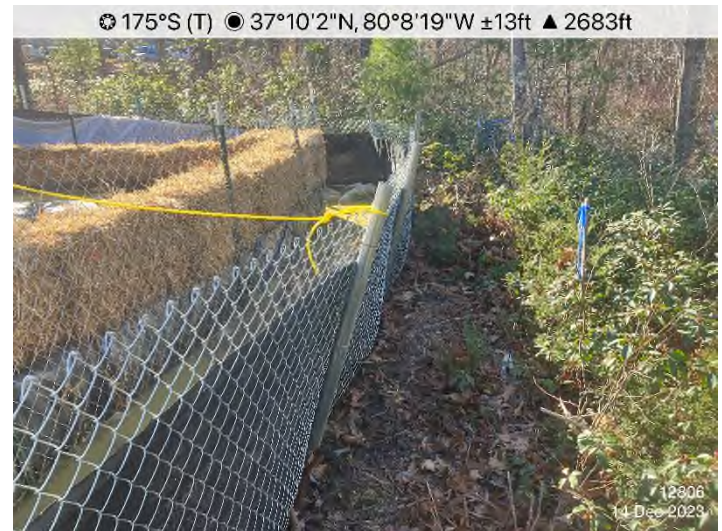
Figure 4: STA 12806+00 – Dewatering structure installed and functioning properly.

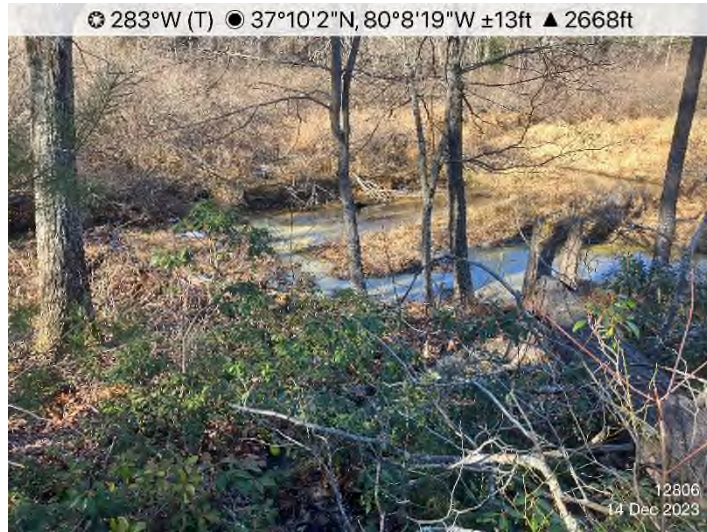
1. Bottom Creek (S-IJ88) is an active boring operation.
2. Two dewatering structures were located at STA 12805+00, one dewatering structure was located at 12806+00 and one dewatering structure was located at STA 12797+00
3. All the dewatering structures were installed and functioning properly.
4. Turbid water discharging from the dewatering structures located at STA 12805+00 and 12806+00 was observed entering Bottom Creek outside of the LOD (Figure 5).
5. No sedimentation off ROW was observed and no corrective actions were noted during the inspection.

Figure 5: STA 12806+00– Treated turbid water entering Bottom Creek downstream of the dewatering operation.

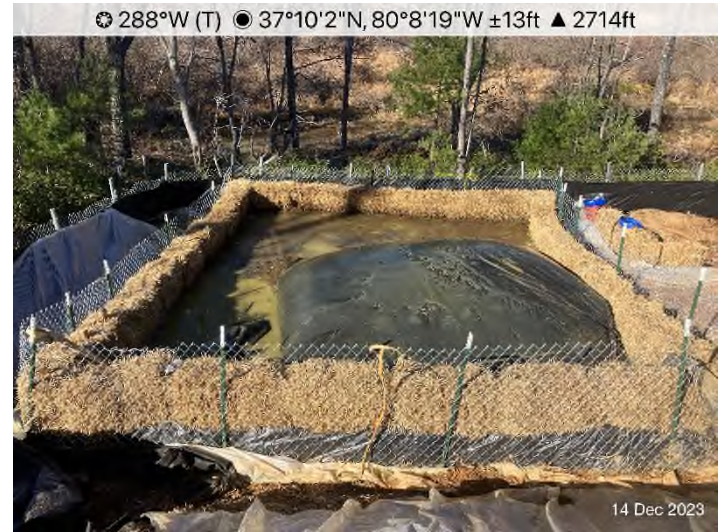
Figure 6: STA 12806+00 – Dewatering structure installed and functioning properly.
