## COMPLAINT INVESTIGATION REPORT

<b>Project Name:</b>	Mountain Valley Pipeline	<b>Inspector:</b>	Marshall Willis
<b>Inspection Date:</b>	Tuesday, December 12, 2023	<b>Project Contact:</b>	Brian Clauto, Cory Chalmers
<b>Spread H: Roanoke County</b>	MVP-RO-283 STA 12796+62 – 12807+43	<b>Weather:</b>	Wet

**Background:** This investigation was conducted in response to complaint IR#: 311809. The incident description is “sedimentation in Bottom Creek” occurring on 12/08/2023. Bottom Creek crosses the ROW at STA 12801+83.

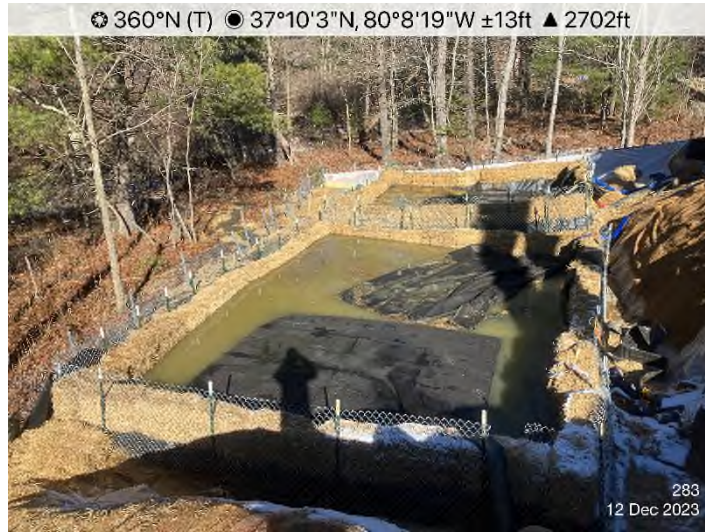
**Figure 1: STA 12805+00** – Dewatering structures installed and functioning properly.

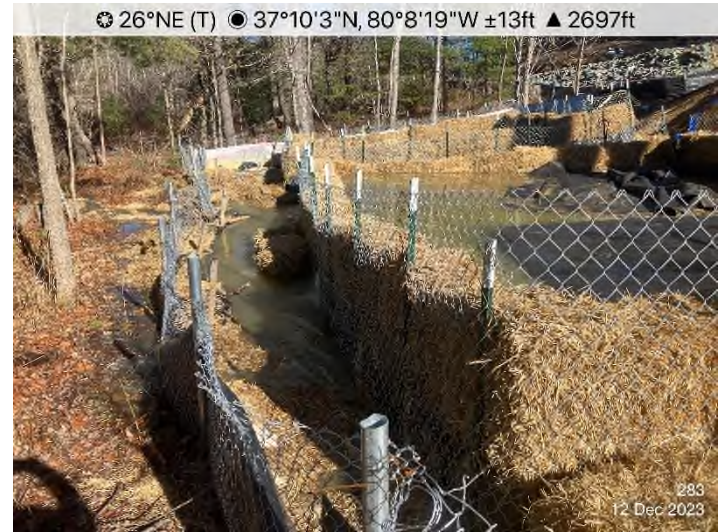
**Figure 2: STA 12805+00** – Dewatering structures installed and functioning properly.

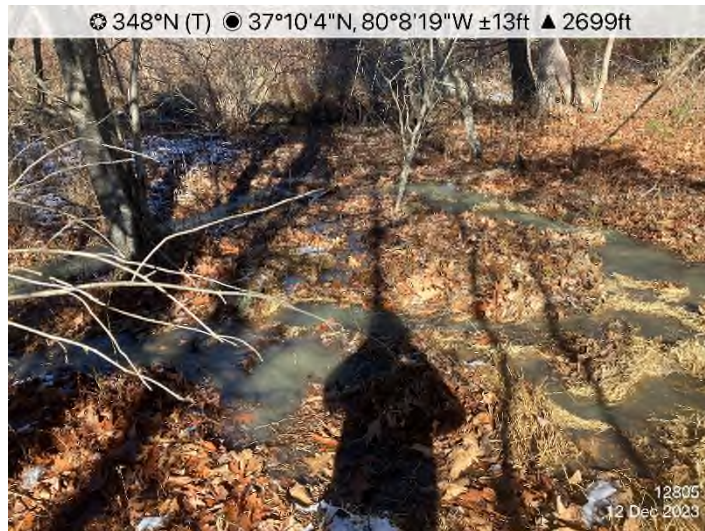
**Figure 3: STA 12805+00** – Treated water discharged outside LOD from dewatering structure at STA 12805+00.

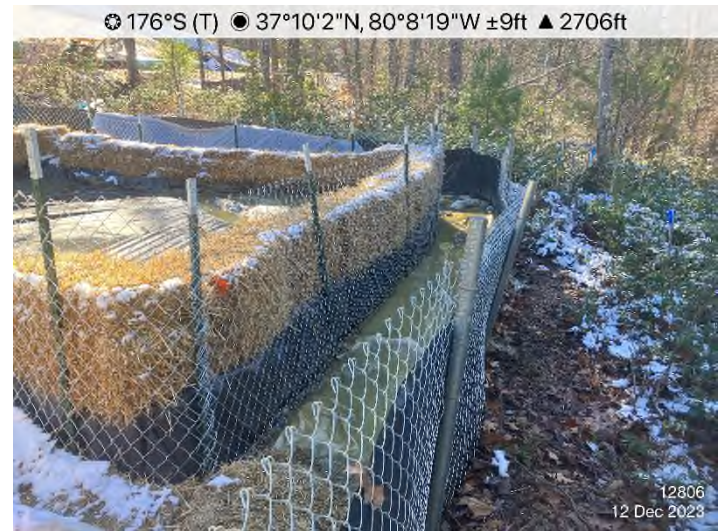
**Figure 4: STA 12806+00** – Dewatering structure installed and functioning properly.

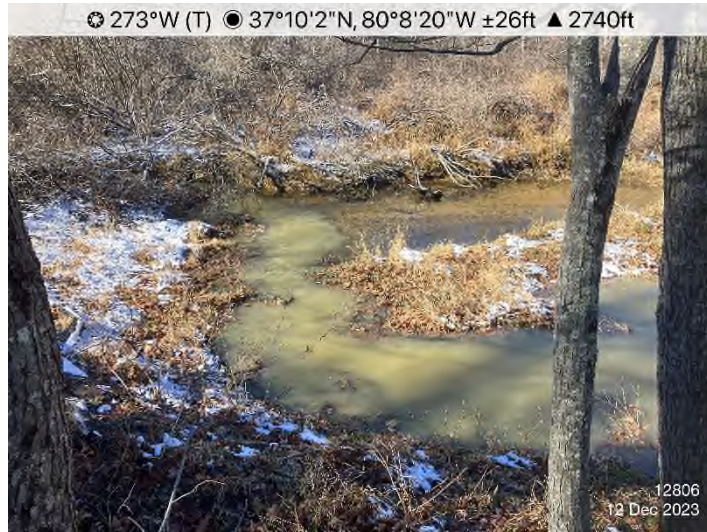
1. Bottom Creek (S-IJ88) is an active boring operation.
2. Two dewatering structures were located at STA 12805+00, one dewatering structure was located at 12806+00 and one dewatering structure was located at STA 12797+00
3. All the dewatering structures were installed and functioning properly.
4. Turbid water discharging from the dewatering structures located at STA 12805+00 and 12806+00 was observed entering Bottom Creek outside of the LOD (Figure 5).
5. No sedimentation off ROW was observed and no corrective actions were noted during the inspection.

**Figure 5: STA 12806+00**– Treated turbid water entering Bottom Creek downstream of the dewatering operation.

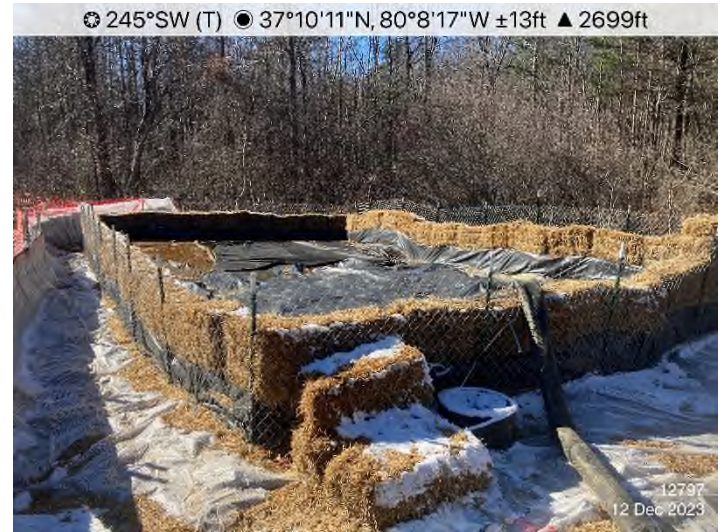
**Figure 6: STA 12797+00** – Dewatering structure installed and functioning properly.
