## FIELD INSPECTION REPORT

<b>Project Name:</b>	Mountain Valley Pipeline	<b>Inspector:</b>	Matthew Grant
<b>Inspection Date:</b>	Wednesday, January 10, 2024	<b>Project Contact:</b>	Brian Clauto
<b>Spread G: Montgomery Giles</b>	Sta 11600-11614+74, 11255+77-11254+57, 11159+31-11163+19 ATWS 1373, 1057, 1369 AR 258.04, 253.03, 249.03	<b>Weather:</b>	Wet

## FIELD INSPECTION PHOTO LOG

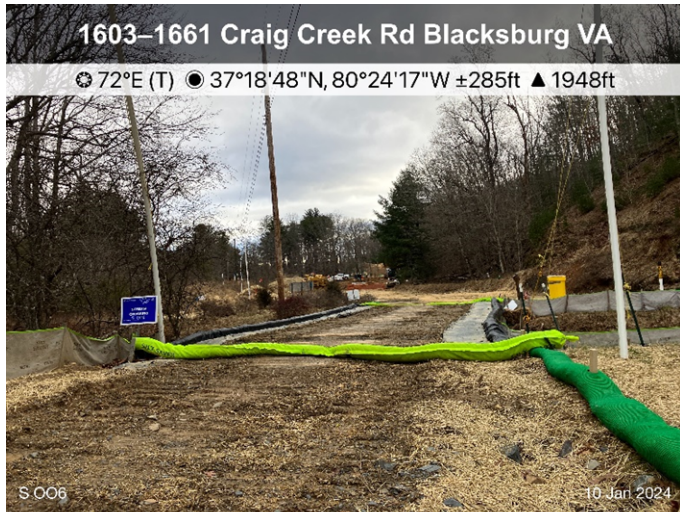
Figure 1: Designated crossing S-006, ECD's are in place.

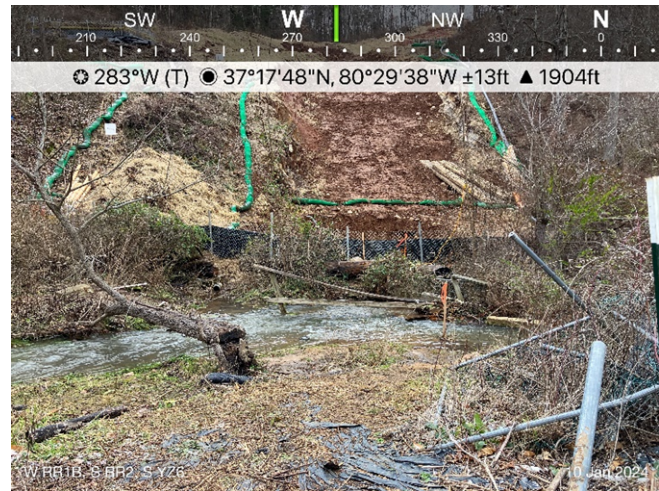
Figure 2: Designated crossing S-RR2, S-YZ6, W-RR1B. ECD's are in place for active construction.

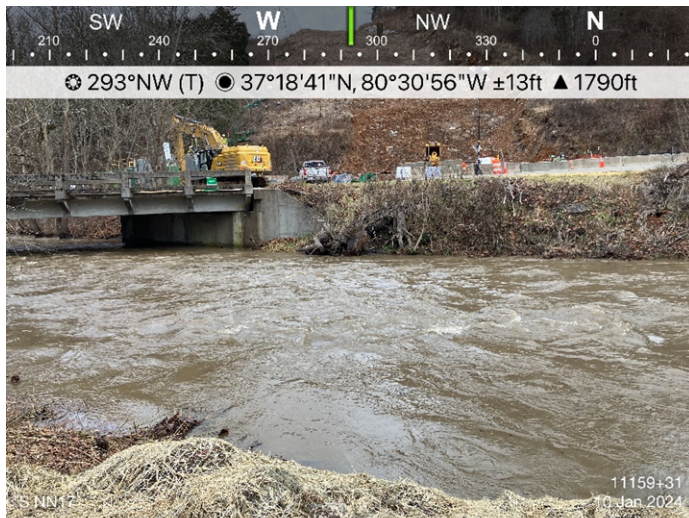
Figure 3: Designated crossing S-NN17, ECD's were being maintained.

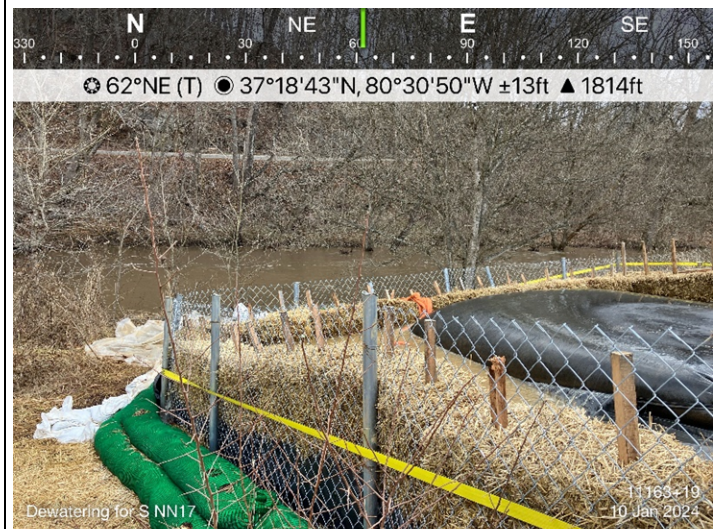
Figure 4: Dewatering structure for S-NN17.
