## **FIELD INSPECTION REPORT**

Project Name:	Mountain Valley Pipeline	Inspector:	Matthew Grant		
Inspection Date:	Thursday, January 4, 2024	Project Contact:	Brian Clauto		
Spread G: Montgomery Giles	Sta 11159+31-11165, 11255- 11254+57, 11600-11614+74 ATWS1369, 1464, 1373 AR GI 249.03, 253.03, MN258.03	Weather:	Wet

## FIELD INSPECTION PHOTO LOG

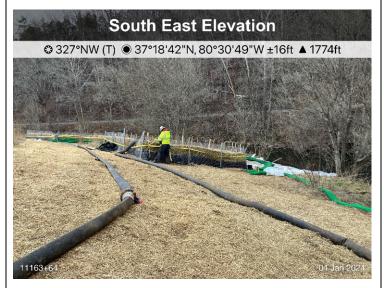
Figure 1: Sta11163+64, ECD's are in place.

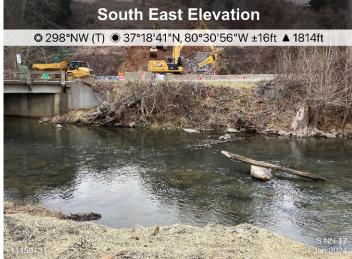
Figure 2: Designated crossing S-NN17. ECD's are in place.

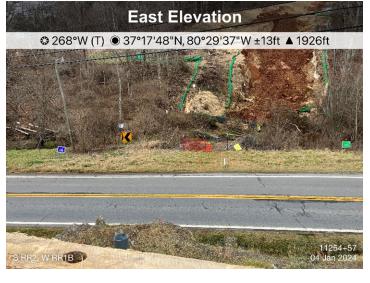
Figure 3: Sta 11254+57, ECD's are in place.

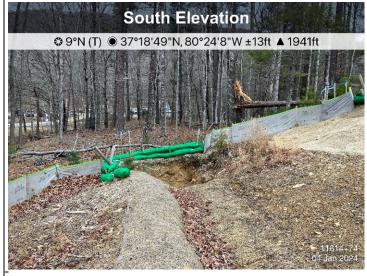
Figure 4: Sta 11614+74, ECD's are in place.
