## COMPLAINT INVESTIGATION REPORT

<b>Project Name:</b>	Mountain Valley Pipeline	<b>Inspector:</b>	Marshall Willis
<b>Inspection Date:</b>	Friday, February 16, 2024	<b>Project Contact:</b>	Brian Clauto, Cory Chalmers
<b>Spread H: Roanoke County</b>	STA 12866+36 – 12890+00	<b>Weather:</b>	Wet

## FIELD INSPECTION PHOTO LOG

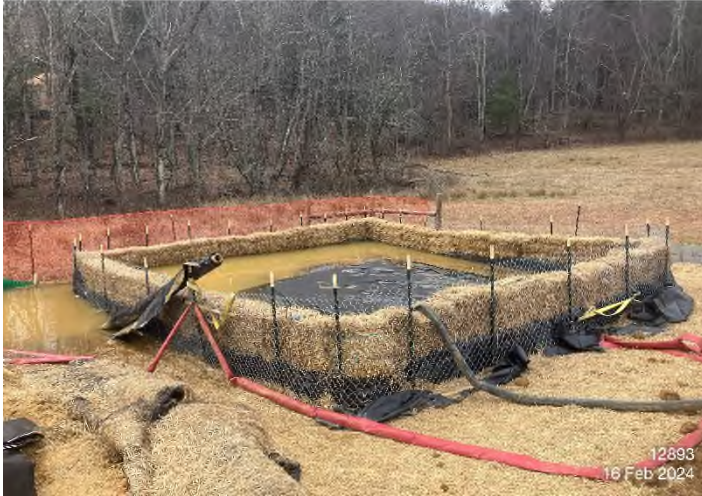
**Figure 1: STA 12893+00** – Dewatering structure #1 installed and functioning properly.

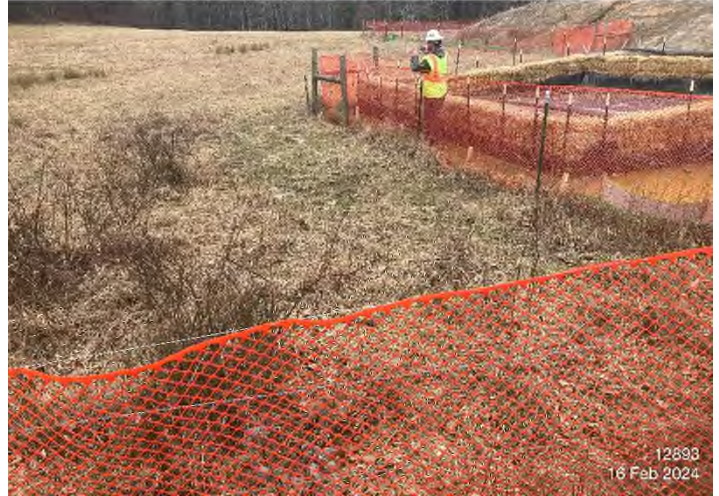
**Figure 2: STA 12893+00** – Dewatering structure #1 installed and functioning properly.

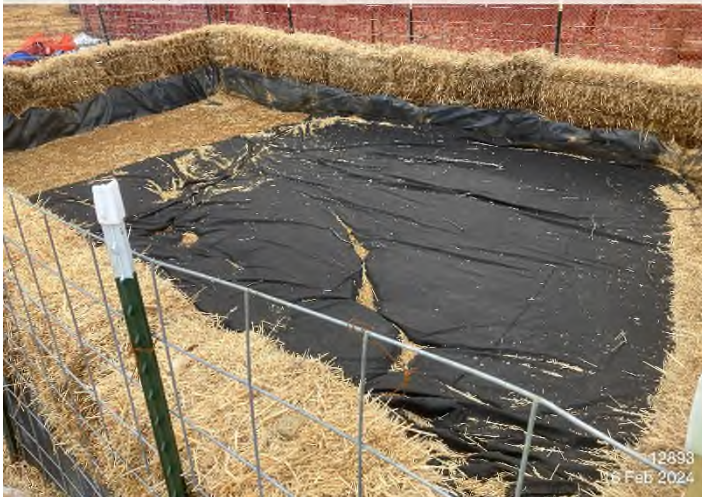
**Figure 3: STA 12893+00** – Dewatering structure #2 installed and functioning properly.

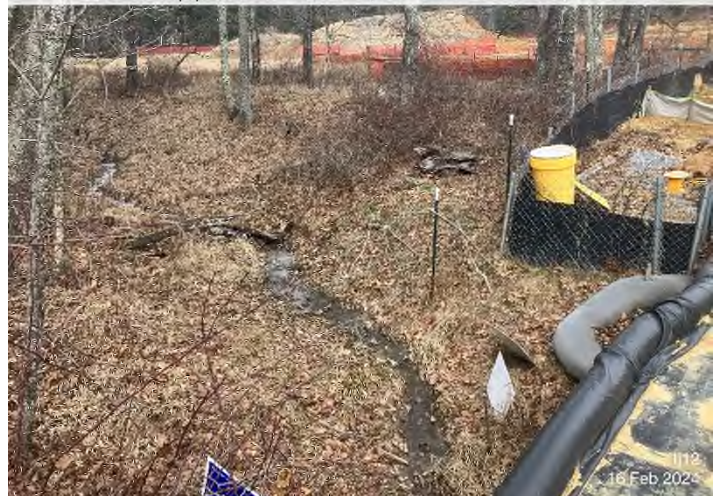
**Figure 4: Stream S-IJ12** – Looking upstream at S-IJ12 from temp. equipment crossing at both dewatering structures. No impacts to resource identified.
