COMPLAINT INVESTIGATION REPORT

Project Name:	Mountain Valley Pipeline	Inspector:	Marshall Willis
Inspection Date:	Tuesday, February 6, 2024	Project Contact:	Brian Clauto, Cory Chalmers
Spread G: Giles County	Rt. 42 and Clover Hollow Rd. STA 11254+00 – 11257+00 STA 11226+00 – 11243+00 MVP-MLV-AR-25	Weather:	Wet

FIELD INSPECTION PHOTO LOG

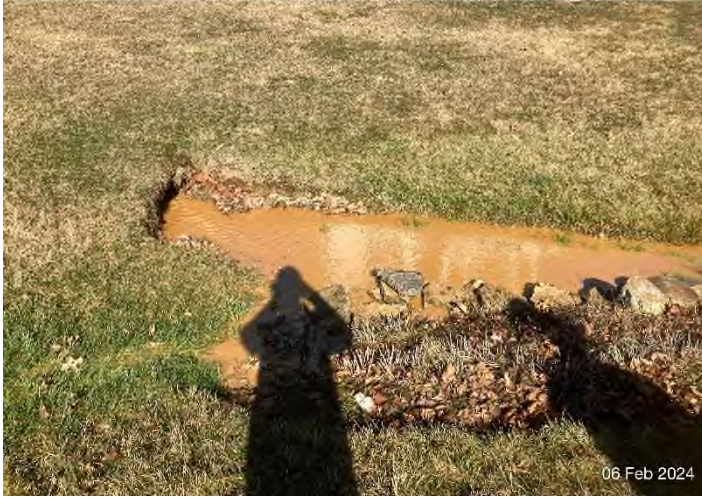
Figure 1: Rt. 42 and Clover Hollow Dr. – Head of spring located off ROW near intersection of Rt. 42 and Clover Hollow Dr.

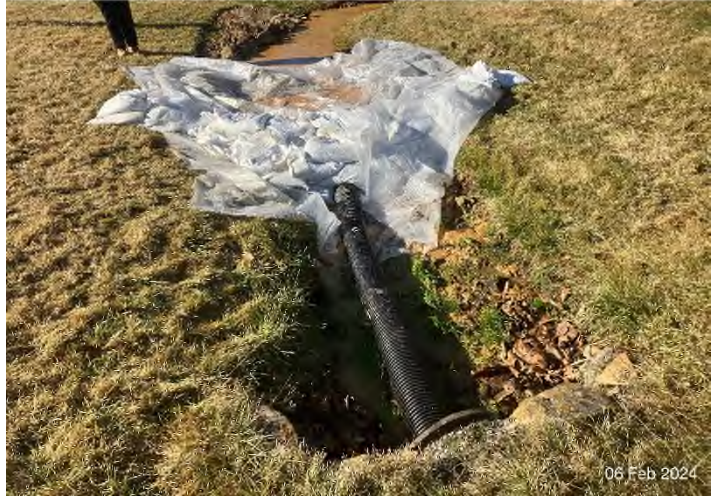
Figure 2: Rt. 42 and Clover Hollow Dr. – Temporary sandbag dam and gravity flume pipe installed for spring conveyance.

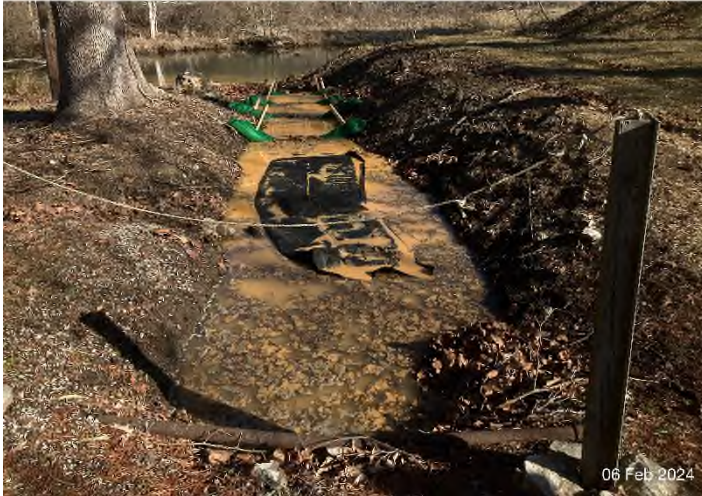
Figure 3: Rt. 42 and Clover Hollow Dr. – North side of Clover Hollow Drive. Flume is connected to sediment bag prior to entering stormwater channel.

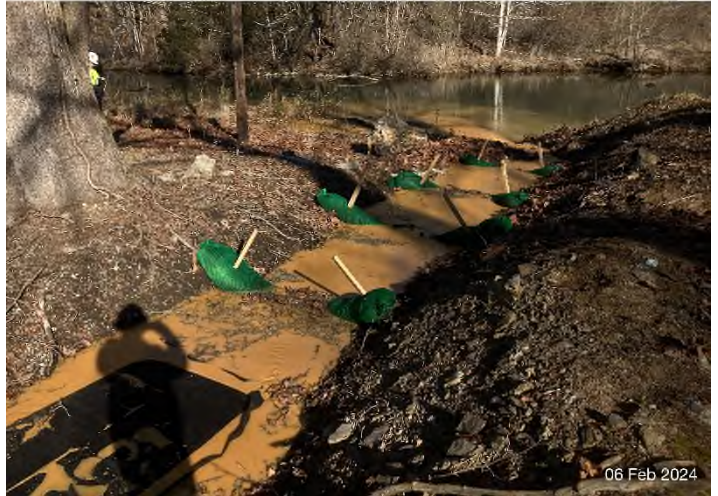
Figure 4: Rt. 42 and Clover Hollow Dr. – CFS check dams installed within stormwater conveyance channel prior to entering Sinking Creek.

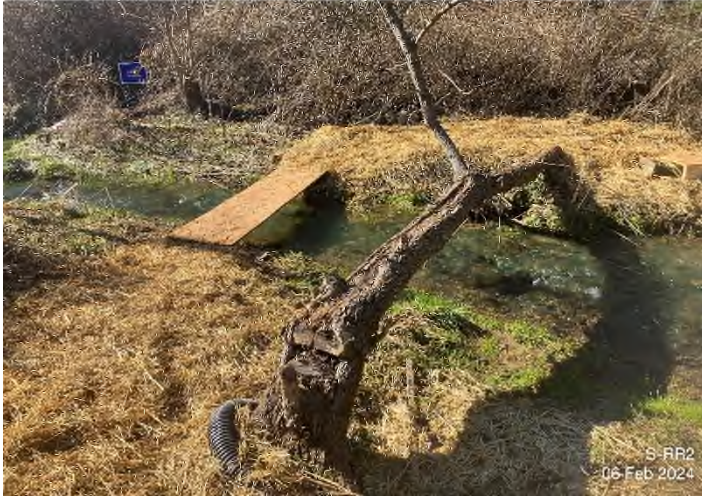
S-RR2
06 Feb 2024

Figure 5: Stream S-RR2 – Controls in place and functioning properly.

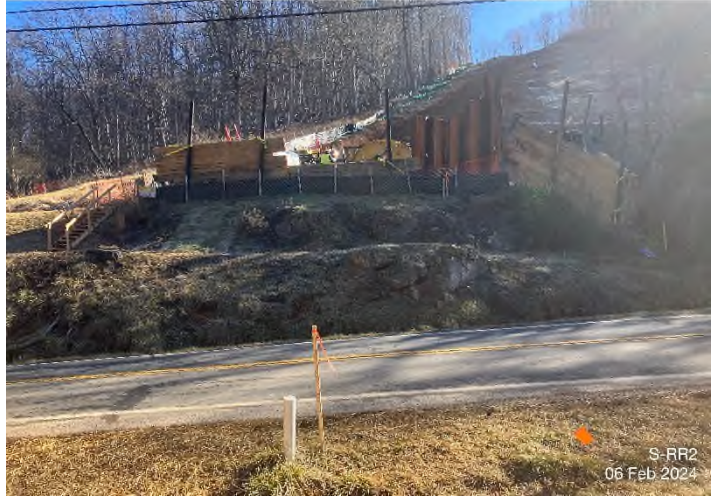
S-RR2
06 Feb 2024

Figure 6: Route 42 Crossing – Controls in place and functioning properly.

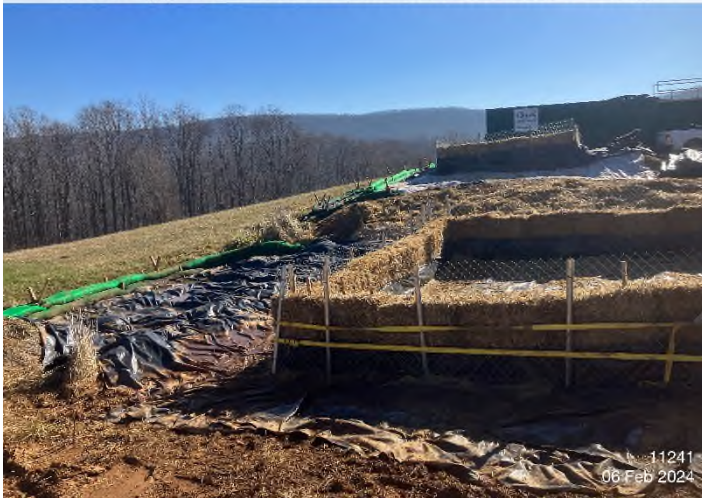
11241
06 Feb 2024

Figure 7: STA 11241+00 – Controls in place and functioning properly.

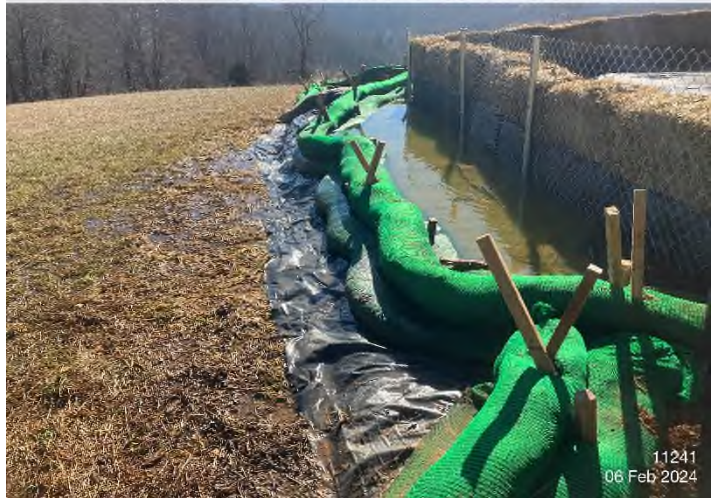
11241
06 Feb 2024

Figure 8: STA 11241+00 – Controls in place and functioning properly.
