FIELD INSPECTION REPORT

Project Name:	Mountain Valley Pipeline	Inspector:	Matthew Grant
Inspection Date:	Monday, February 26, 2024	Project Contact:	Brian Clauto
Spread G: Giles	Sta 10512-10514+60, 10600, 11023+80, 11026-11015+58 ATWS 610, 610A, 1145, 1146 AR GI 244, 234	Weather:	Dry

FIELD INSPECTION PHOTO LOG

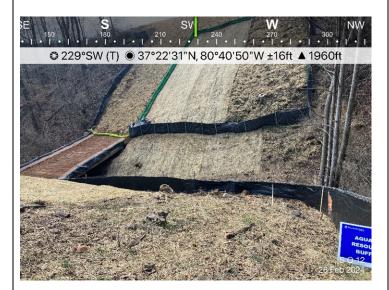
Figure 1: Designated stream S-Q12, ESC is in place.

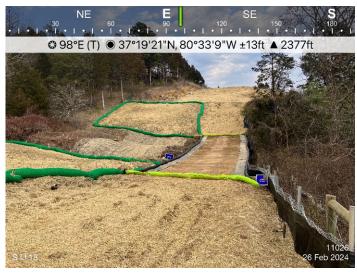
Figure 2: Designated stream S-IJ18, ESC is in place.

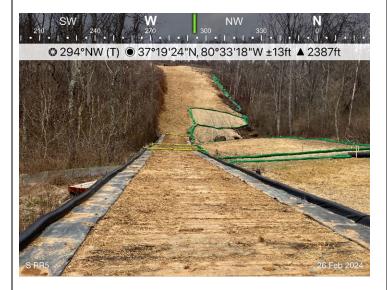
Figure 3: Designated stream S-RR5, ESC is in place.

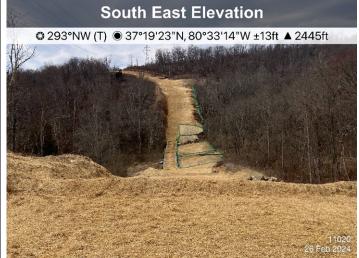
Figure 4: Sta 11020, area is stabilized and ESC is in place.
