## COMPLAINT INVESTIGATION REPORT

<b>Project Name:</b>	Mountain Valley Pipeline	<b>Inspector:</b>	Marshall Willis
<b>Inspection Date:</b>	Thursday, February 29, 2024	<b>Project Contact:</b>	Brian Clauto, Cory Chalmers
<b>Spread H: Roanoke County</b>	STA 12938+00 – 12960+00 MVP-RO-287 MVP-RO-288	<b>Weather:</b>	Wet

## FIELD INSPECTION PHOTO LOG

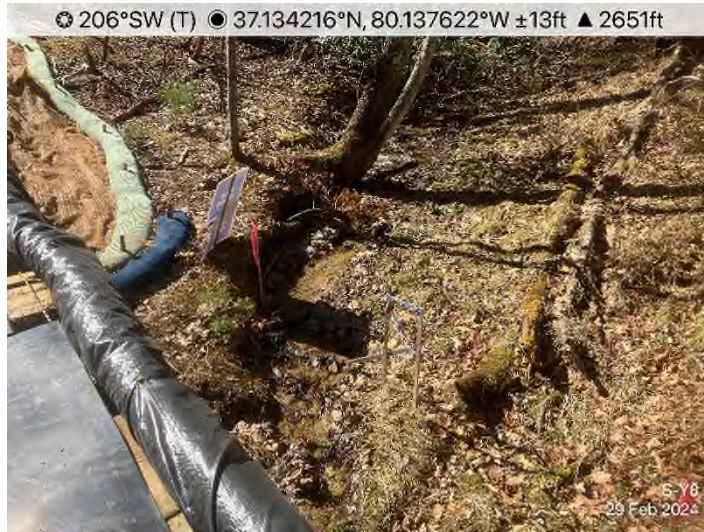
**Figure 1: Stream S-Y8** – Looking upstream at S-Y7 from equipment crossing.

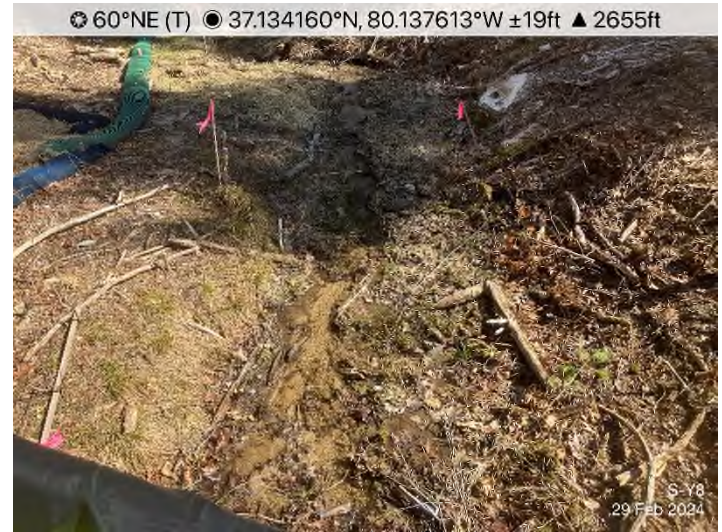
**Figure 2: Stream S-Y8** – Looking downstream at S-Y7 from equipment crossing.

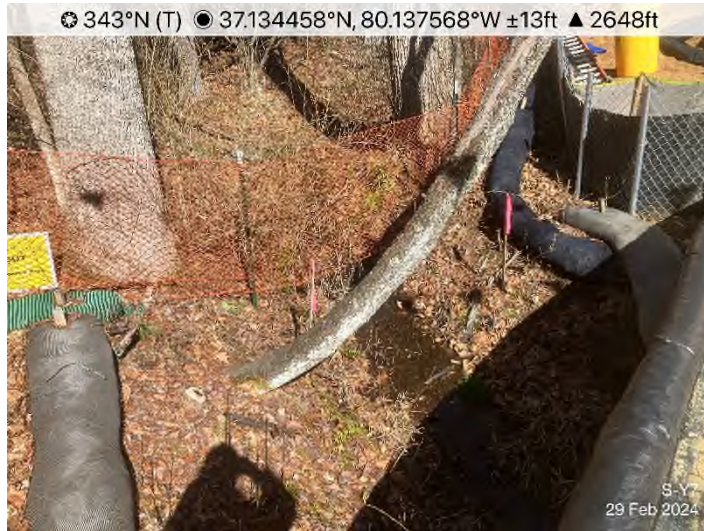
**Figure 3: Stream S-Y7** – Looking upstream at S-Y7 from equipment crossing.

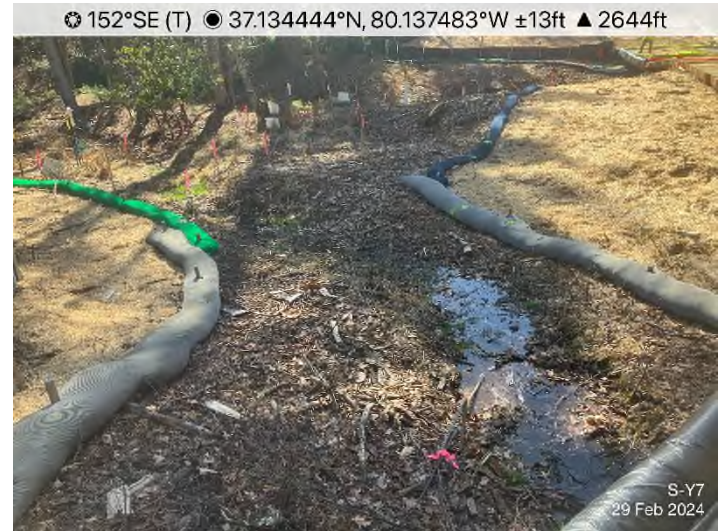
**Figure 4: Stream S-Y7** – Looking downstream at S-Y7 from equipment crossing.

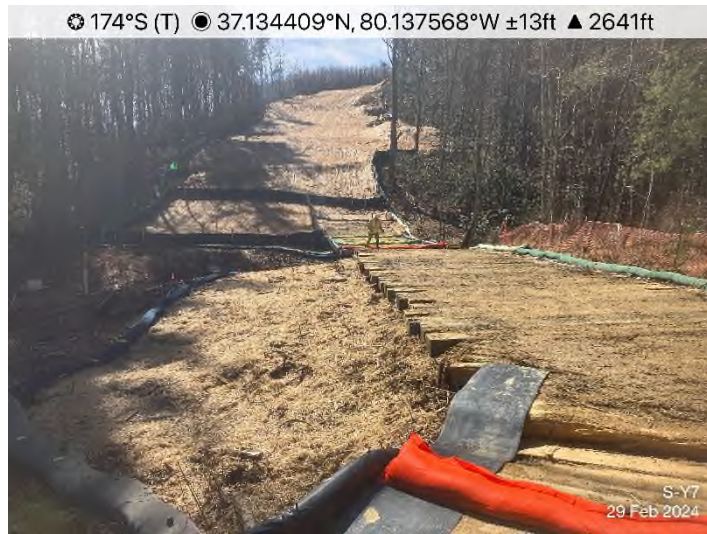
**Figure 5: Stream S-Y7/S-Y8 Crossing** – Controls in place and functioning properly. Area is temporarily stabilized.

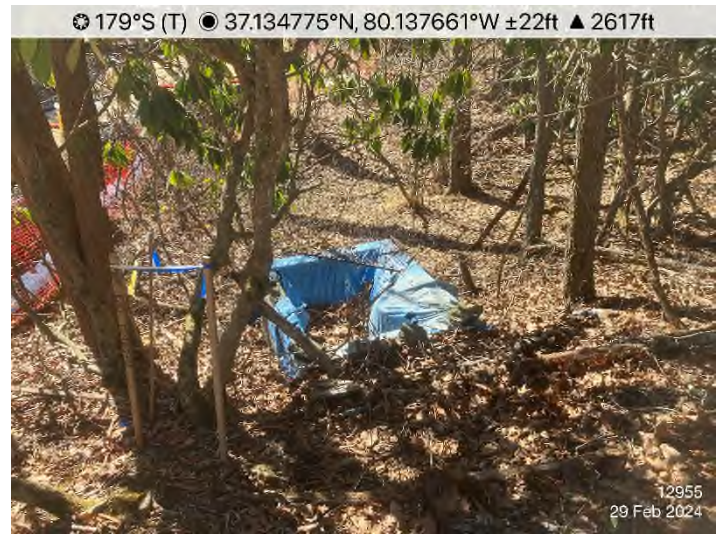
**Figure 6: STA 12955+93** – Looking south at S-Y9 and associated spring box.

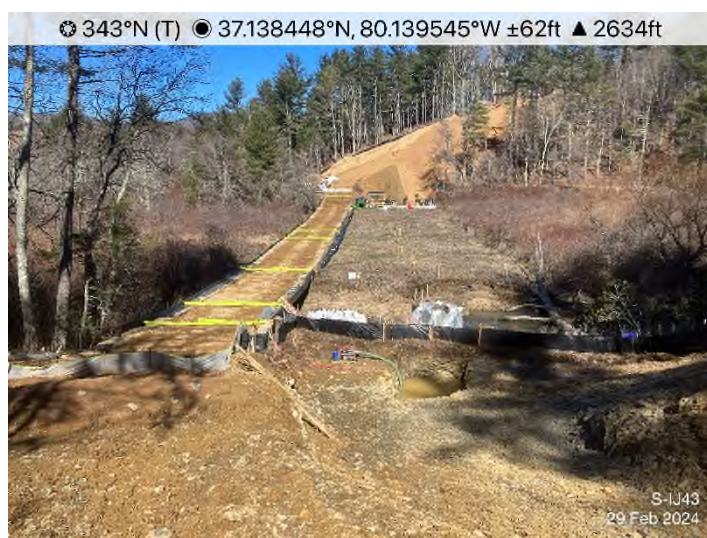
**Figure 7: Stream S-IJ43/Wetland W-IJ36** – Looking north at active bore site for Mill Creek and associated wetland. Controls in place and functioning properly.

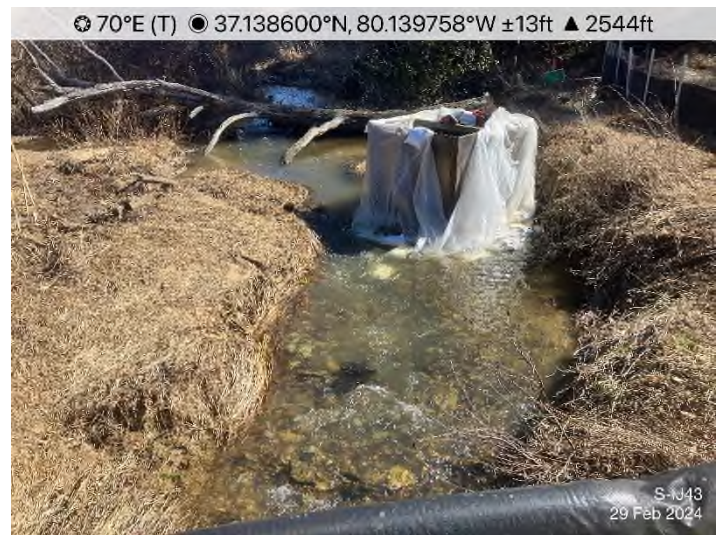
**Figure 8: Stream S-IJ43** – Looking upstream at Mill Creek from equipment bridge.

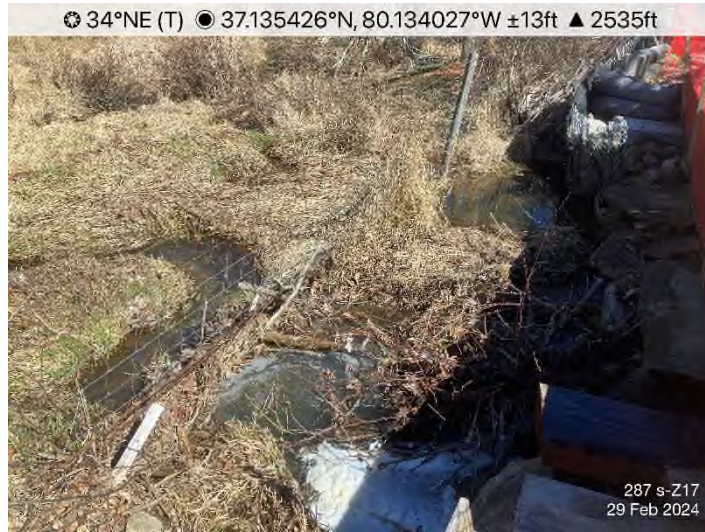
**Figure 9: MVP-RO-287** – Looking downstream at Stream S-Z17 from Green Hollow Dr.

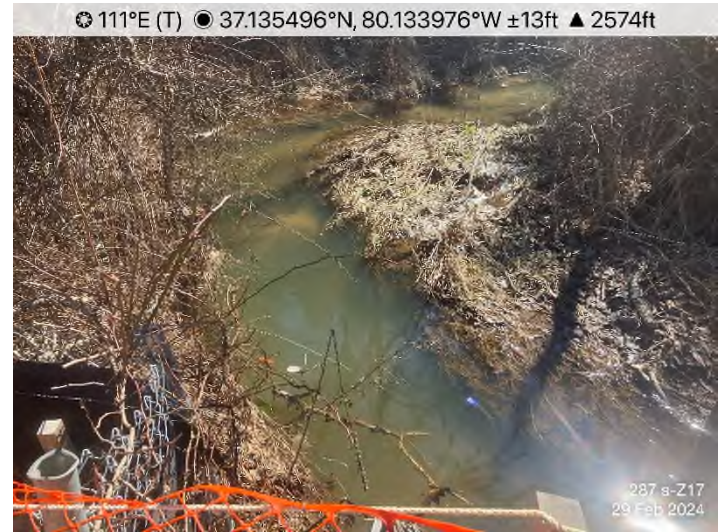
**Figure 10: MVP-RO-287** – Looking upstream at Stream S-Z17 from Green Hollow Dr.

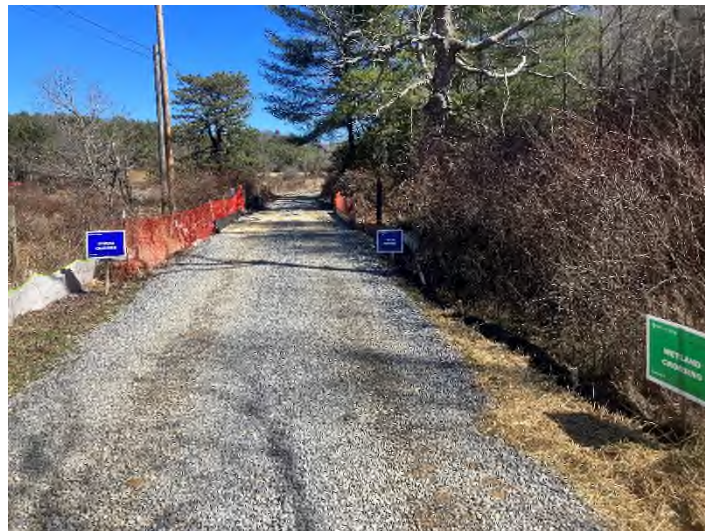
**Figure 11: MVP-RO-287** – Stream S-Z17 and Green Hollow Dr.
