COMPLAINT INVESTIGATION REPORT

Project Name:	Mountain Valley Pipeline	Inspector:	Marshall Willis
Inspection Date:	Friday, March 15, 2024	Project Contact:	Brian Clauto, Cory Chalmers
Spread H: Roanoke County	STA 12938+19 – 12957+38 MVP-RO-287	Weather:	Rainy

FIELD INSPECTION PHOTO LOG

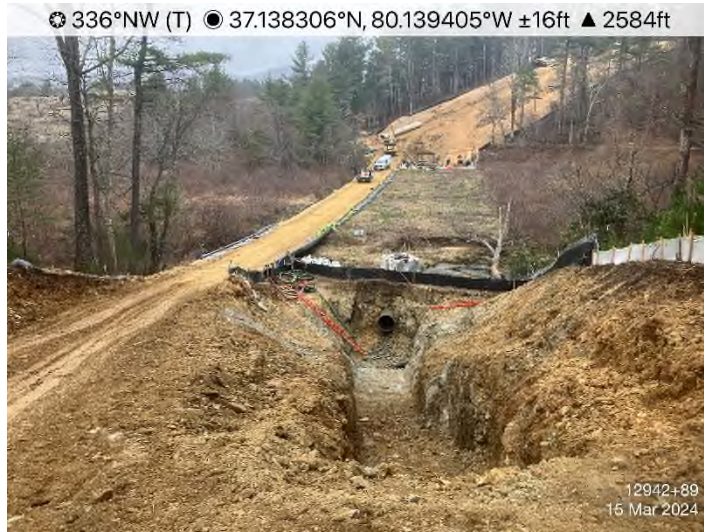
Figure 1: STA 12942+89 – Looking NW at Wetland W-IJ36 and S-IJ43 (Mill Creek) bore site.

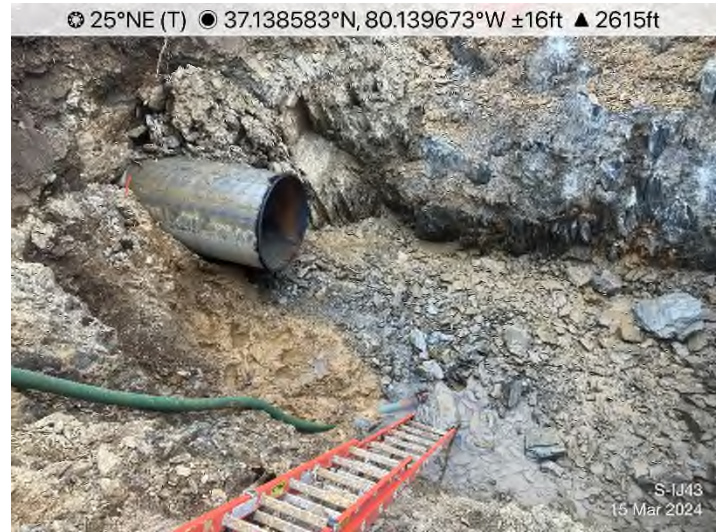
1. Water entering the worksite is properly being treated and discharged.
2. No sedimentation was found to be impacting W-IJ36 or S-IJ43 (Mill Creek).
3. No sediment discharged off ROW was found during the inspection.
4. Controls were installed and functioning properly. No corrective actions were noted during the inspection.

Figure 2: Stream S-IJ43 – Exit bore pit shown. Water entering bore pit is treated properly.

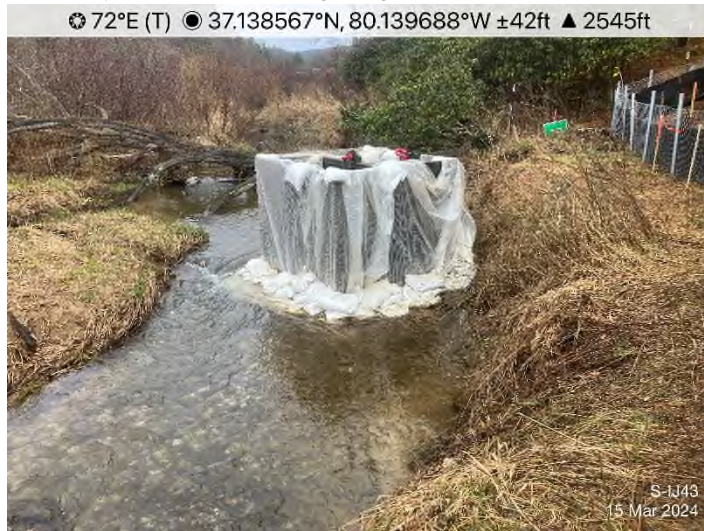
Figure 3: Stream S-IJ43 – Looking upstream at Mill Creek from temporary equipment crossing bridge.

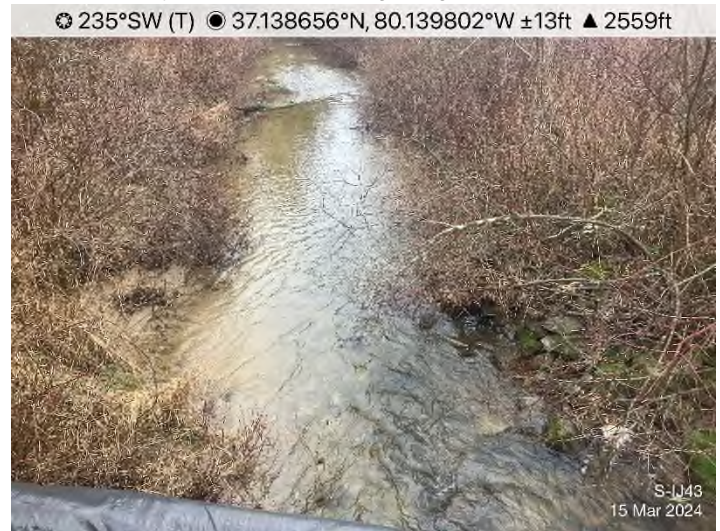
Figure 4: Stream S-IJ43 – Looking downstream at Mill Creek from temporary equipment crossing bridge.

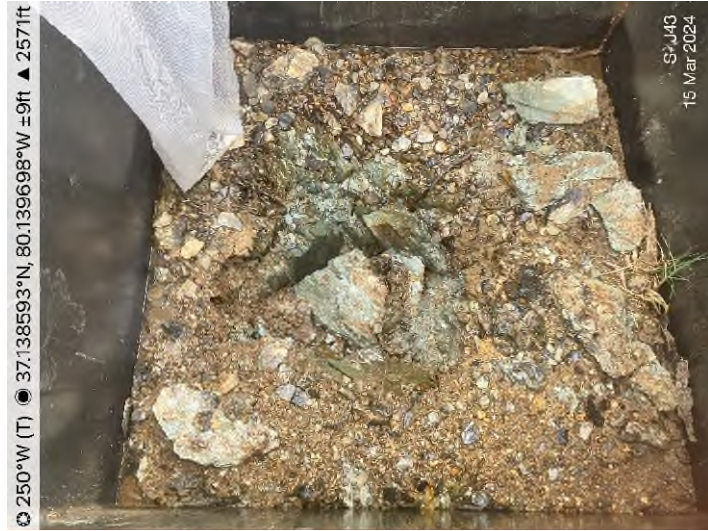
Figure 5: Stream S-IJ43 – Looking into the temporary coffer dam placed inside Mill Creek.

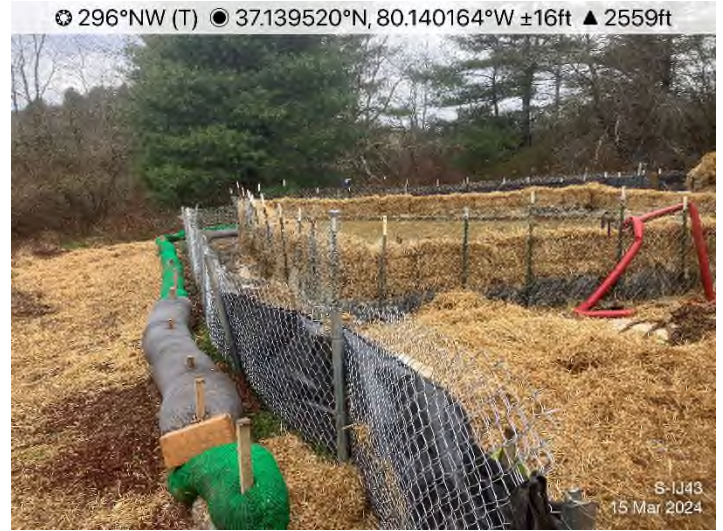
Figure 6: STA 12938+00 – Dewatering structure for boring operation at S-IJ43 and W-IJ36.

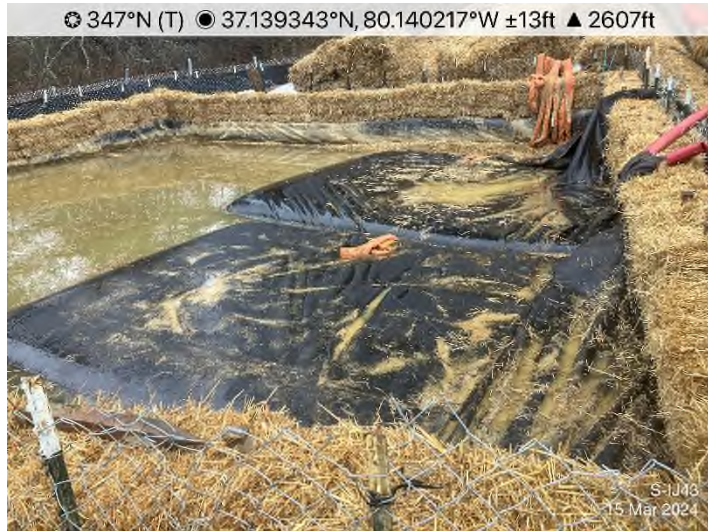
Figure 7: STA 12938+00 – Dewatering structure for boring operation.

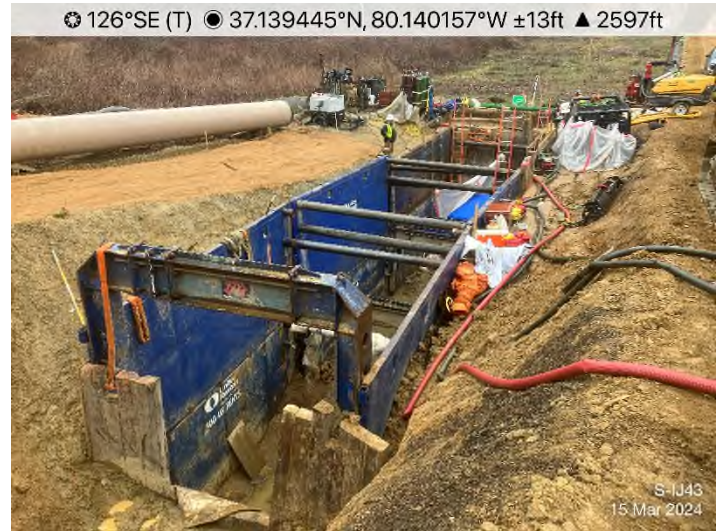
Figure 8: STA 12938+00 – Bore pit entrance for S-IJ43 and W-IJ36.
