FIELD INSPECTION REPORT

Project Name:	Mountain Valley Pipeline	Inspector:	Matthew Grant
Inspection Date:	Monday, March 25, 2024	Project Contact:	Brian Clauto
Spread G: Giles	Sta11230+70-11158+68 ATWS 1370, 1370A, 1347, 1464, 1369 AR MLV25, GI249.01, 249.02, 249.03	Weather:	Dry

FIELD INSPECTION PHOTO LOG

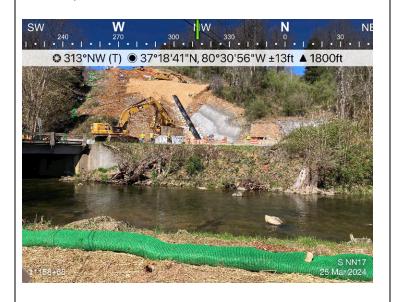
Figure 1: Designated crossing S-NN17, stabilization and ESC are in place.

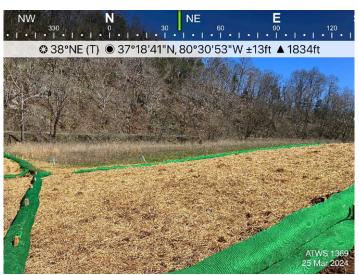
Figure 2: ATWS 1369, stabilization and ESC are in place.

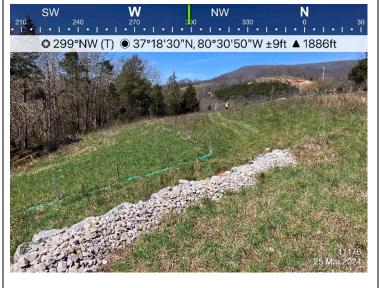
• <u>Figure 3:</u> Sta 11176, ESC and permanent style waterbars are in place.

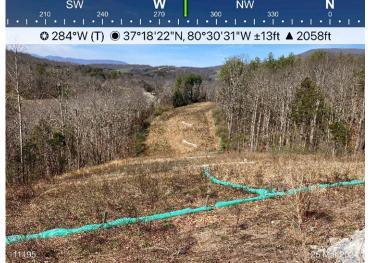
<u>Figure 4</u>: Sta 11195, ESC and permanent style waterbars are in place.
