FIELD INSPECTION REPORT

Project Name:	Mountain Valley Pipeline	Inspector:	Matthew Grant
Inspection Date:	Tuesday, April 16, 2024	Project Contact:	Brian Clauto
Spread G: Montgomery	Sta 11670-11767+26 AR MLV 26	Weather:	Dry

FIELD INSPECTION PHOTO LOG

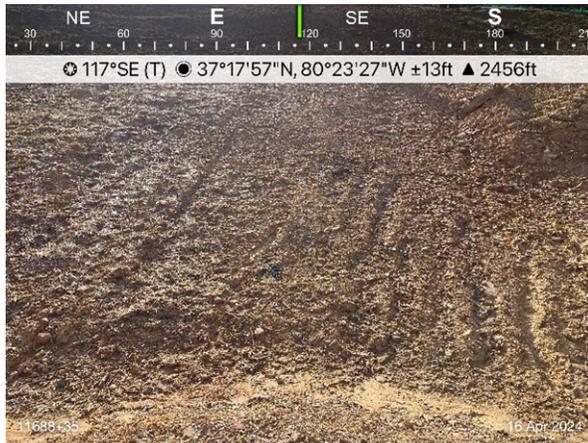
- Figure 1: Sta 11688+35, area lacks adequate stabilization and is showing signs of rill erosion.

- Sta 11690-11688+35, repair rill and restabilize.
- MVP MLV 26 repair rill and re stabilize.

Recommended Corrective Action: Maintain and install all controls per the approved PSS&S.

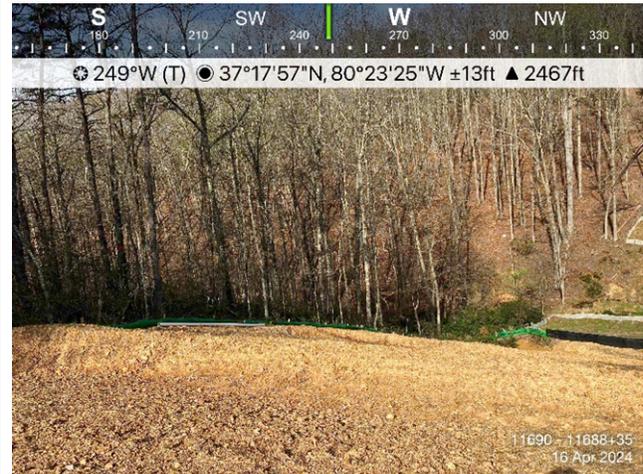
- Figure 2: Sta 11690, area lacks adequate stabilization.

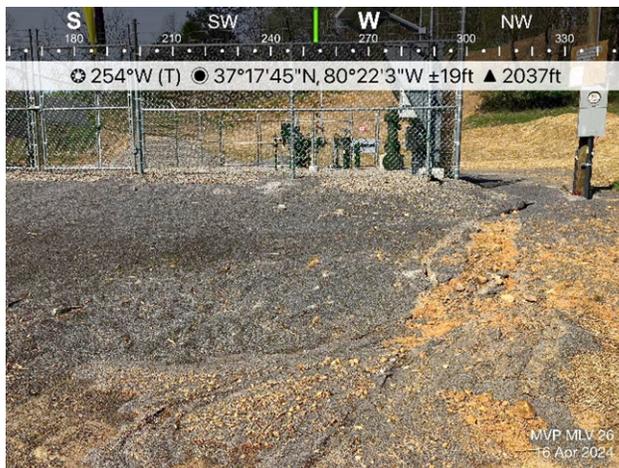
- Figure 3: MVP MLV 26 station, rear of pad area is showing signs rill erosion.

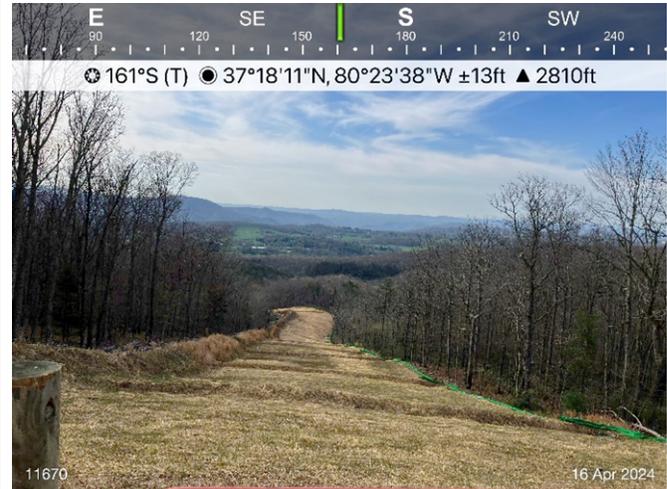
- Figure 4: Sta 11670, area is stabilized and ESC is in place.
