## FIELD INSPECTION REPORT

<b>Project Name:</b>	Mountain Valley Pipeline	<b>Inspector:</b>	Matthew Grant
<b>Inspection Date:</b>	Tuesday, June 4, 2024	<b>Project Contact:</b>	Brian Clauto
<b>Spread G: Giles</b>	Sta 11767+44, 11670-11680, 11158-11158+68, 11040-11020, 11254, 11614+20-11600 ATWS 1145, 1146, AR GI 244, 258.04	<b>Weather:</b>	Dry

# FIELD INSPECTION PHOTO LOG

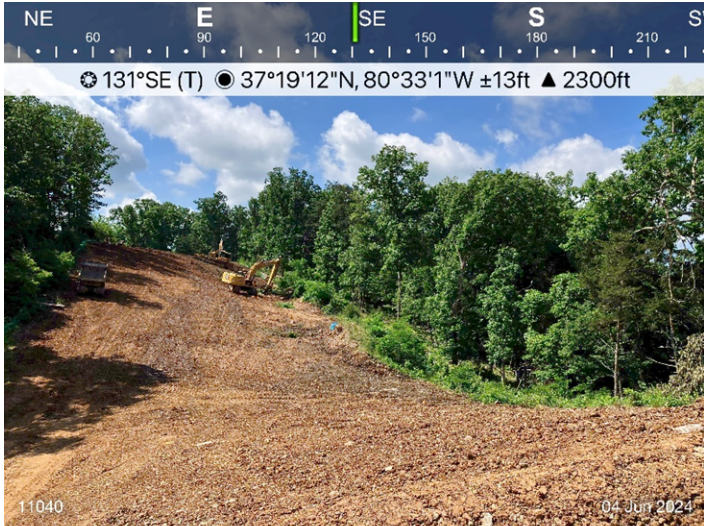
Figure 1: Sta 11040, final grading is being constructed.

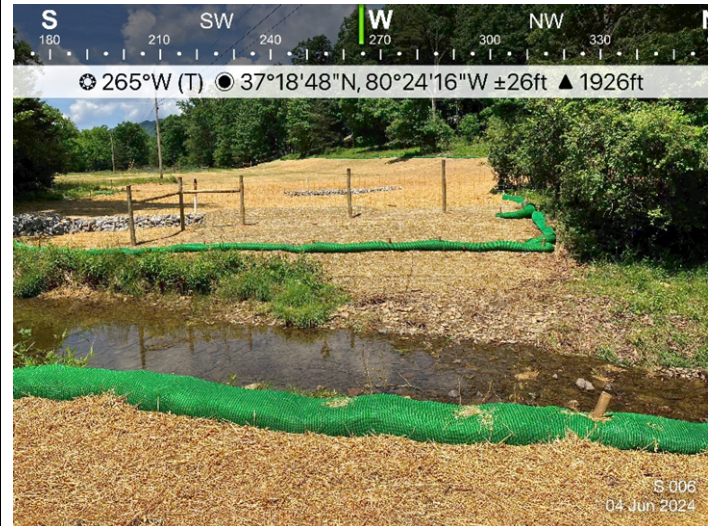
Figure 2: Designated crossing S-006, ESC is in place.

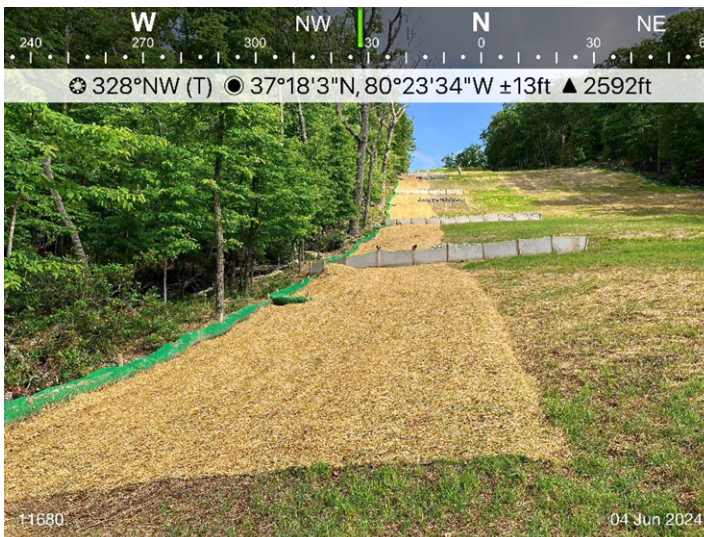
Figure 3: Sta 11680, ESC is in place.

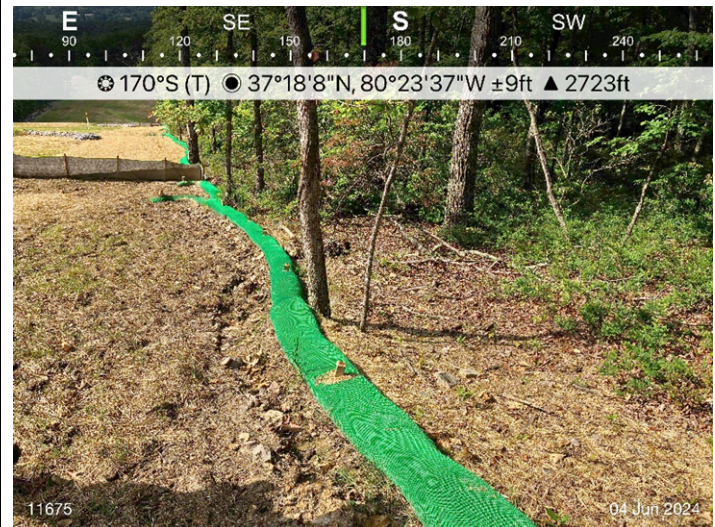
- Sta 11675 rill erosion requires repair and re stabilized.

Figure 4: Sta 11675, approximately 30ft of erosion requires repair and re stabilized.

**Recommended Corrective Action:** Maintain and install all controls per the approved PSS&S.

**Deadline:** Within 72-Hour of Notification
