FIELD INSPECTION REPORT

Project Name:	Mountain Valley Pipeline	Inspector:	Matthew Grant
Inspection Date:	Tuesday, June 25, 2024	Project Contact:	Brian Clauto
Spread G: Giles	Sta 11156+80-11158, 10700-10690 ATWS 1391, 1390, 816 AR GI 241.04	Weather:	Dry

FIELD INSPECTION PHOTO LOG

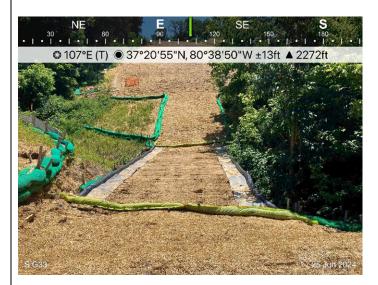
Figure 1: Designated crossing S-G33, ESC is in place.

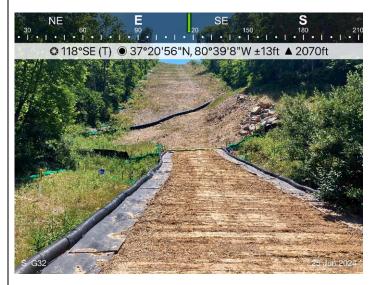
■ Figure 2: Designated crossing S-G32, ESC is in place.

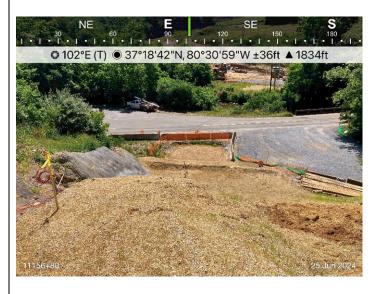
Figure 3: Sta 1156+80, ESC is in place.

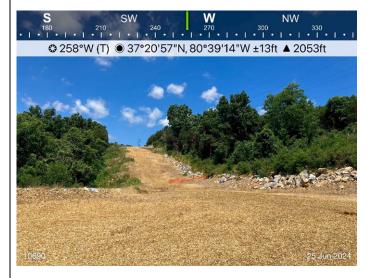
■ Figure 4: Sta 10690, ESC is in place.
