FIELD INSPECTION REPORT

Project Name:	Mountain Valley Pipeline	Inspector:	Marshall Willis
Inspection Date:	Tuesday, June 25, 2024	Project Contact:	Brian Clauto, Cory Chalmers
Spread G: Giles County	STA 11150+00 – 11160+00 STA 11053+00 – 11064+00 STA 10920+00 – 10929+71 MVP-GI-245.01 MVP-GI-249 MVP-MLV-AR-25	Weather:	Dry

FIELD INSPECTION PHOTO LOG

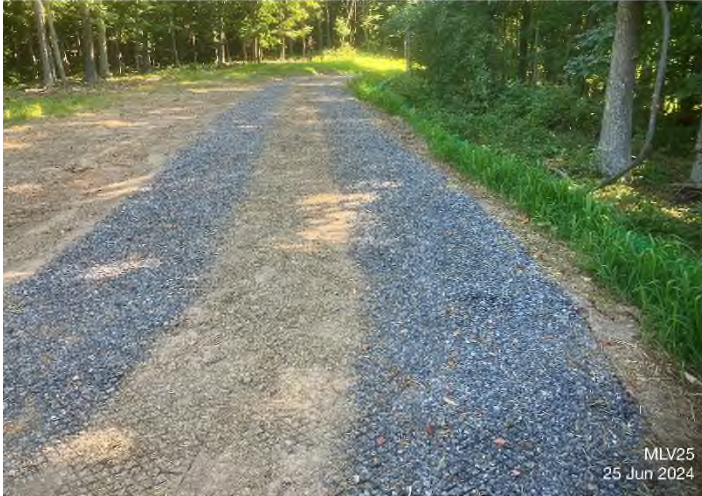
Figure 1: MLV-AR-25 – Controls in place and functioning properly.

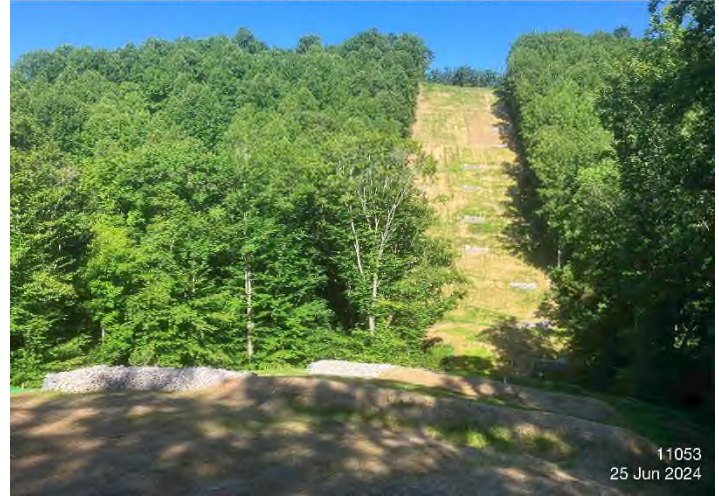
Figure 2: STA 11053+00 – Controls in place and functioning properly.

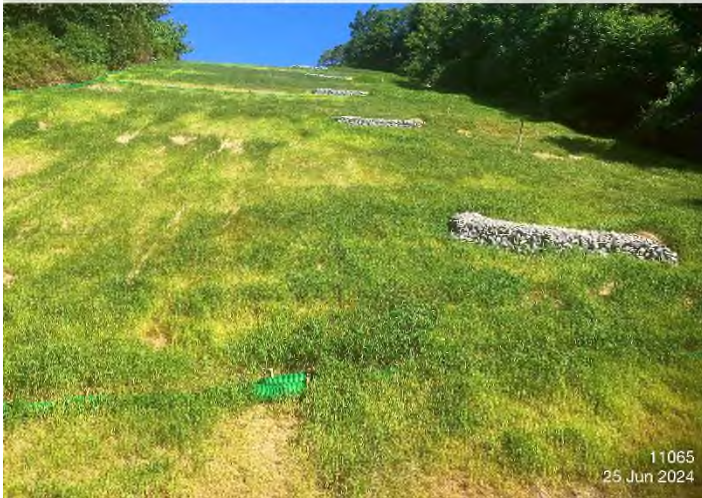
Figure 3: STA 11065+00 – Controls in place and functioning properly.

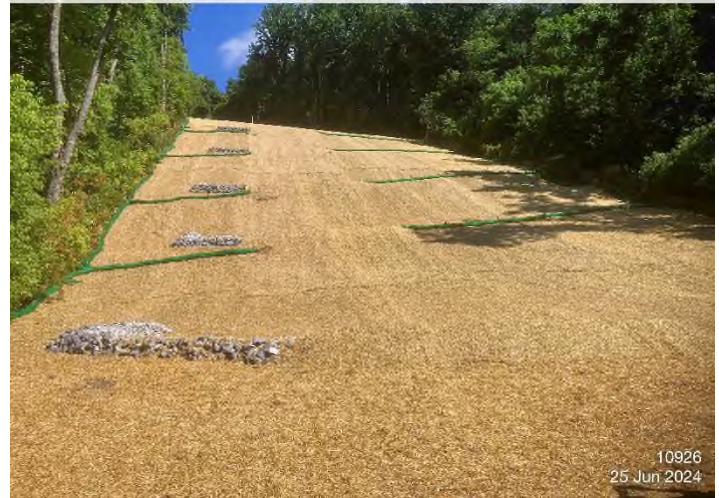
Figure 4: STA 10926+00 – Controls in place and functioning properly.
