FIELD INSPECTION REPORT

Project Name:	Mountain Valley Pipeline	Inspector:	Matthew Grant
Inspection Date:	Wednesday, July 3, 2024	Project Contact:	Brian Clauto
Spread G: Giles	Sta 10880-10890, 11158+68-11160 ATWS 1360, 1333 AR GI 241.04	Weather:	Dry

FIELD INSPECTION PHOTO LOG

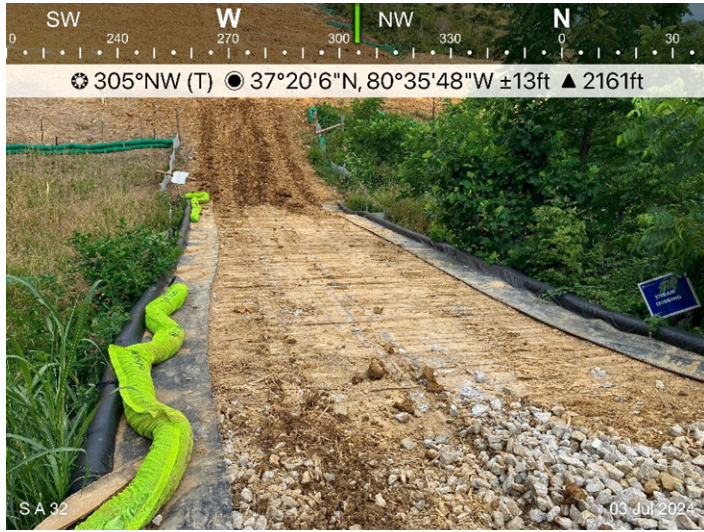
Figure 1: Designated crossing S-A32, ESC is in place for active construction.

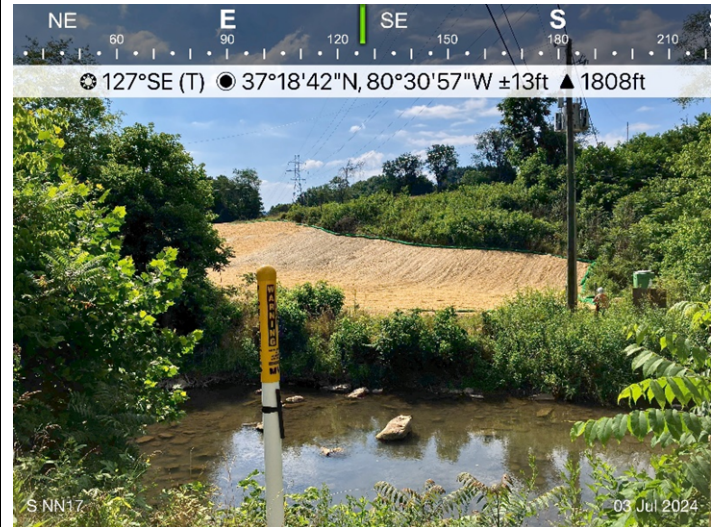
Figure 2: Designated crossing S-NN17, ESC is in place.

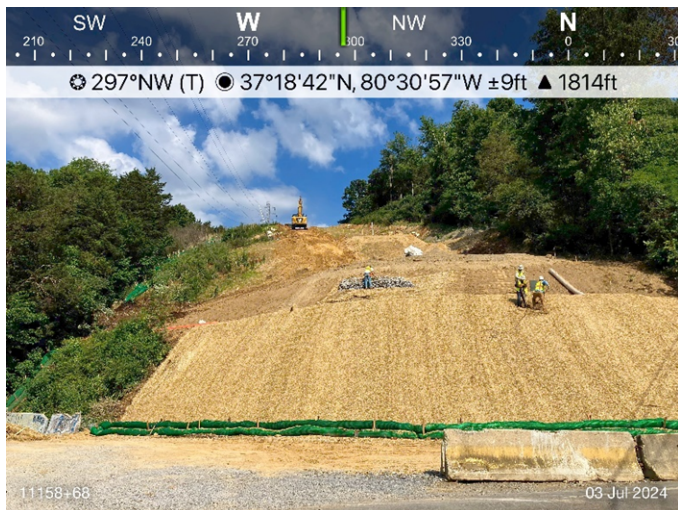
Figure 3: Sta 11158+68, ESC is in place.

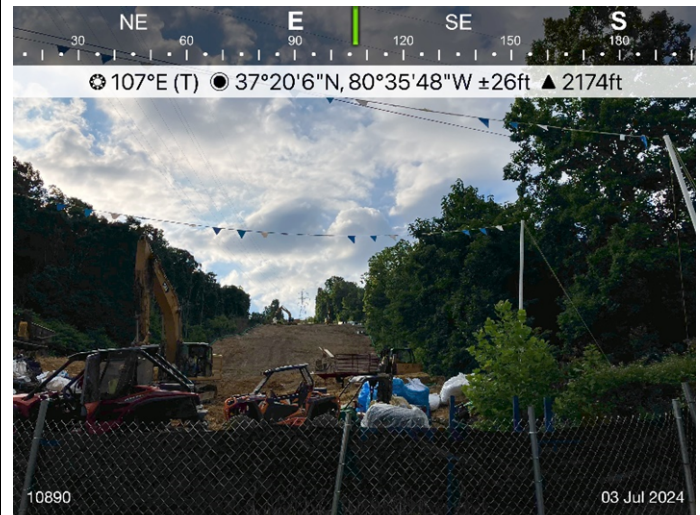
Figure 4: Sta 10890, permanent waterbars are being constructed and ESC is in place.
