STANDARDS & SPECIFICATIONS SITE INSPECTION REPORT LEVEL 1 (FIELD REPORT)

Project Name:	Mountain Valley Pipeline	S&S Program:	Mountain Valley Pipeline (SS027)
Inspector:	Marshall Willis	Inspection Date:	Tuesday, July 23, 2024
Project Contact:	Cory Chalmers Brian Clauto	Project Contact Email:	cchalmers@equitransmidstream.com bclauto@equitransmidstream.com
Spread G: Giles County	STA 10590+00 – STA 10620+00 STA 10640+00 – STA 10656+00 MVP-GI-240 MVP-GI-238 MVP-MLV-AR-24	Site Conditions:	Dry

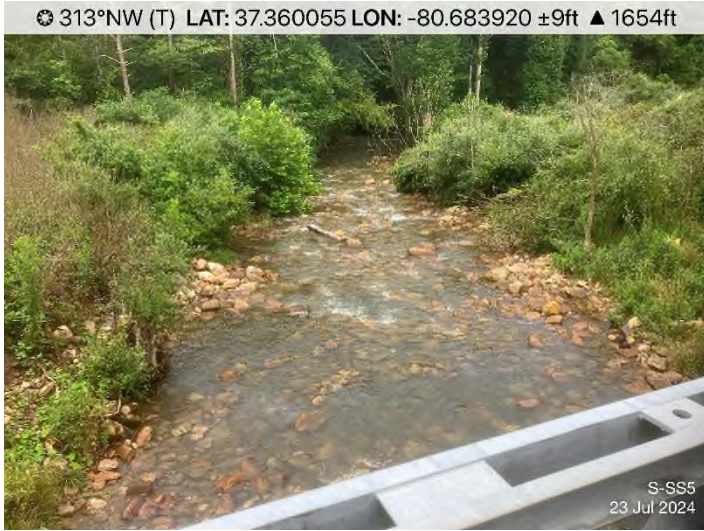
Fig. 1
Stream S-S5: Controls in place and functioning properly.

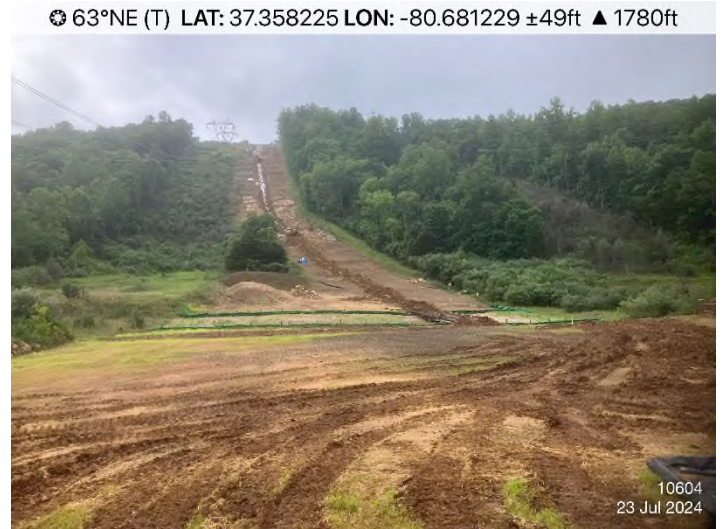
Fig. 2
STA 10604+00: Controls in place and functioning properly.

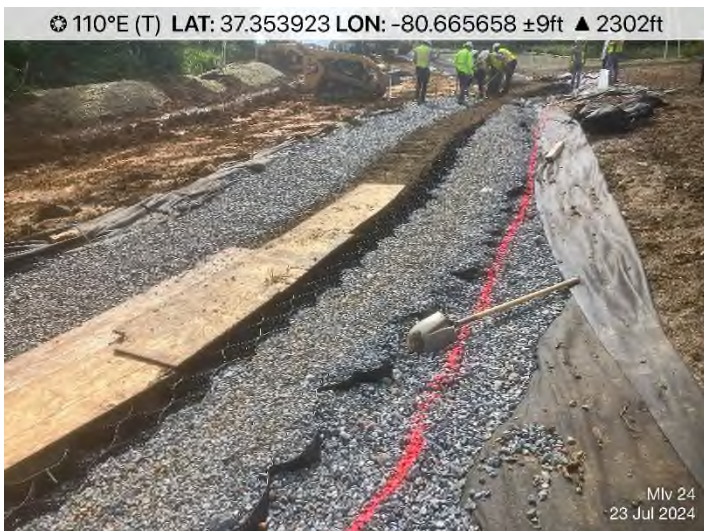
Fig. 3
MVP-MLV-AR-24: Controls in place and functioning properly.

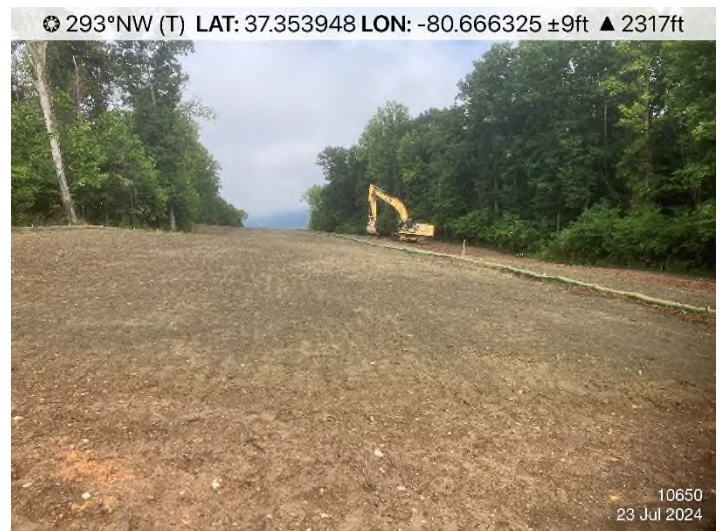
Fig. 4
STA 10650+00: Controls in place and functioning properly.
